Board of Park Commissioners  
January 16, 2026  
Rocky River Nature Center  
Erosion Protection

# Rocky River Nature Center – Erosion Protection

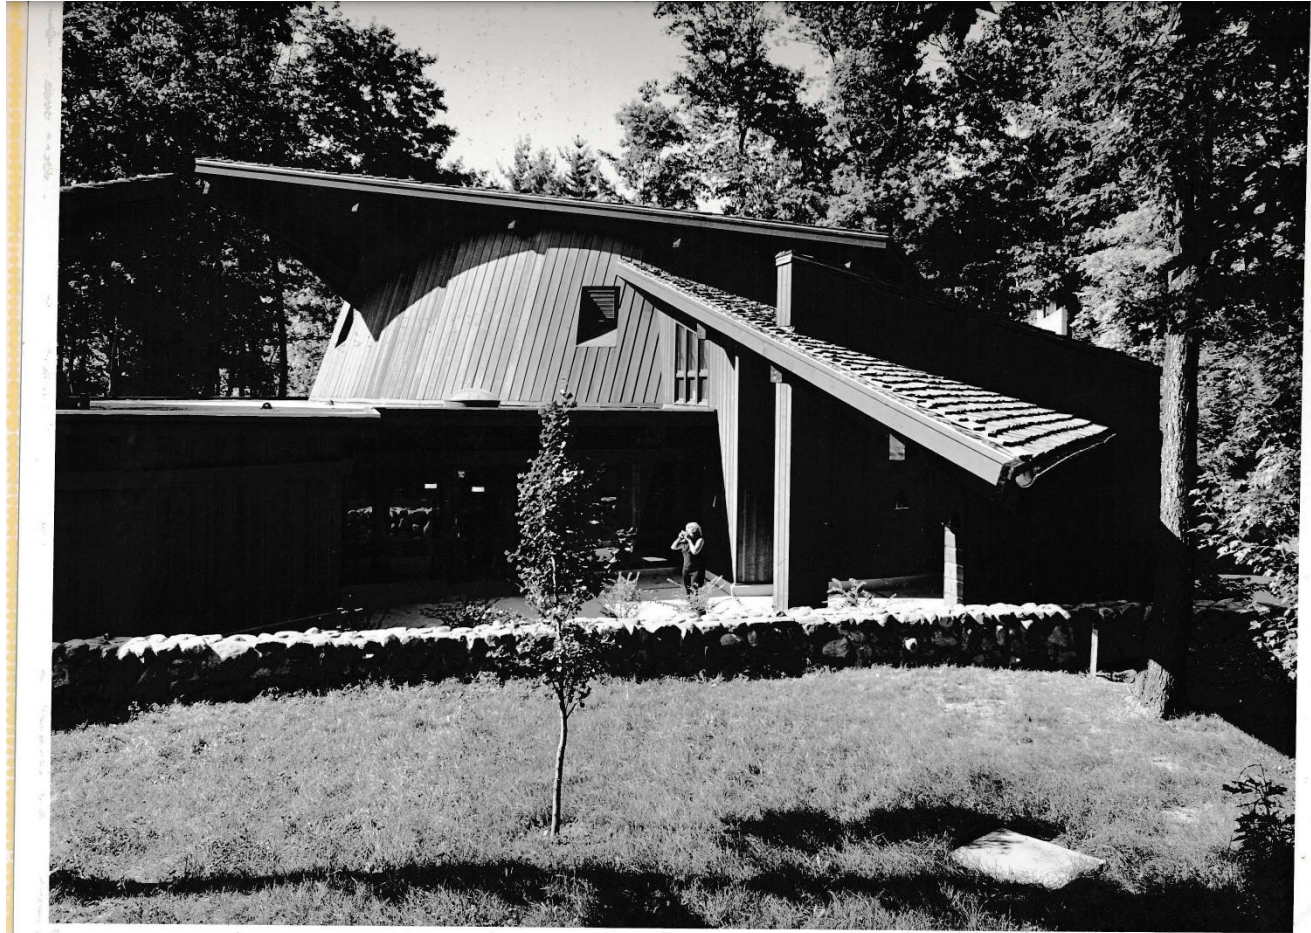
COLUMBIA CEDAR SIDING AND CEDAR SHAKE SHINGLES CREATE A RUSTIC ATMOSPHERE

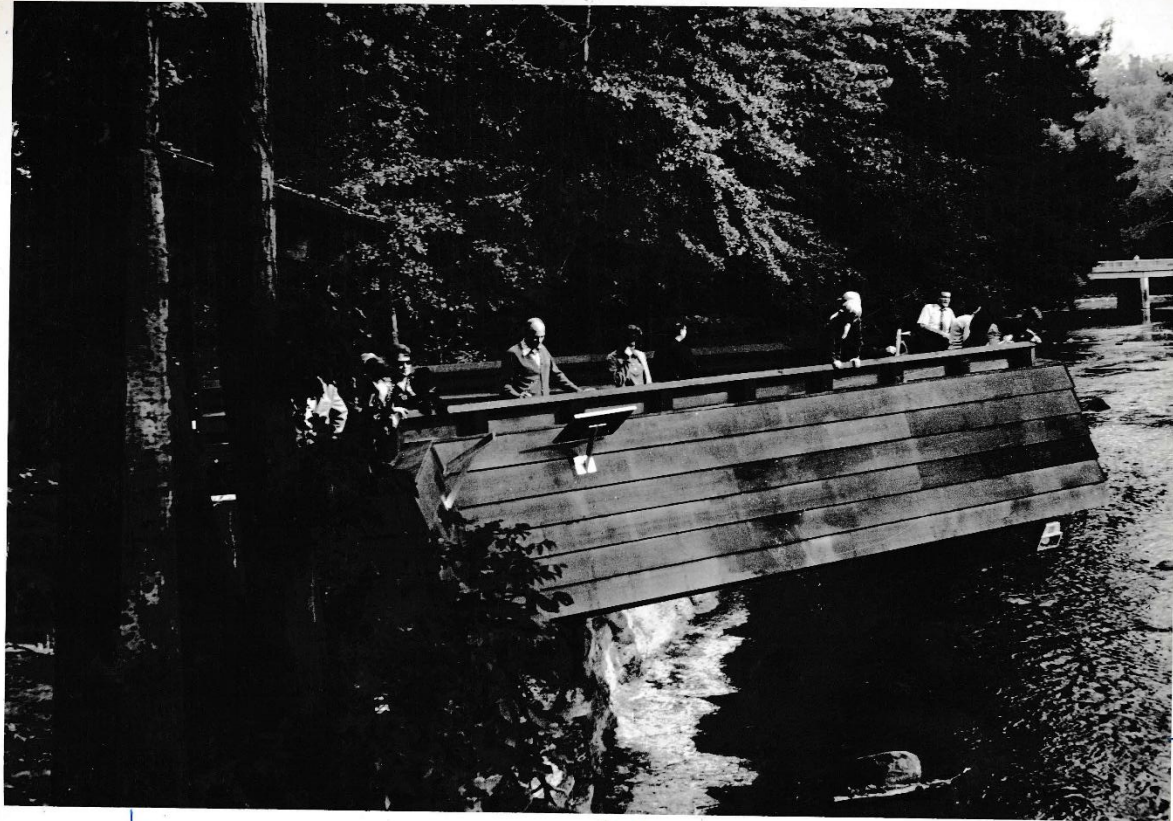
CANTILEVERED OBSERVATION DECK OVERLOOKS ROCKY RIVER IN CLEVELAND METROPOLITAN PARK

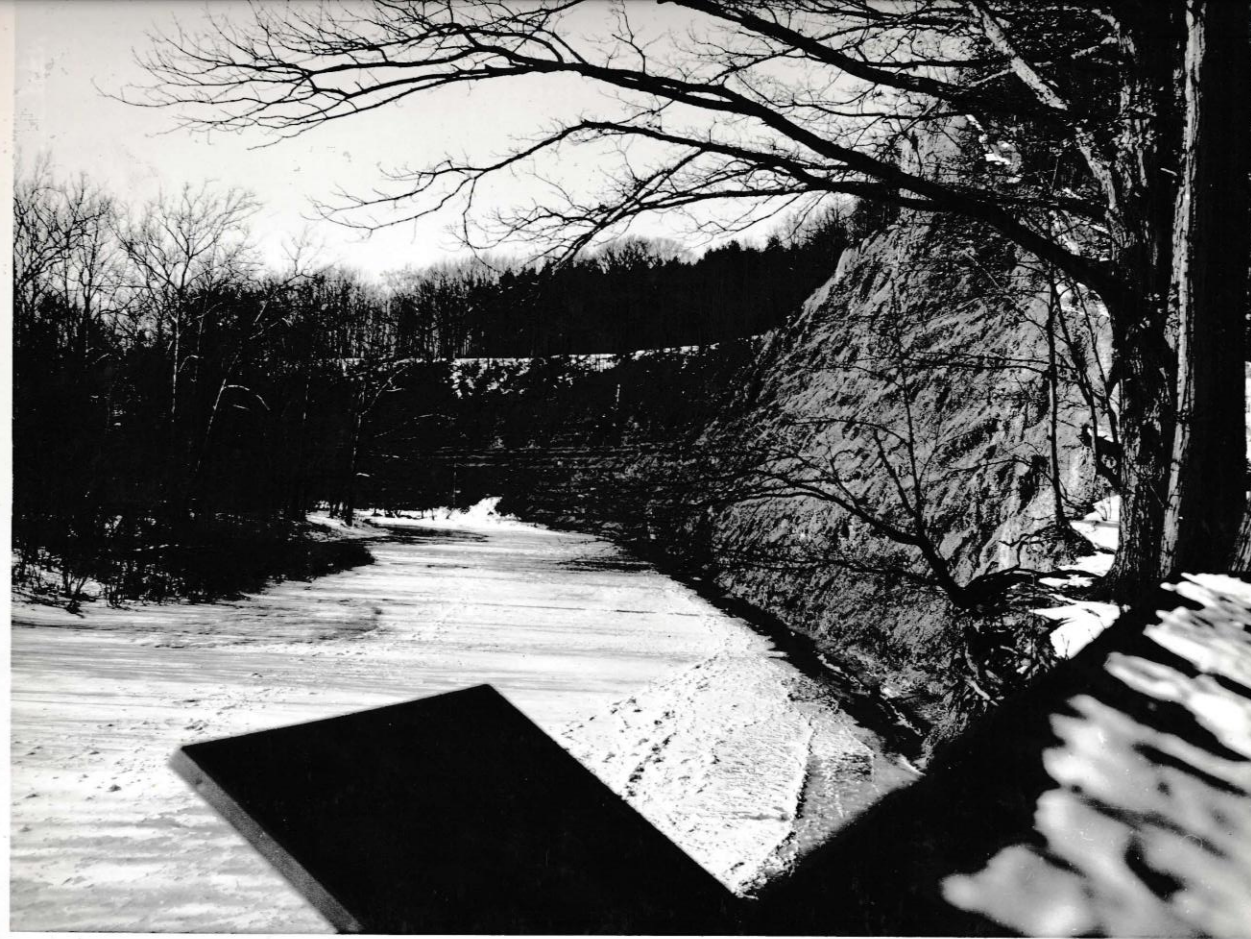
OBSERVATION DECK AFFORDS VIEW OF DEVONIAN PERIOD IN SHALE WALL

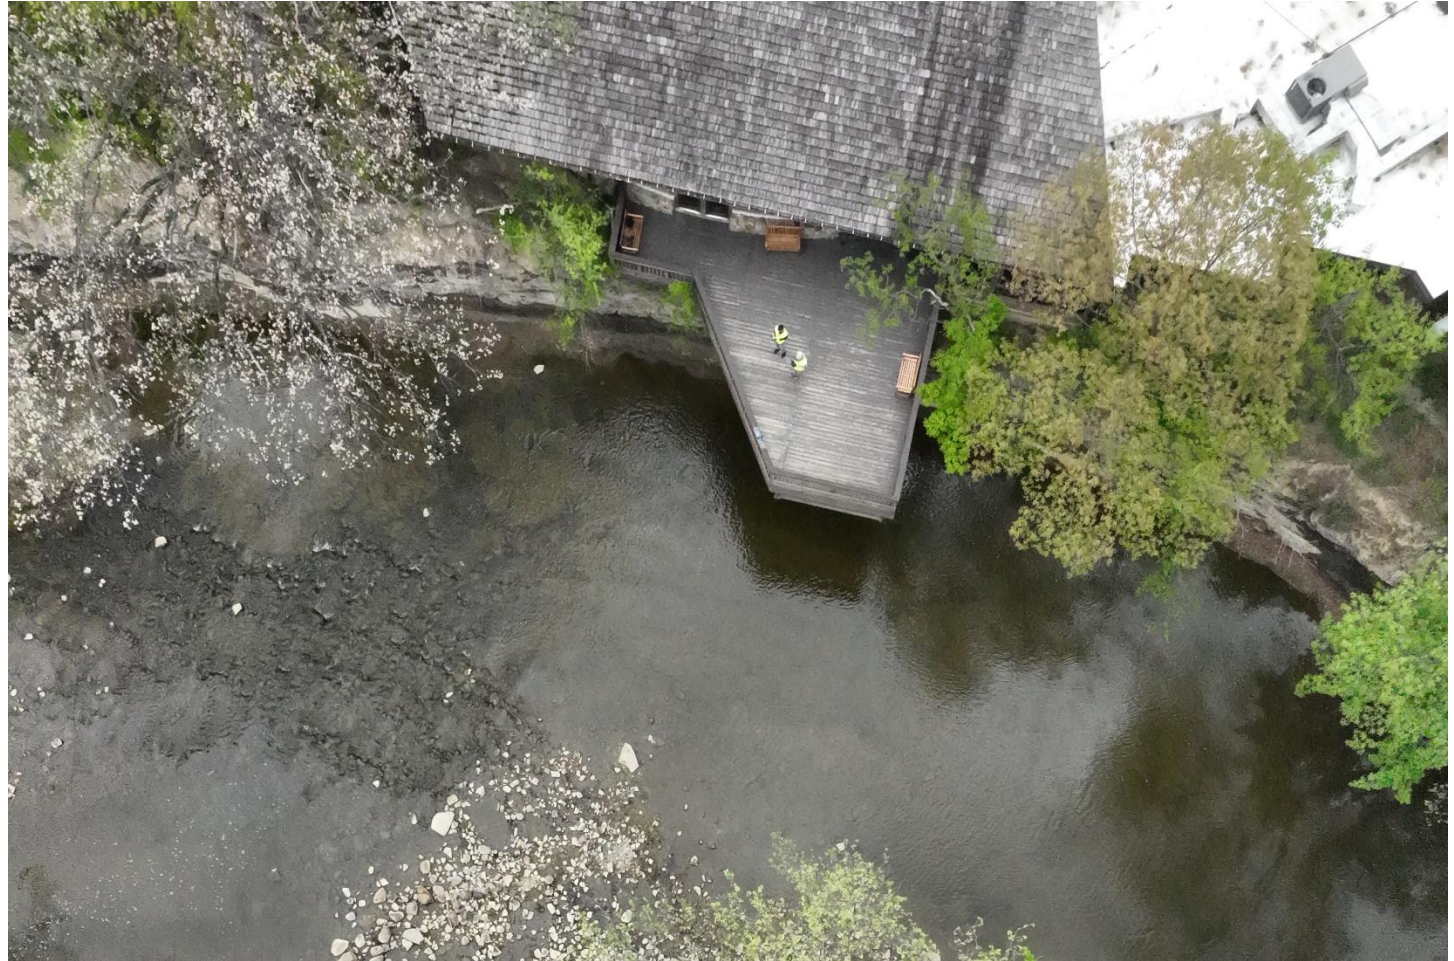
Based on historical architectural drawings and the most recent survey, the bluff has retreated roughly 4 feet since 1969.

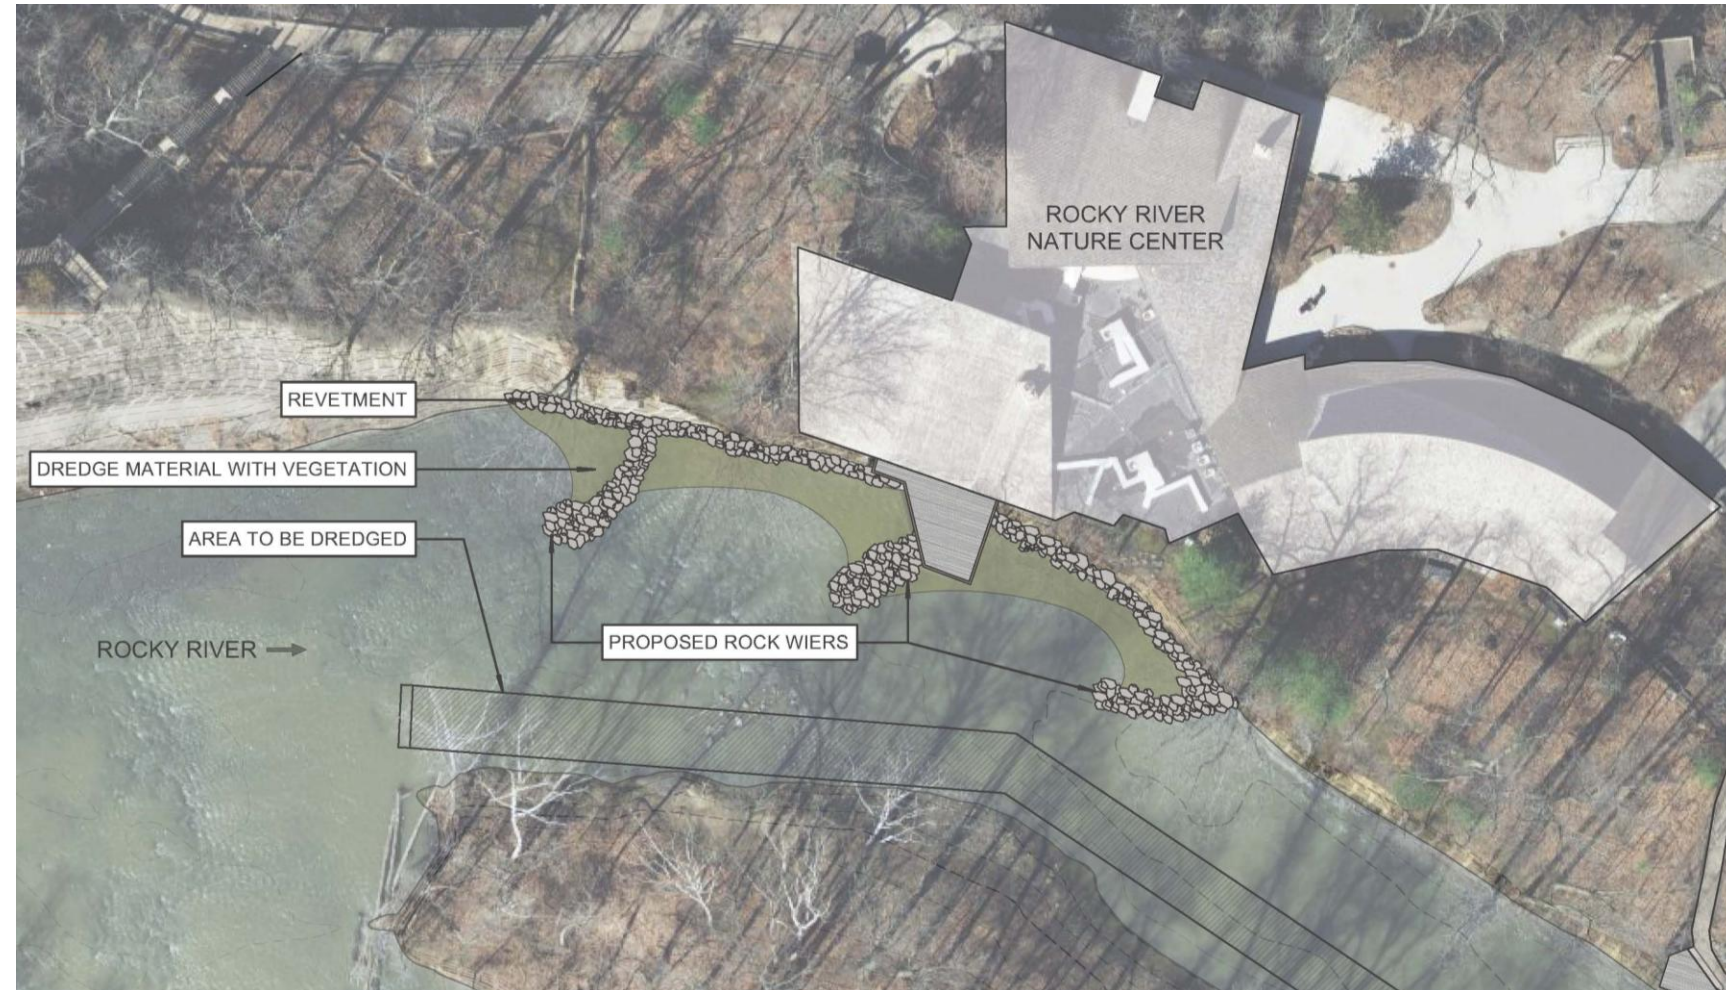
## Shoreline Protection Design

- **Stone revetment** along toe of bluff will protect it from constant erosion and undercutting
- **Rock weirs** and **vegetated fill** extending out into the river will direct flow away from the bluff
- **Dredged area** will also help direct flow away from the bluff
