Cleveland Metroparks®

TRAILS DIVISION 2020 YEARBOOK

BRECKSVILLE GORGE PROJECT

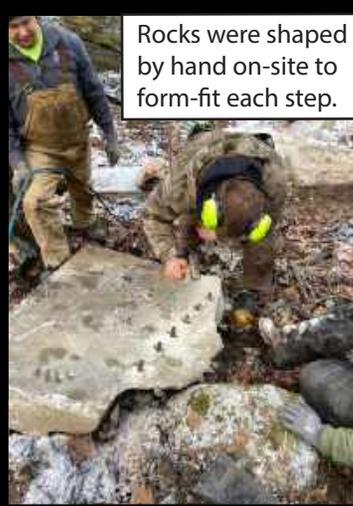
One of two shorter staircase sections completed along the main trail.

Rocks were shaped by hand on-site to form-fit each step.

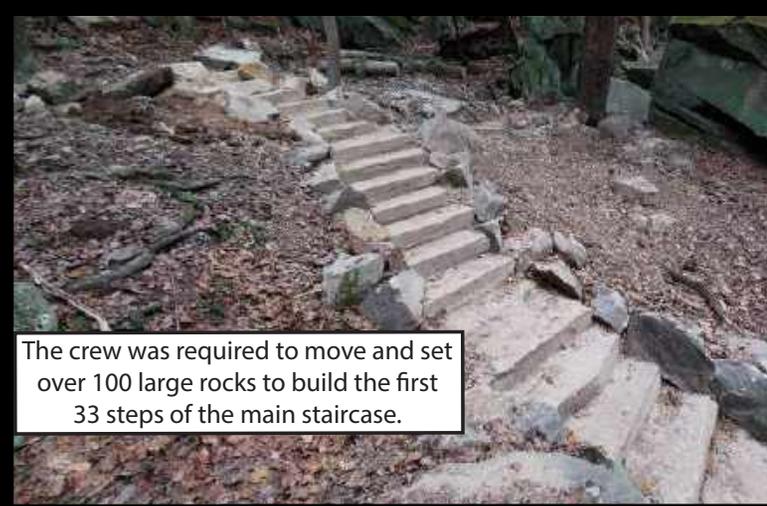
The crew was required to move and set over 100 large rocks to build the first 33 steps of the main staircase.

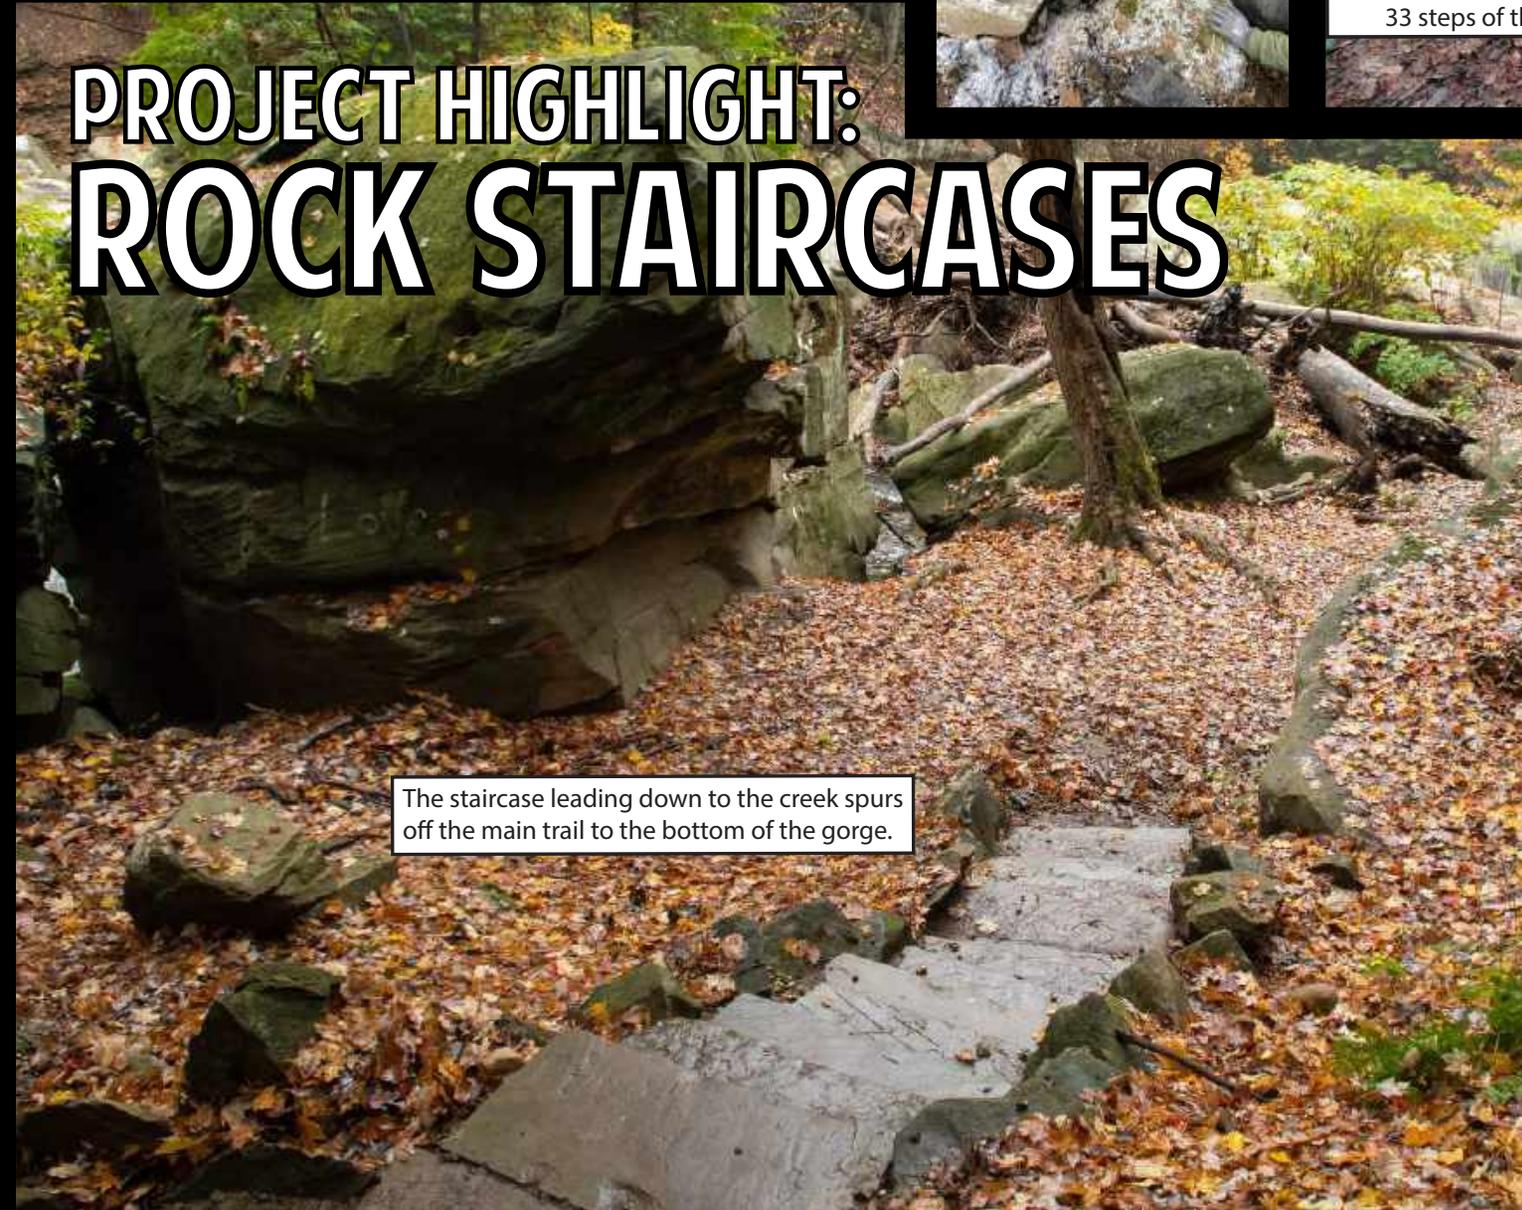
PROJECT HIGHLIGHT: ROCK STAIRCASES

The staircase leading down to the creek spurs off the main trail to the bottom of the gorge.

The rocks used to build the staircase were belayed down the hill using pulleys hung in trees and a special tool called a "griphoist."

The rocks often weighed 300-450 lbs and needed to be moved in 3-man teams using heavy steel bars to set the steps correctly.

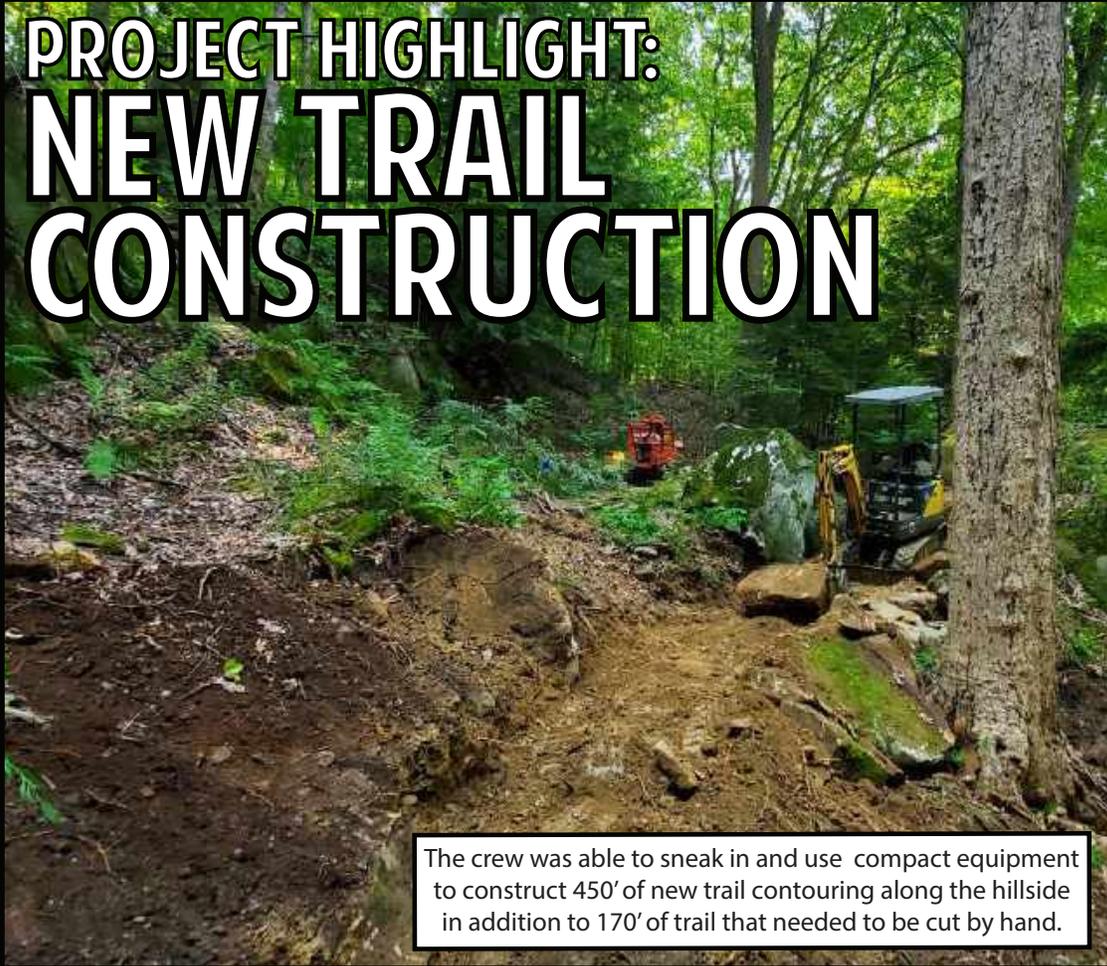
PROJECT HIGHLIGHT: NEW TRAIL CONSTRUCTION

The crew was able to sneak in and use compact equipment to construct 450' of new trail contouring along the hillside in addition to 170' of trail that needed to be cut by hand.

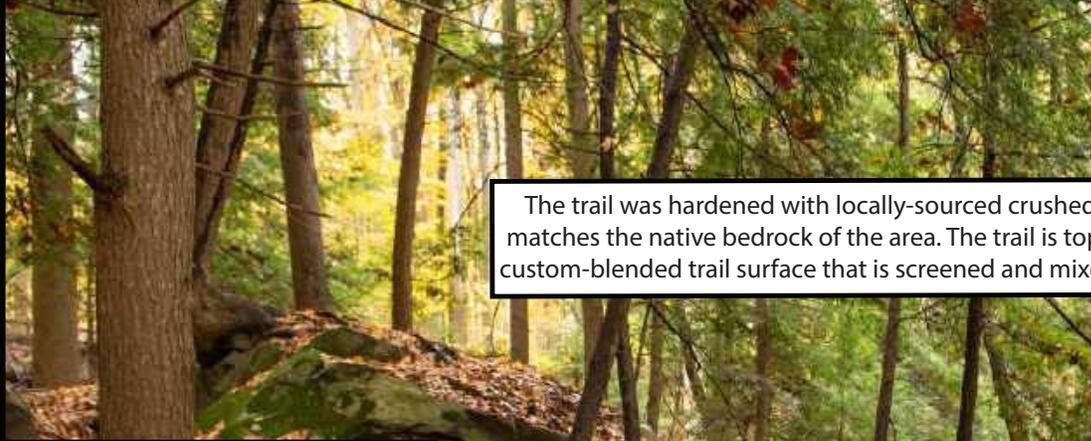
The trail was hardened with locally-sourced crushed rock that matches the native bedrock of the area. The trail is topped with a custom-blended trail surface that is screened and mixed in-house.

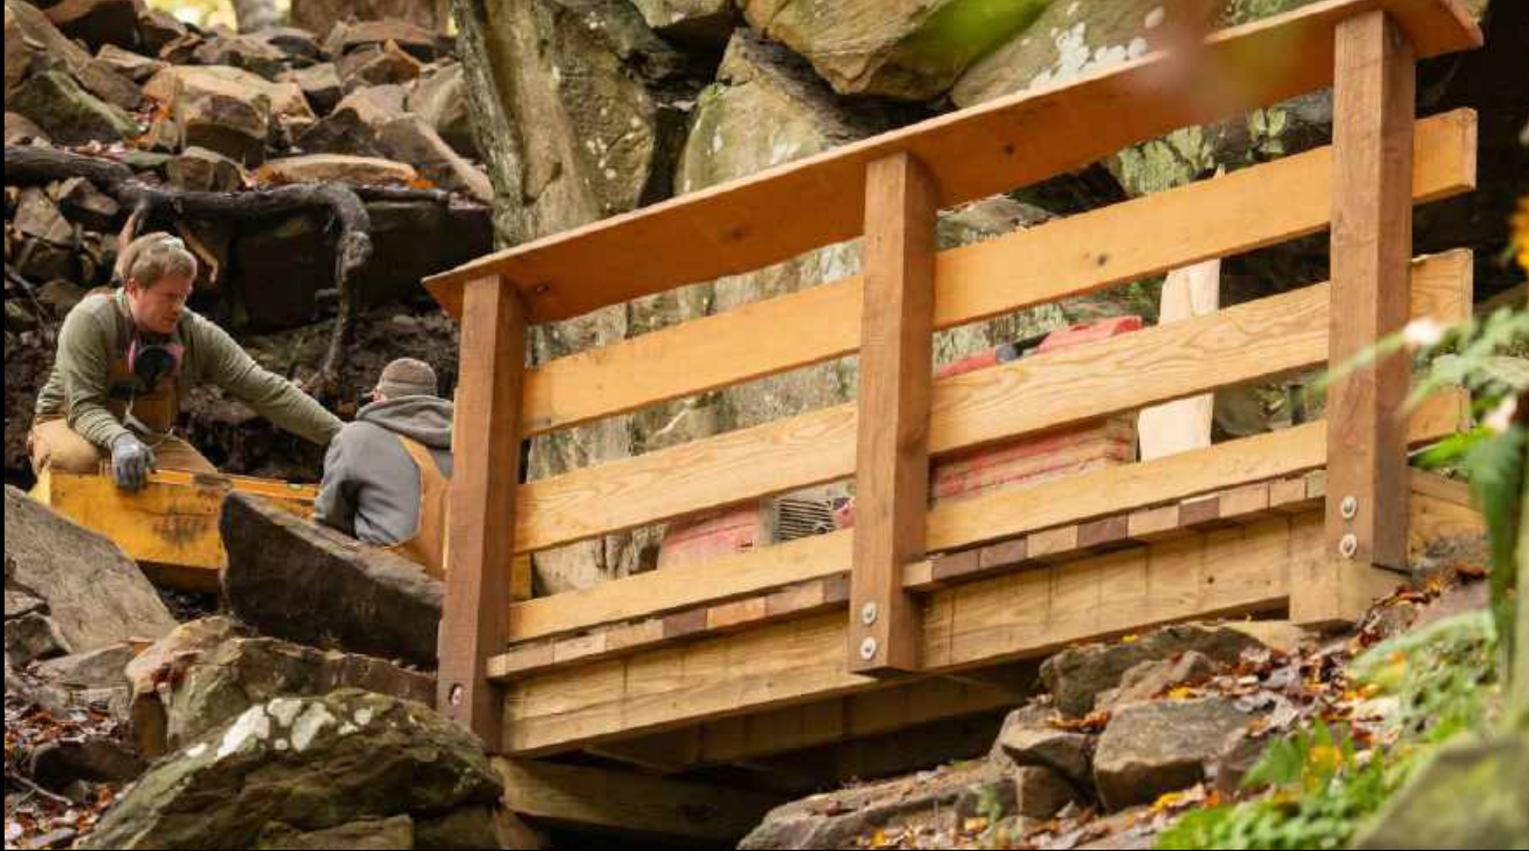
PROJECT HIGHLIGHT: OVERLOOK BRIDGE

The deck's railing and decking were made from park-sourced ash, cherry, walnut and white oak lumber that was milled in-house. The lumber was carried in and assembled entirely by hand at the difficult-to-access site.

Significant rockwork was required to support the trail up around the bridge.

The crew utilized rigging applications to set and pin large rocks on the steep hillside.

The surrounding bedrock was chiseled to fit the sills and were then anchored together using in-house fabricated brackets.

Extreme care was taken to not disturb the adjacent ledge and its vegetation.

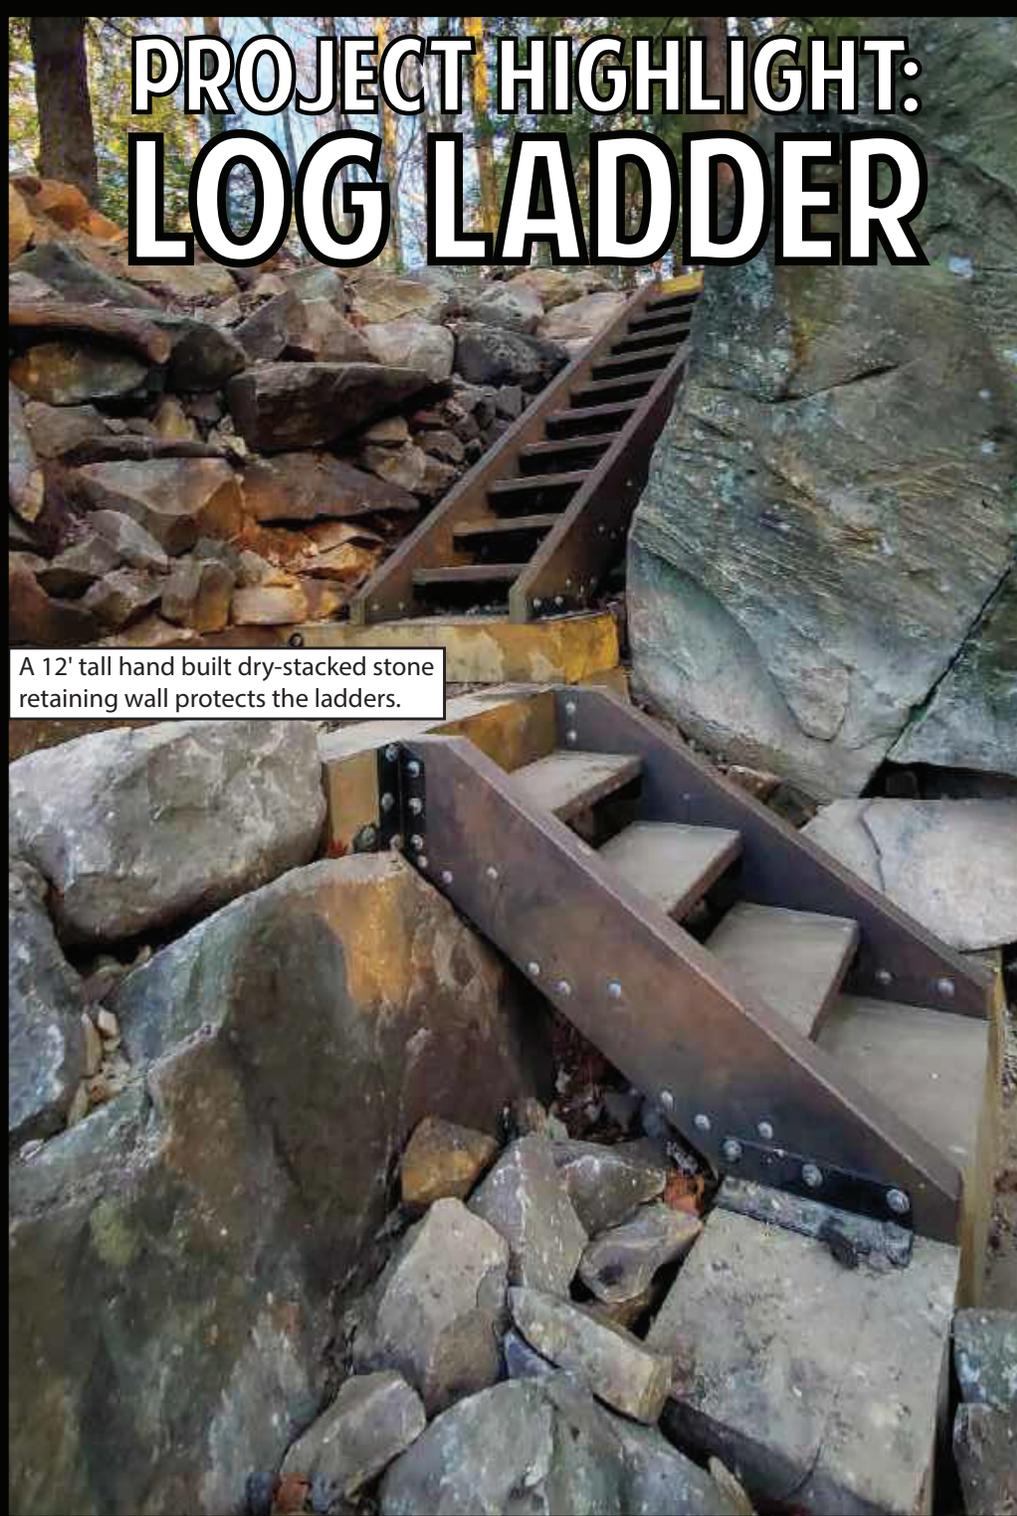
PROJECT HIGHLIGHT: LOG LADDER

A 12' tall hand built dry-stacked stone retaining wall protects the ladders.

The gravel used to build the trail landings was crushed by hand using rock generated from around the site. The material was carried in with buckets and tamped by hand.

Park-Sourced Black Walnut Lumber and Osage-Orange Beams were milled in-house.

The materials were carried in and assembled by hand to minimize disturbance to the site.

The step risers are supported by brackets that were welded and fabricated in-house.

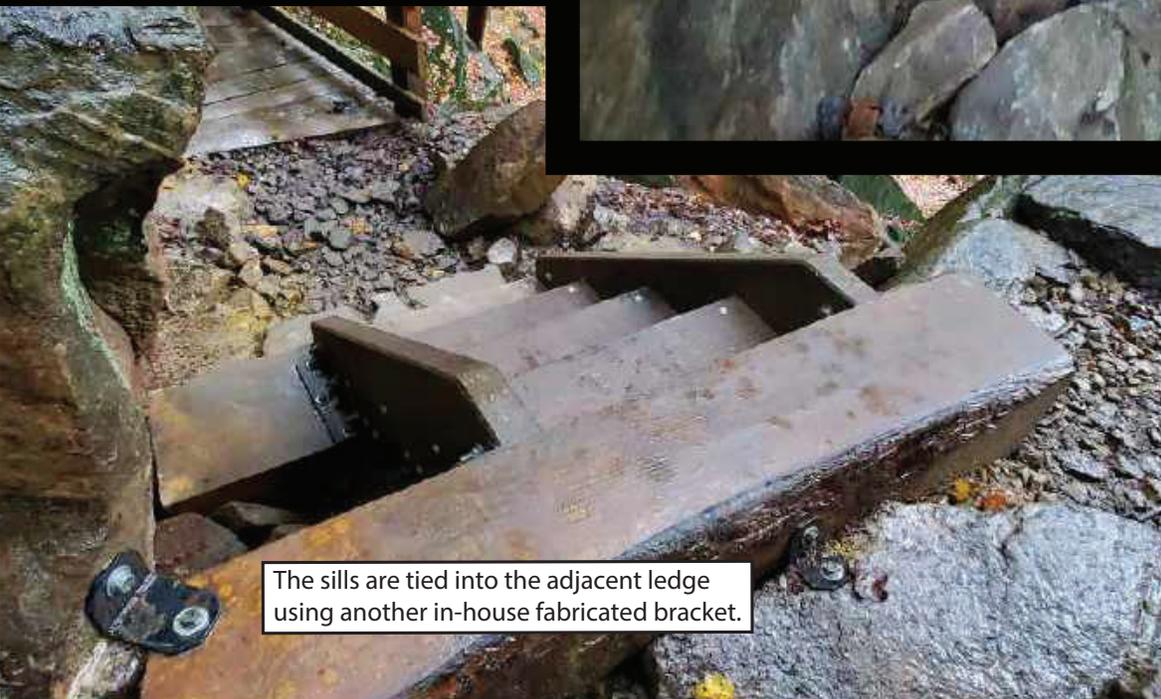
The sills are tied into the adjacent ledge using another in-house fabricated bracket.

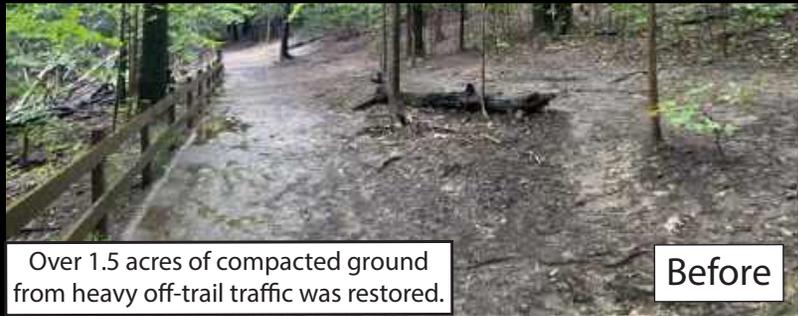
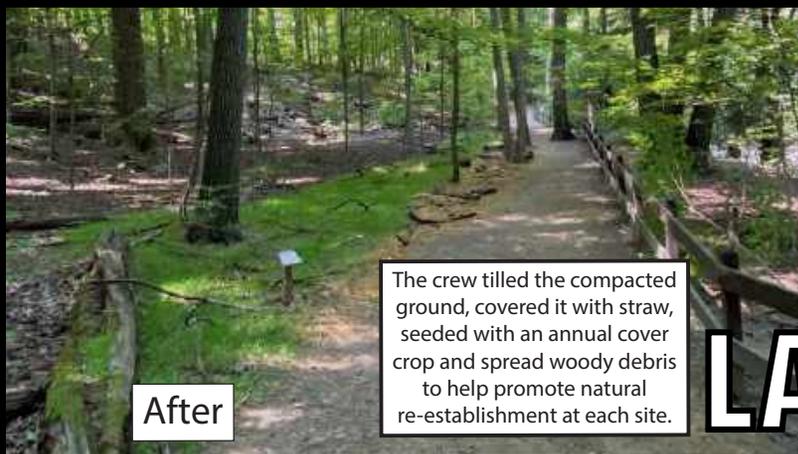
In the fall, the grass/straw/brush mixture captures fallen leaves that will break down into the ground and re-establishes the organic layer that was lost from the compaction caused from trampling by off-trail users.

Over 1.5 acres of compacted ground from heavy off-trail traffic was restored.

The crew tilled the compacted ground, covered it with straw, seeded with an annual cover crop and spread woody debris to help promote natural re-establishment at each site.

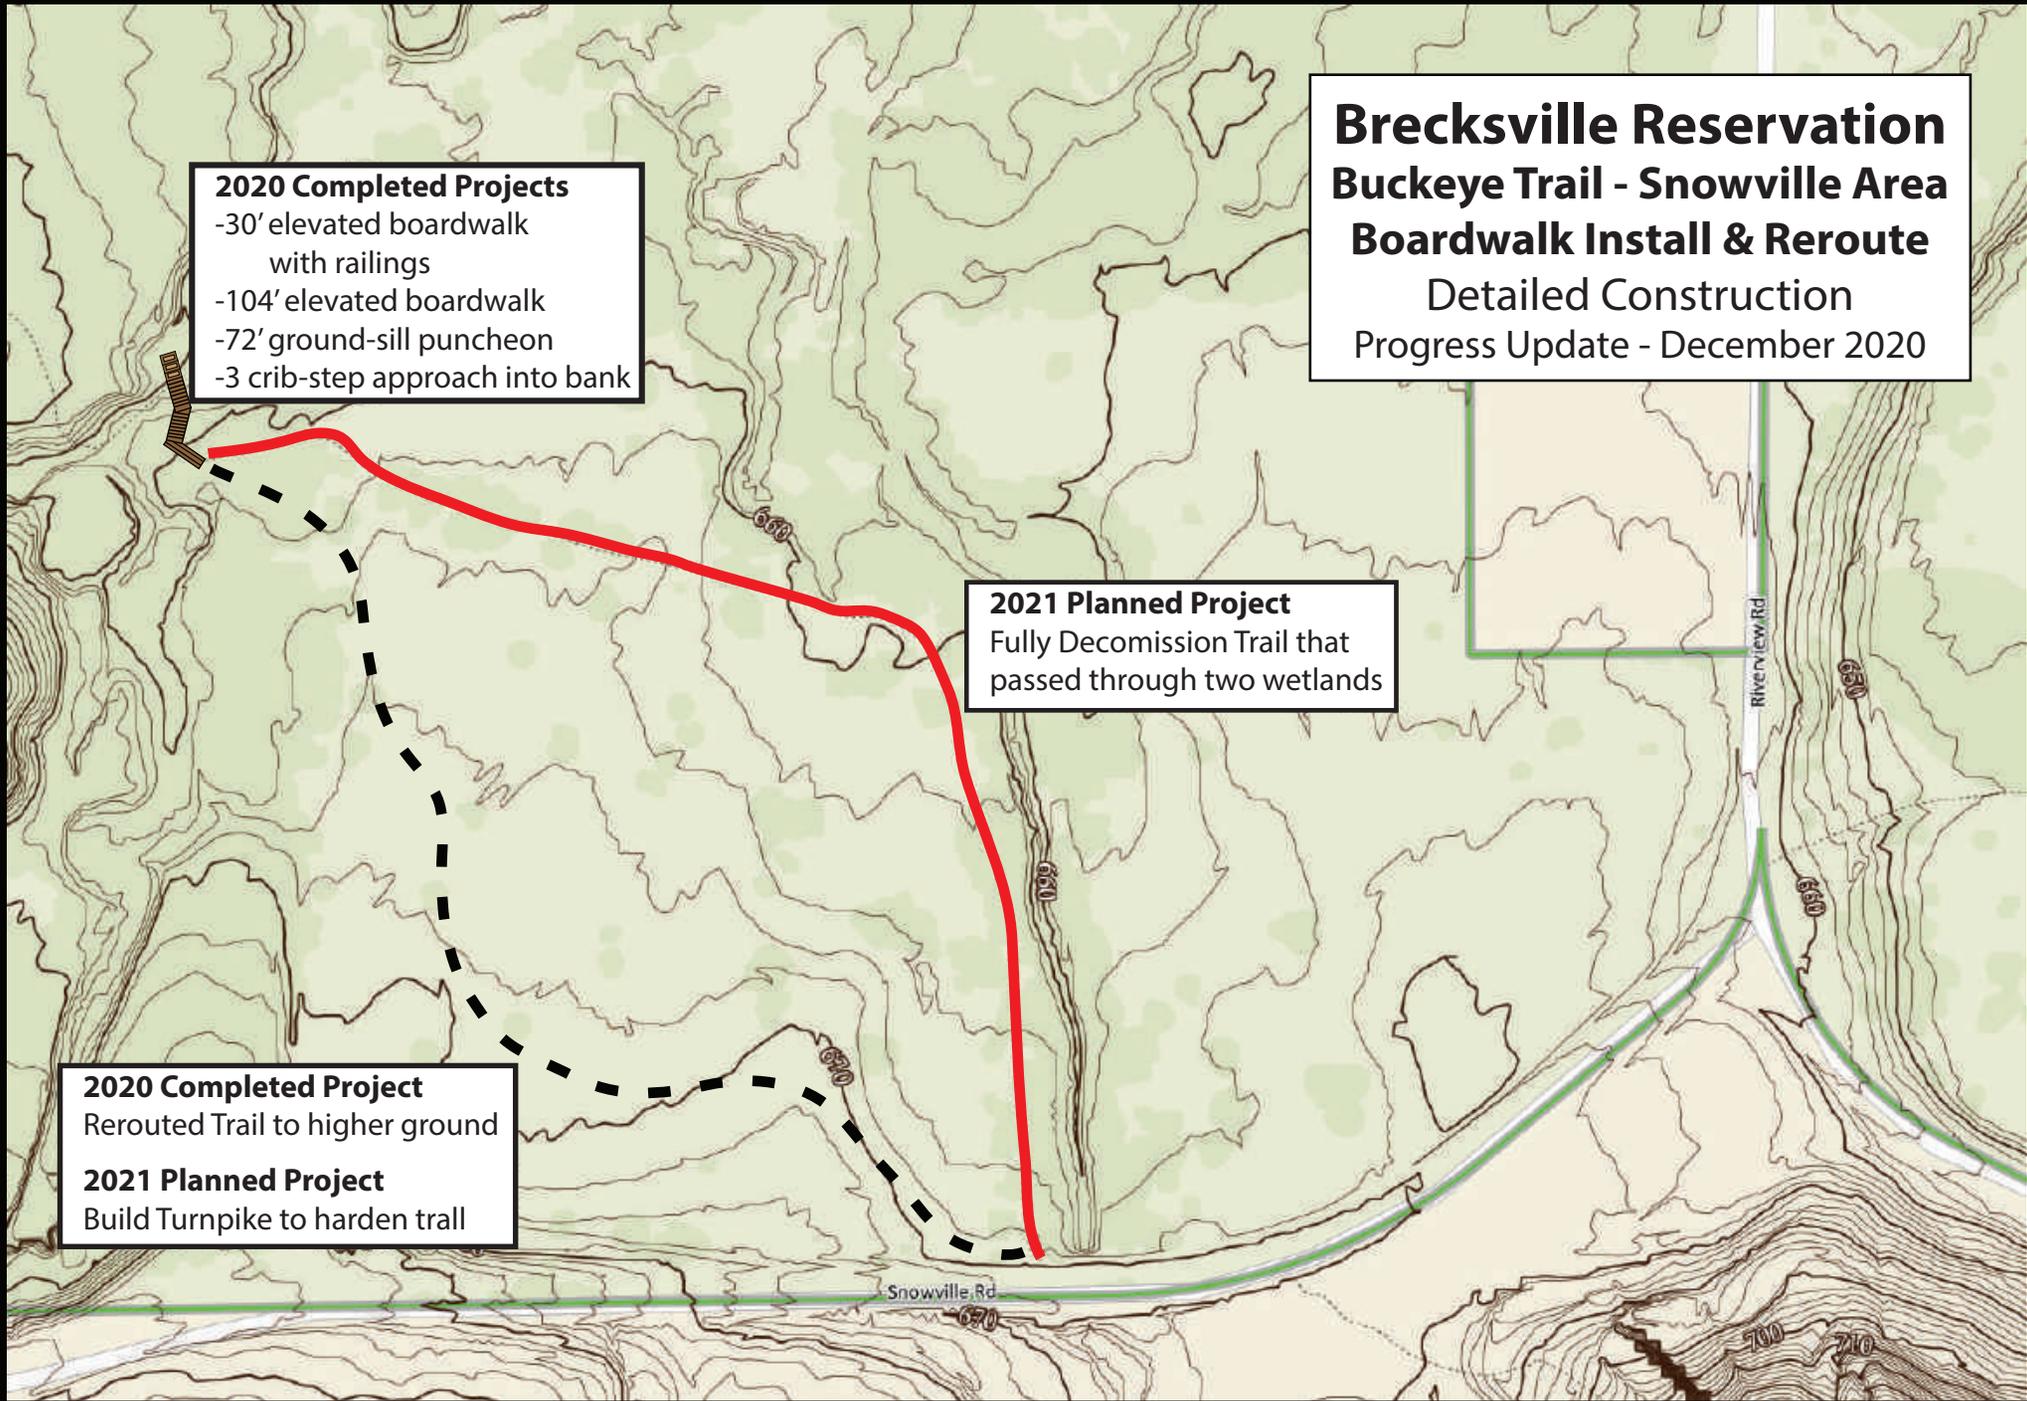
Brecksville Reservation Buckeye Trail - Snowville Area Boardwalk Install & Reroute Detailed Construction Progress Update - December 2020

2020 Completed Projects
-30' elevated boardwalk with railings
-104' elevated boardwalk
-72' ground-sill puncheon
-3 crib-step approach into bank

2021 Planned Project
Fully Decommission Trail that passed through two wetlands

2020 Completed Project
Rerouted Trail to higher ground
2021 Planned Project
Build Turnpike to harden trail

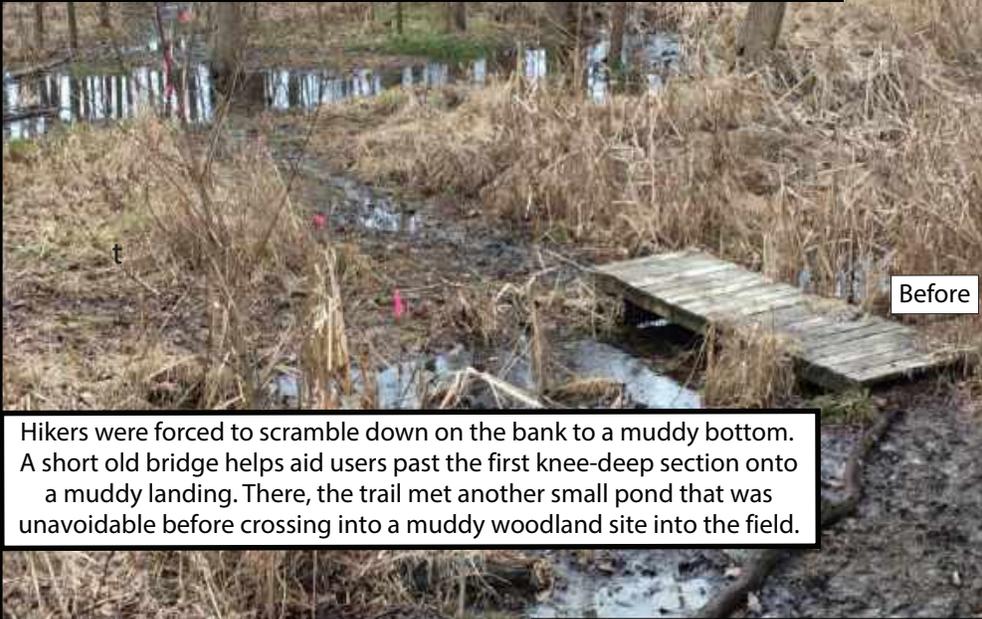
The new trail begins with 3 steps that are tied into a bank before traversing over 170' of gently sloping raised boardwalk that transitions into a puncheon structure that sits just above ground level.

The boardwalk sections set on 2.5" post pipes which account for a total of just 0.35 square foot of ground contact over 170' of linear boardwalk through the sensitive wetland area while allowing the trail to step down at a gentle grade from the woodland bank to the field near Snowville.

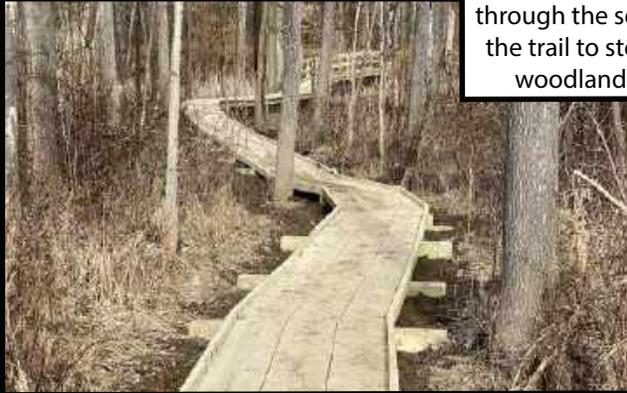
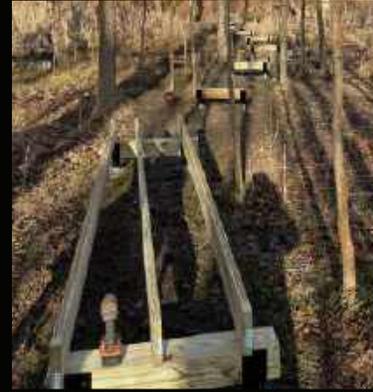
The added 72' of puncheon after the boardwalk slightly elevates the trail through some of the muddiest section of forest protecting the root systems of the trees in this area.

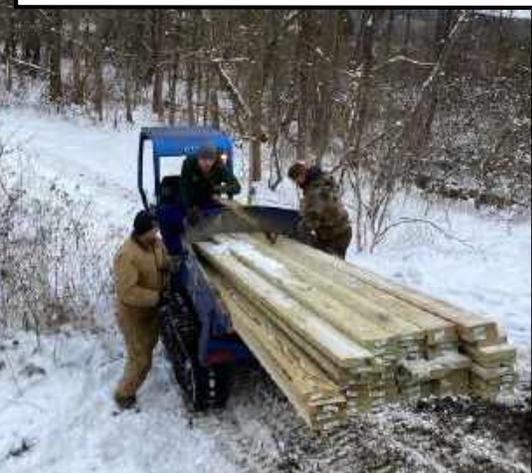
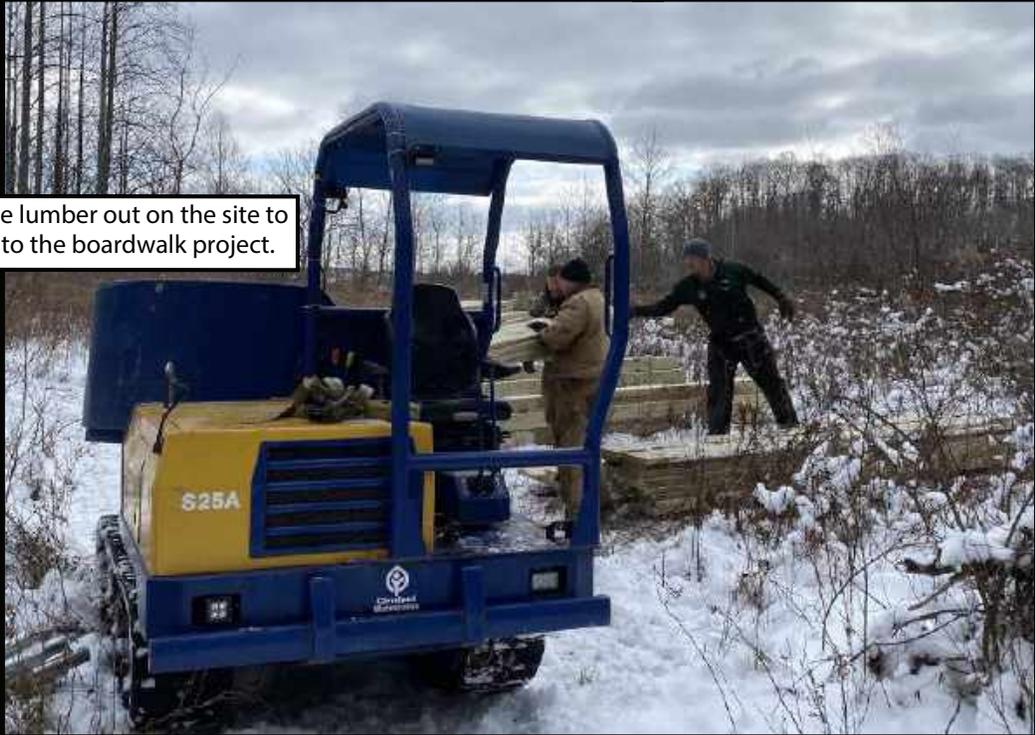
The boardwalk was completed in the "off-season" months of February-March and was typically worked on by no more than two crew members at a time.

The crew waited for frozen conditions to move the lumber out on the site to minimize the impact on the ground leading out to the boardwalk project.

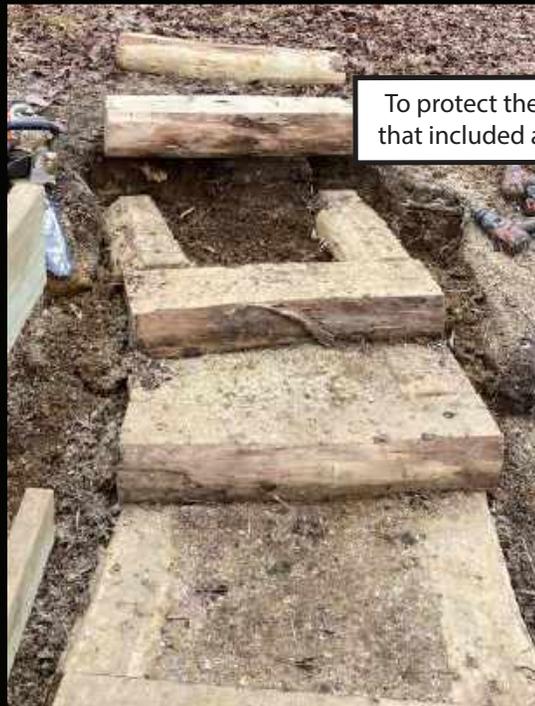
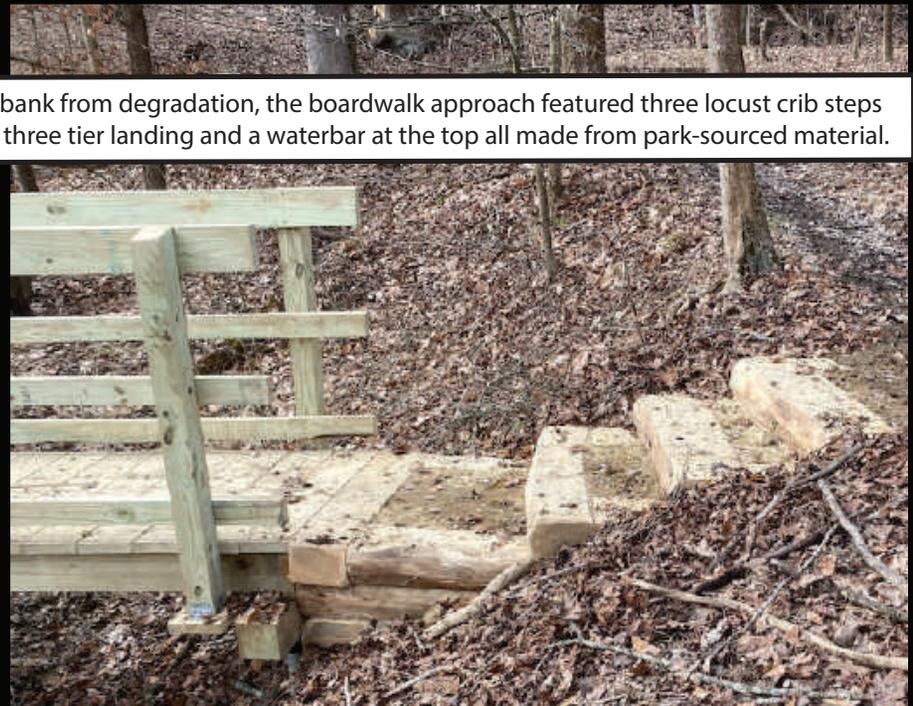
To protect the bank from degradation, the boardwalk approach featured three locust crib steps that included a three tier landing and a waterbar at the top all made from park-sourced material.

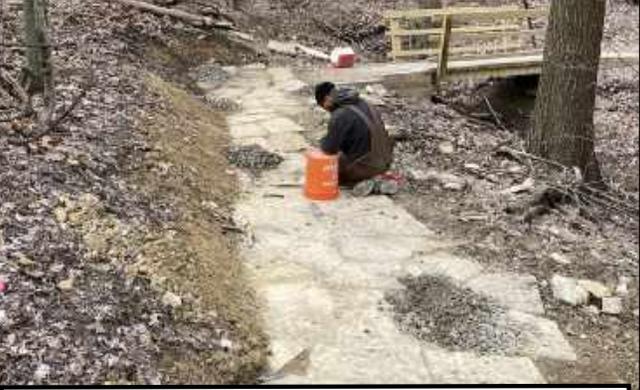
The work was prioritized by armoring the stretches of trail that were known for keeping the system closed. Four distinct locations were finished by late spring.

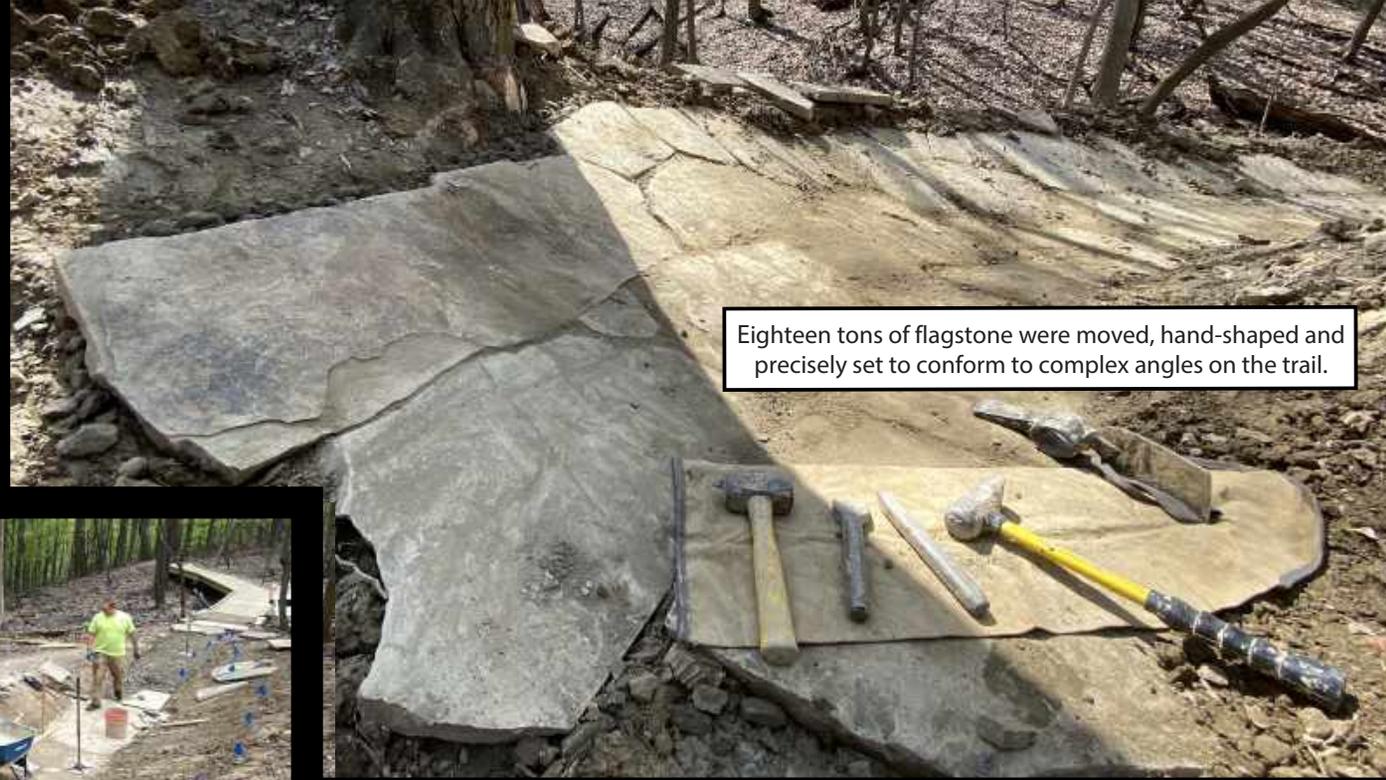
IMPROVEMENT PROJECT: ARMORING

Eighteen tons of flagstone were moved, hand-shaped and precisely set to conform to complex angles on the trail.

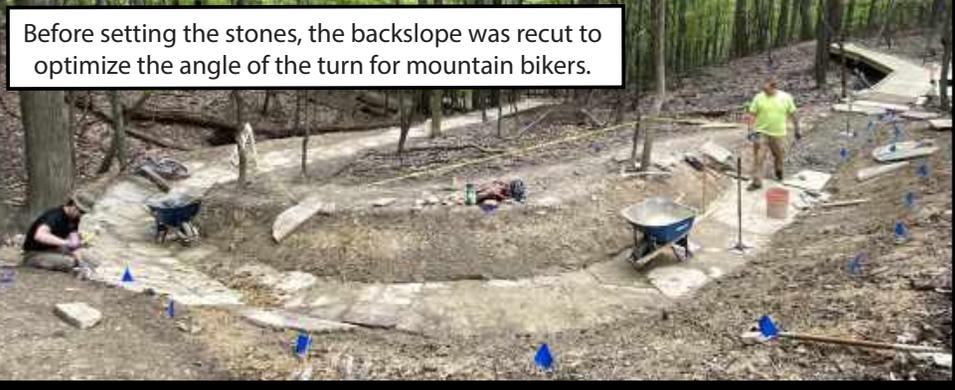
Before setting the stones, the backslope was recut to optimize the angle of the turn for mountain bikers.

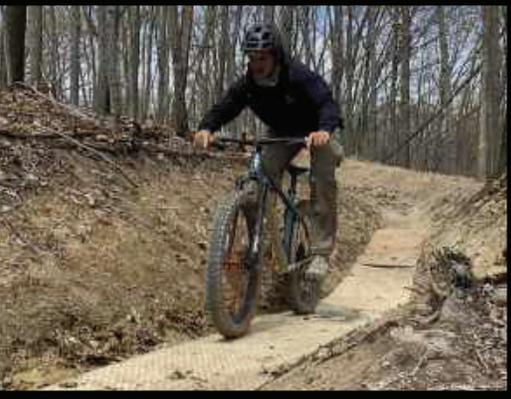
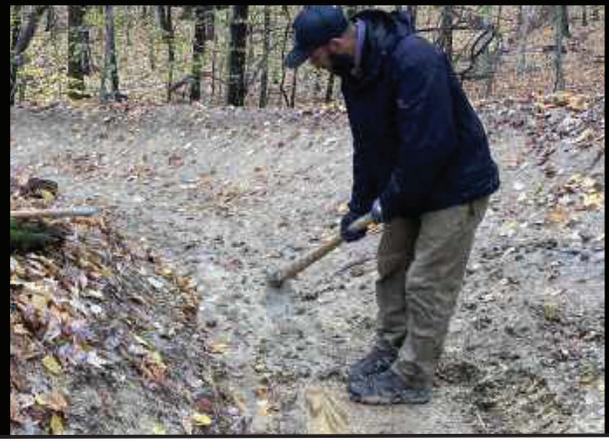
Mud mats serve as a temporary, low cost, and easy-to-install fix to extend riding season and a short-term alternative to stone armoring.

Some prep site work is required to make sure the entire mud mat is in solid contact with the ground before pinning.

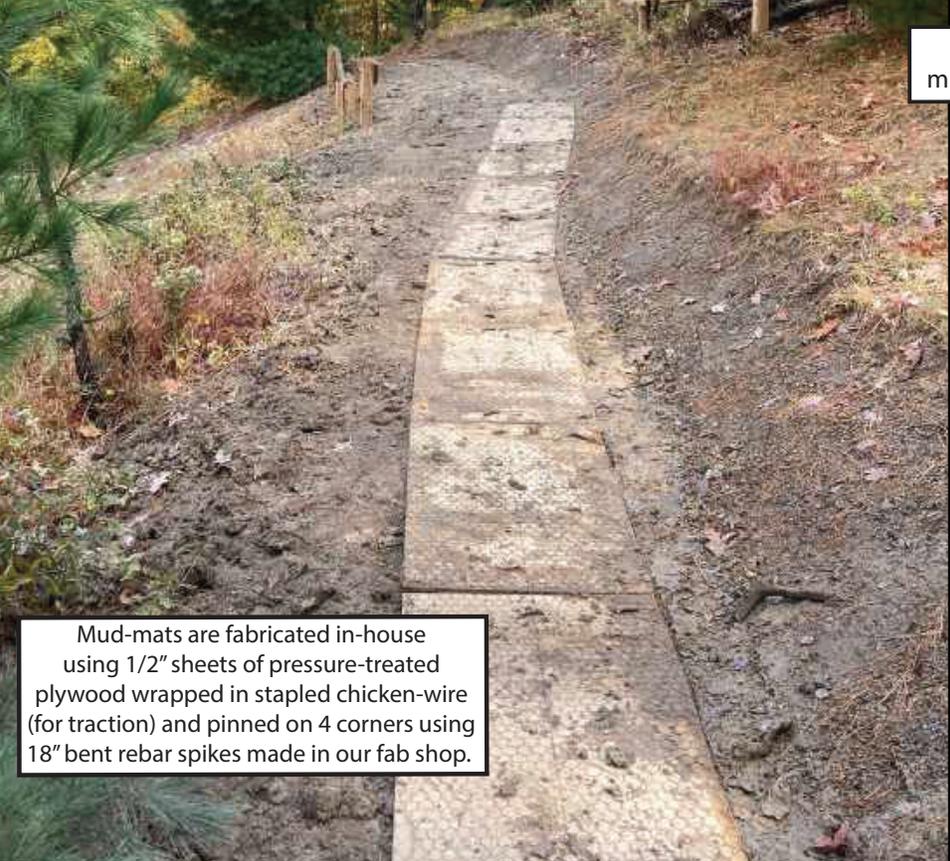
Mud-mats are fabricated in-house using 1/2" sheets of pressure-treated plywood wrapped in stapled chicken-wire (for traction) and pinned on 4 corners using 18" bent rebar spikes made in our fab shop.

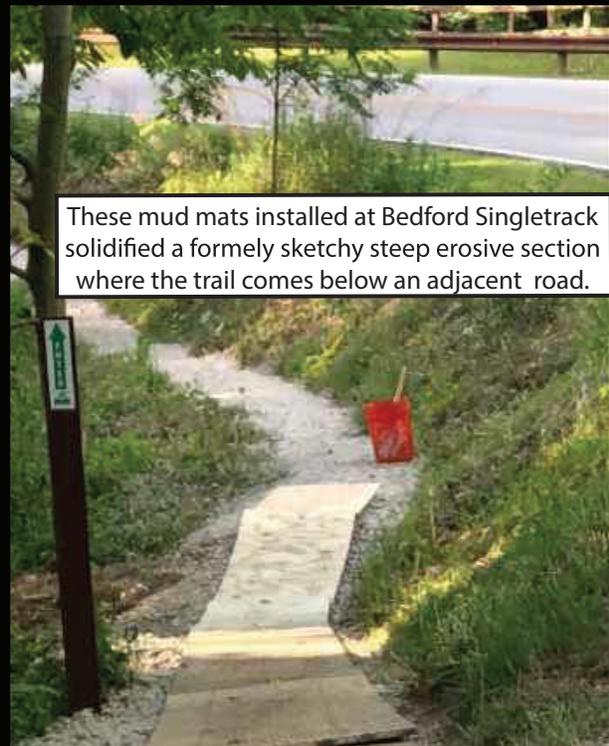
These mud mats installed at Bedford Singletrack solidified a formerly sketchy steep erasive section where the trail comes below an adjacent road.

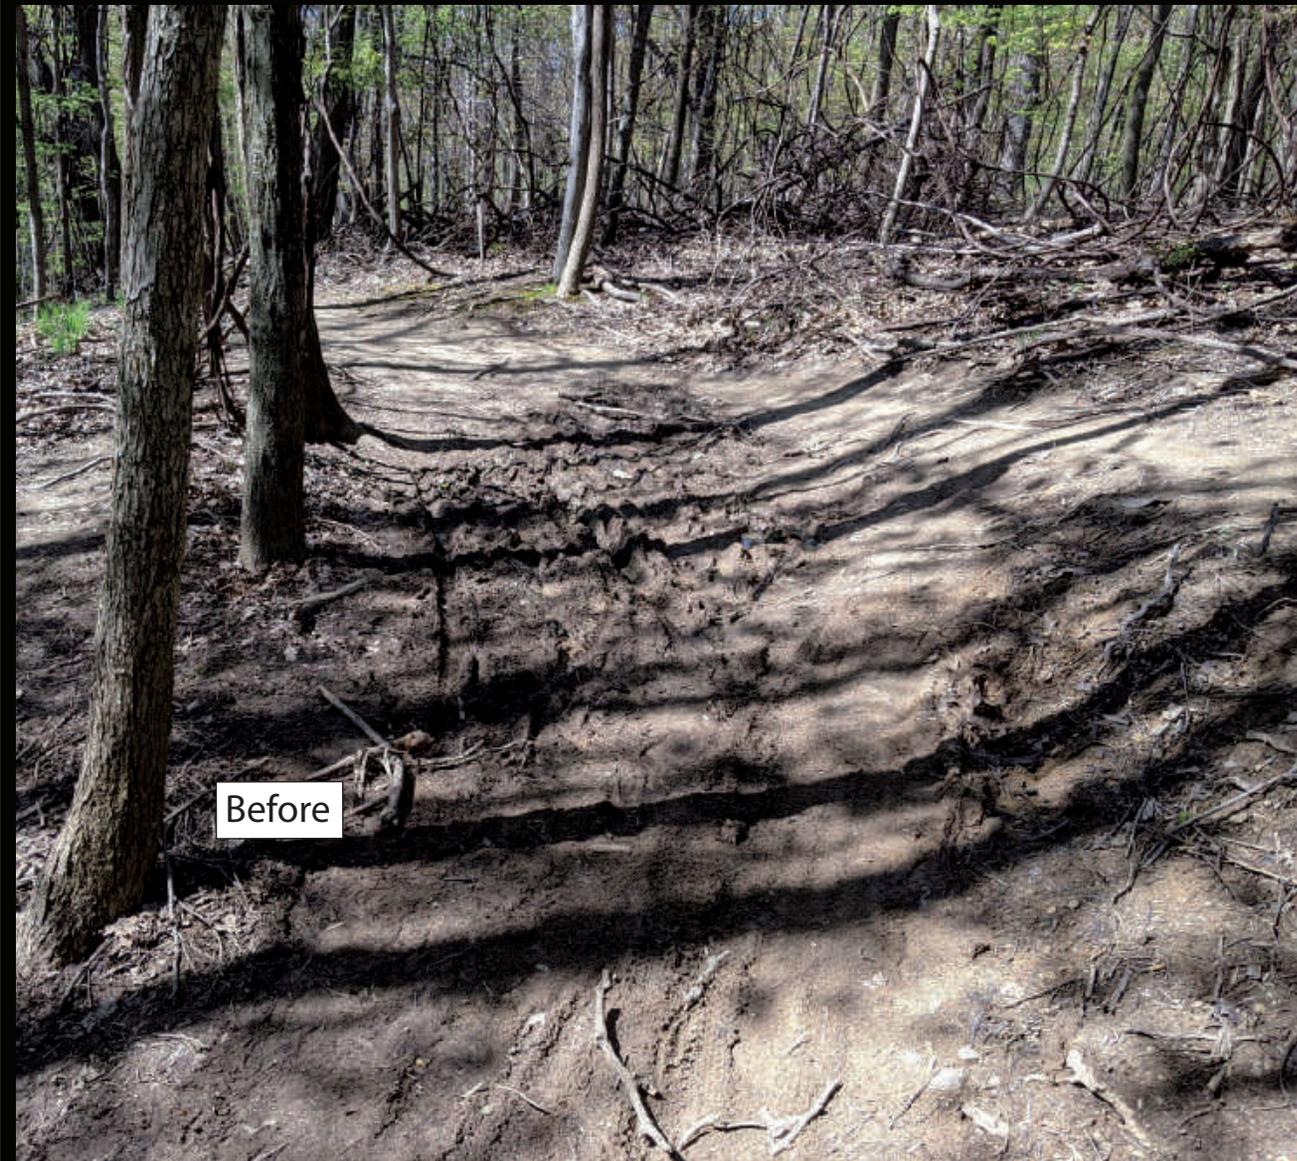
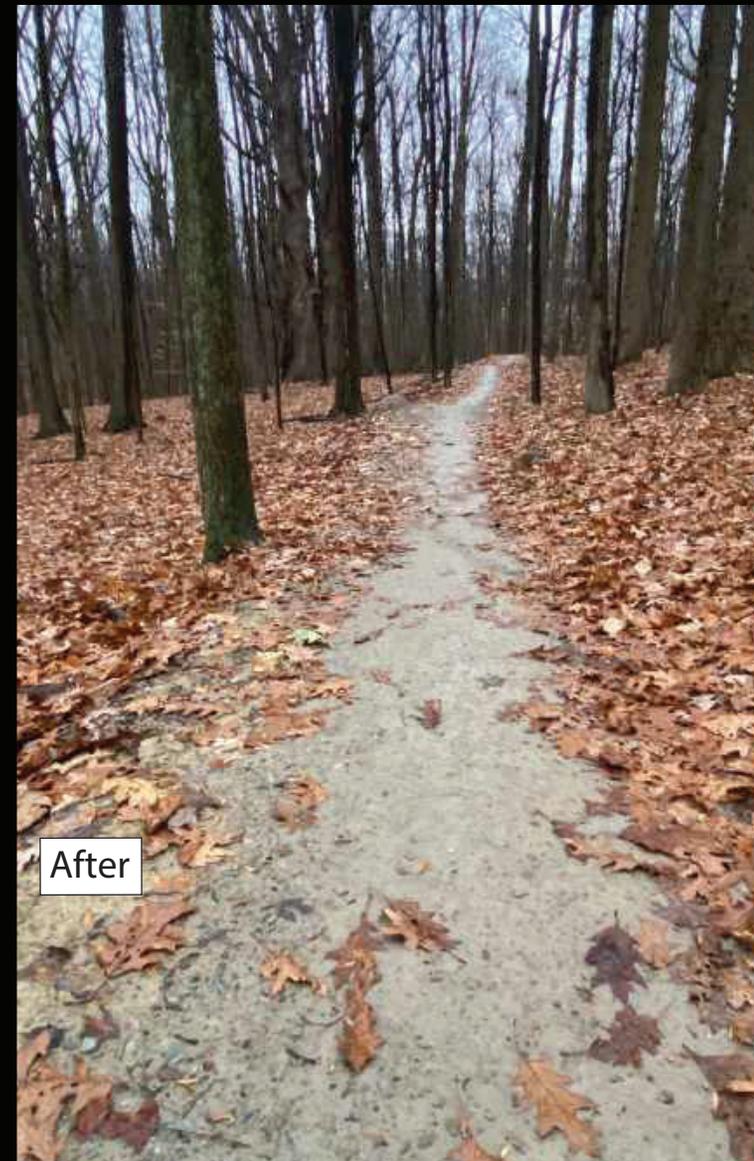
Once seasonal crews came into the picture, resources were mobilized to Royalview. In peak summer, the trail crew worked diligently on hardening a 2000 ft stretch of trail on the western portion of the red loop that was infamous for taking a while to dry out. Because of this inability to properly dry out, the trail had widened to over 30ft in some sections. To remedy this, crews reworked the trail to incorporate better drainage and laid down gravel and surface material screened in-house to improve the stability of the trail. In tandem with the gravel and sand, various timber structures were constructed to cross natural and designed drainage areas. The trail has now evolved from a section that could often take months to properly dry, to one that is dry and rideable the day after a normal weather event.

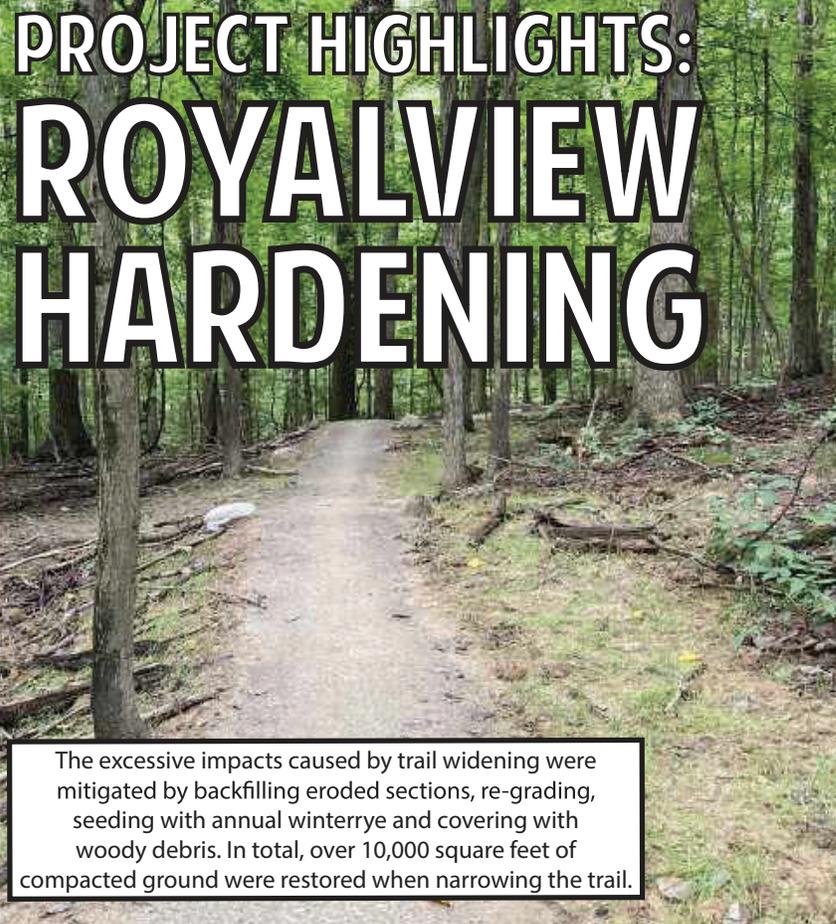
The excessive impacts caused by trail widening were mitigated by backfilling eroded sections, re-grading, seeding with annual winter rye and covering with woody debris. In total, over 10,000 square feet of compacted ground were restored when narrowing the trail.

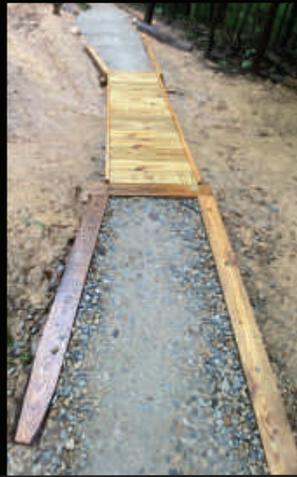
Two box culverts and three bridges (plus approaches) support the trail in its poorest draining locations.

Forty-three logs and 18 rocks were set to define trail corridor and to prevent widening along the improved trail.

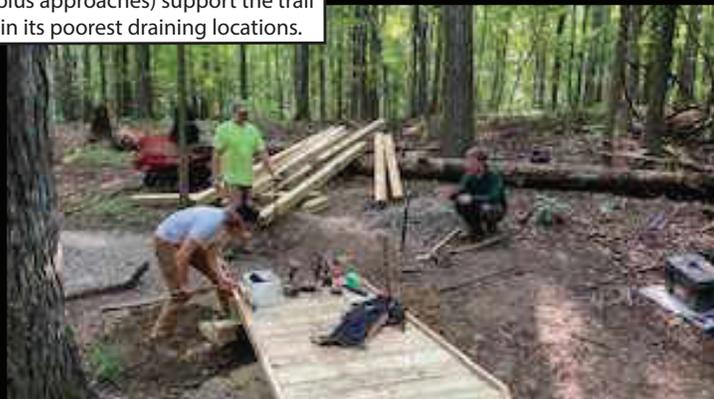
Just over 2000 ft of trail were improved this season using 250 tons of gravel and 130 tons of trail surface material. The crew used a combination of mechanized equipment and handwork as appropriate to finish the project.
