Cleveland Metroparks®

TRAILS DIVISION 2020 YEARBOOK

BRECKSVILLE GORGE PROJECT

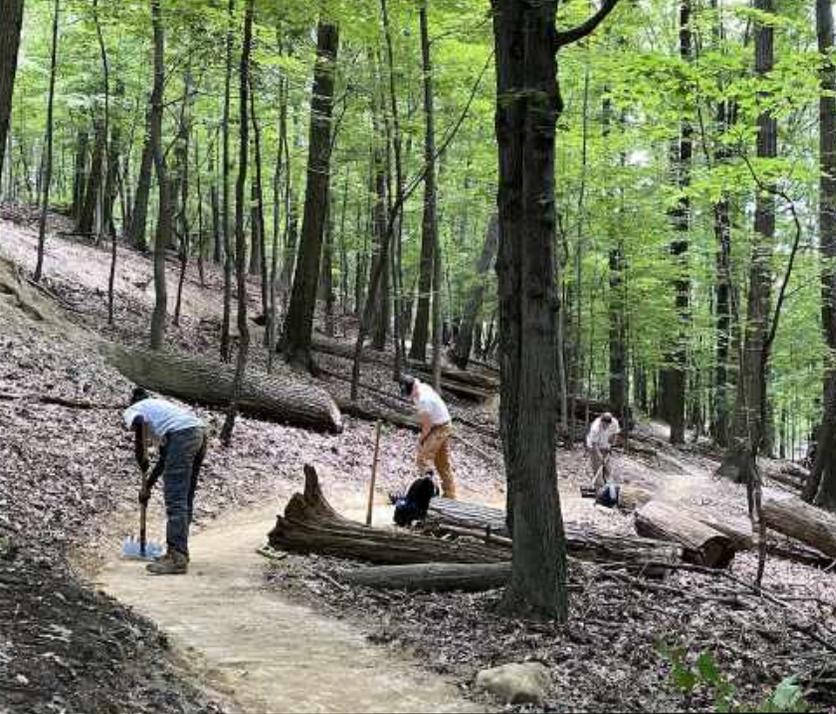
Seasonal crews removed and re-benched over two miles of trail at West Creek, improving the rideability of the trail and preventing it from widening.

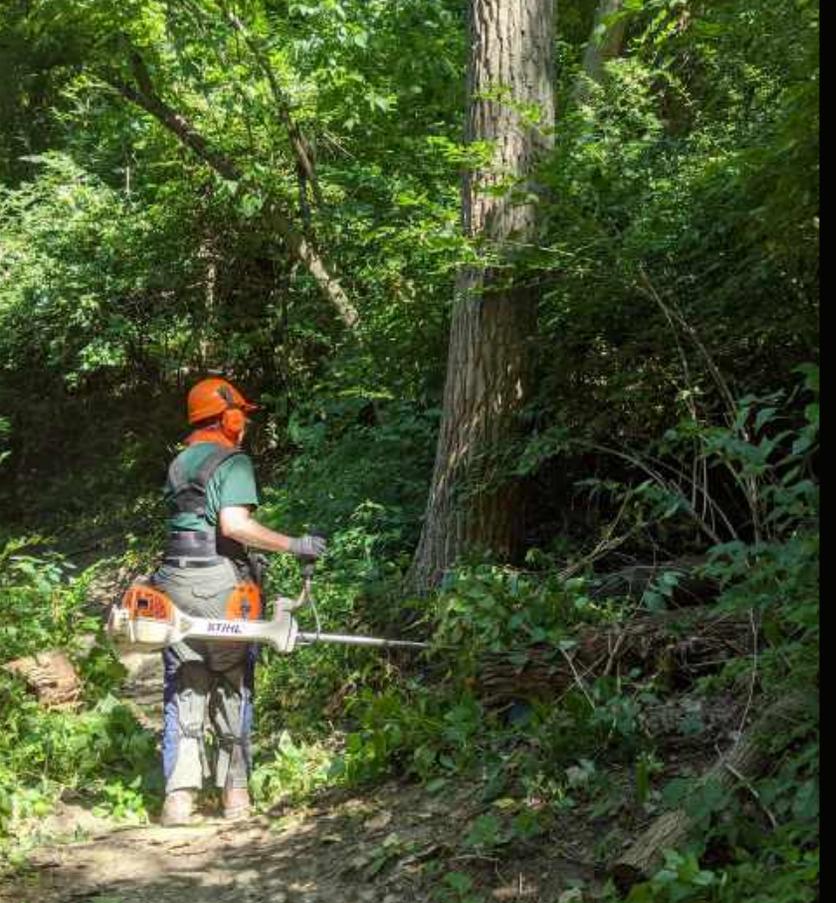
Seasonal crews cleared over 7 miles worth of heavy vegetation spread across three mountain bike trails to keep the sections rideable all summer.

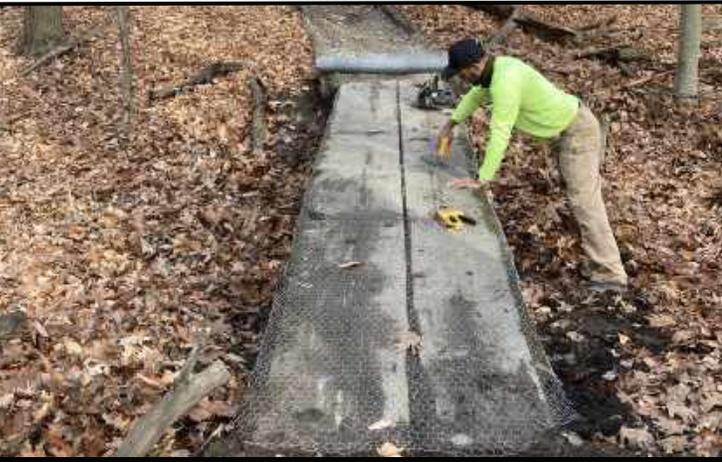
Over 180' of chicken wire was added to bridges across Bedford Singletrack in addition to 120' of deckboard replacements at Mars Quarry Trail.

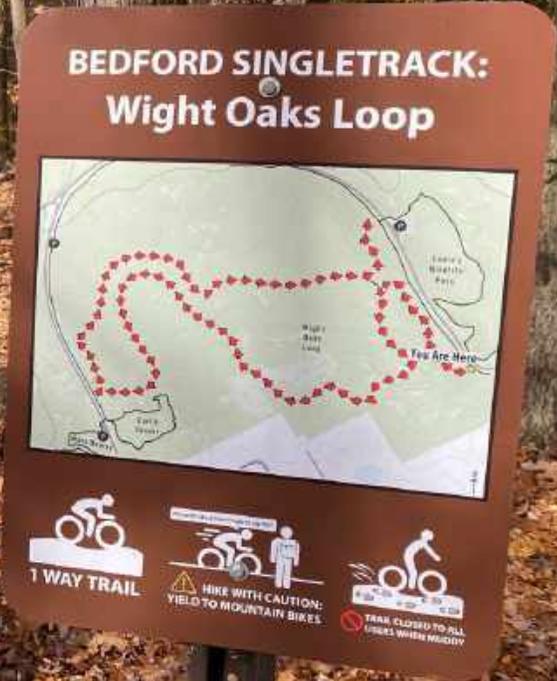
The new signs and markers at Bedford match the style of the ones installed at West Creek Trails last year to positive reviews.

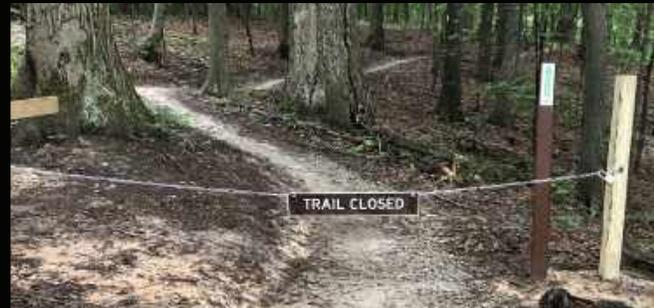
Eleven chains and 4 flip signs were installed at Royalview and West Creek Trail Systems to help inform visitors and deter trail poaching during times when the trail is closed.

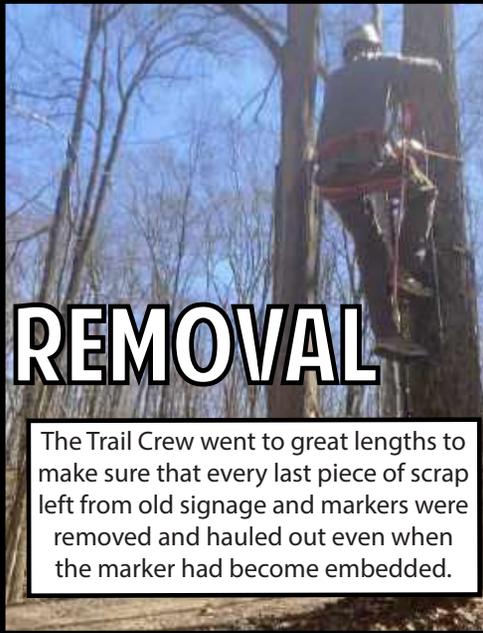
The Trail Crew went to great lengths to make sure that every last piece of scrap left from old signage and markers were removed and hauled out even when the marker had become embedded.

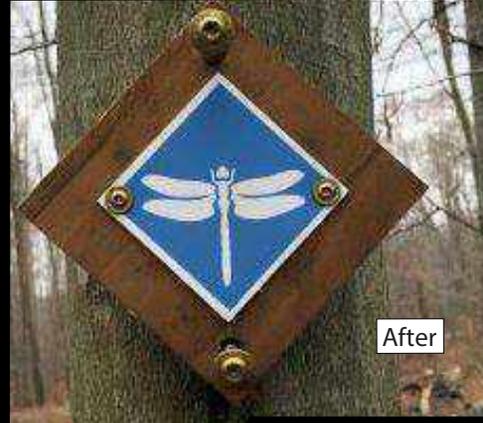
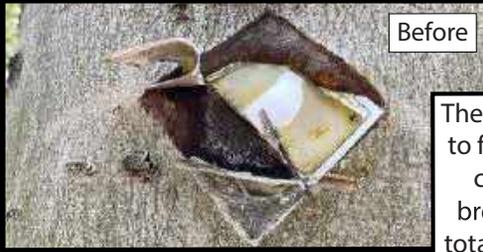
One inch of space is left between the new confidence marker and the tree to allow for growth. The screws are oriented vertically to accommodate tree growth and are periodically backed out to maintain the life of the marker with the least amount of impact to the tree. Backers made from scrap wood serve as a bumper and provide extra support for the tree.

The old markers were set up to fail after just a few years, causing signs to either break off or end up being totally engulfed by the tree.

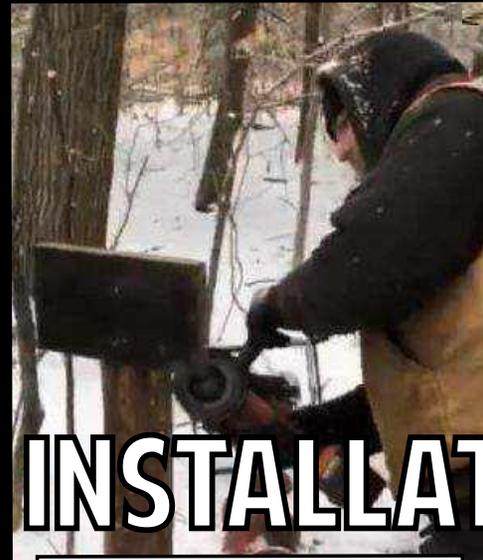
All sign backers and post material are used from native and reclaimed wood produced in-house.

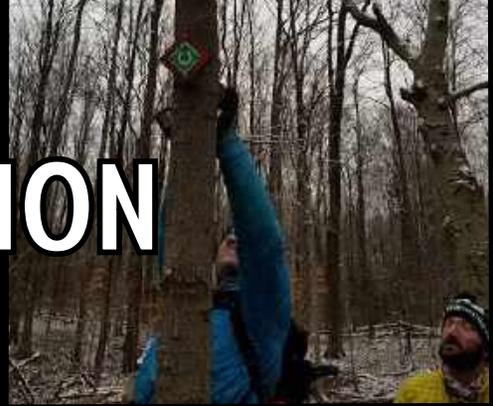
The new markers were set at a height of 7 ft to ensure they would be easy to spot by hikers and help guide them along the trail, regardless of their ability to read or identify colors.

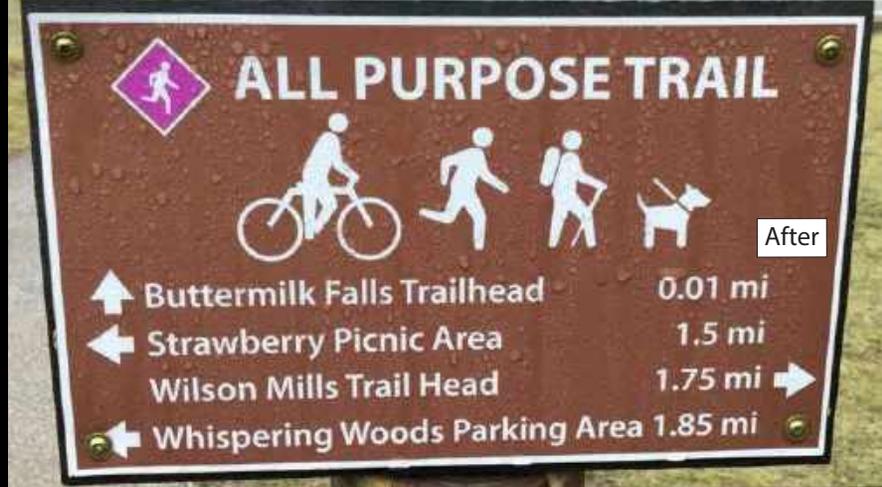
The prior trail sign system lacked detail, relying entirely on color and arrows and tried to combine information about multiple trails on a single post. With this limited palette, the signage would get confusing and colorblind trail users were left with no means of distinction at trail junctions. The new system is designed to allow users to easily navigate their way through the reservations while being provided with more information when on trails.

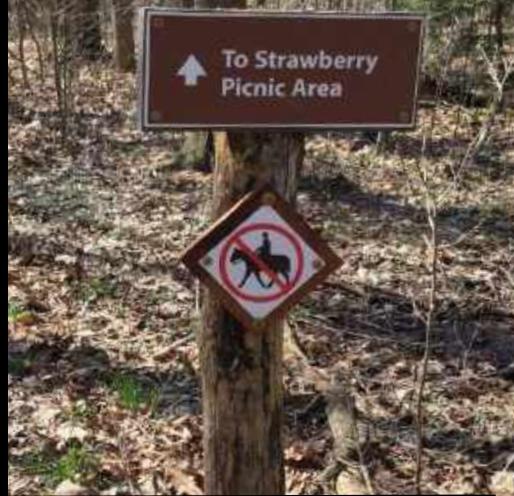
Unique clarifying sign for an unnamed trail connector.

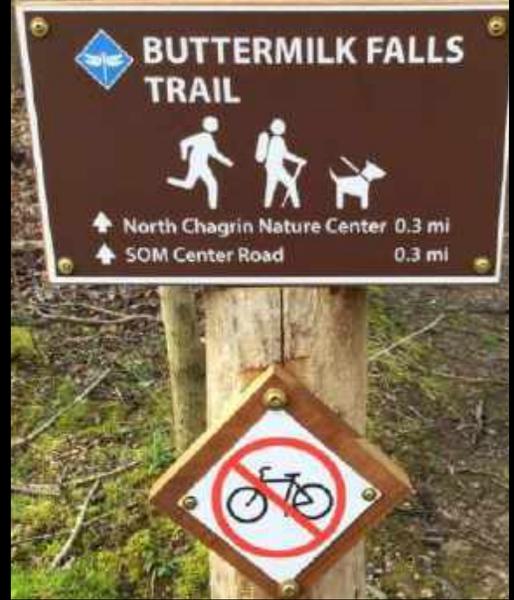
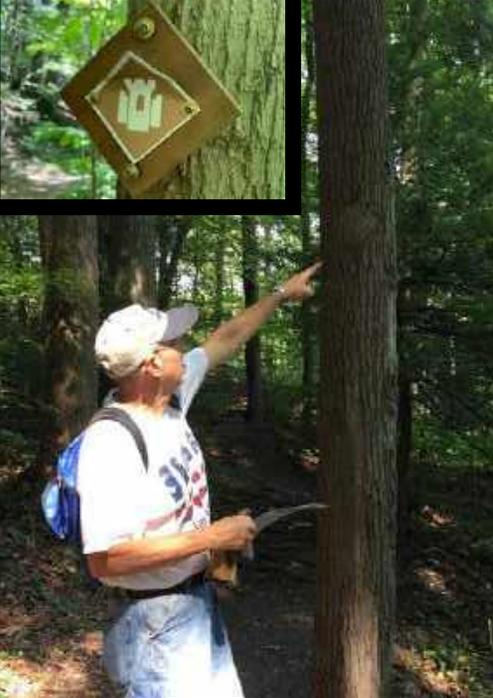
The new trail signs include the trail name with accompanying symbol and color, distances and directions to key locations and clear postings for permitted and restricted users on that trail.

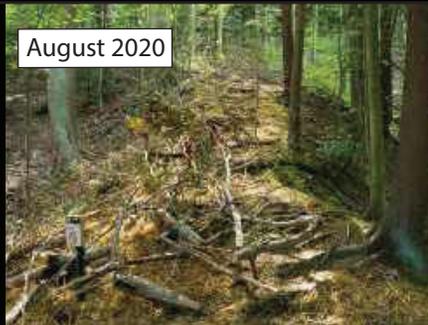
August 2020

This steep bootleg near Castle Valley Trail was broken up by hand and seeded by our seasonal crew in late summer. By fall, the established annual grass and straw was capturing fallen leaves, re-establishing the organic layer on the formerly beaten path.

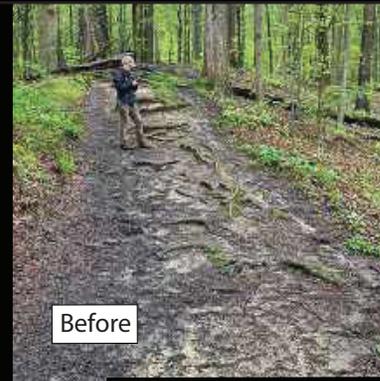
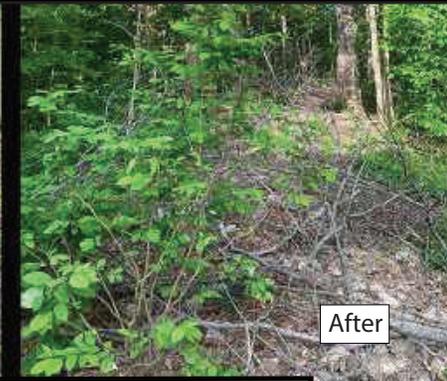
This major bootleg directly behind Squire's Castle was so clear and well-established, that many users assumed it was a part of the trail system. The crew installed a low, permanent barrier in this high-use area to clearly distinguish the former trail as a restoration area with restricted access.

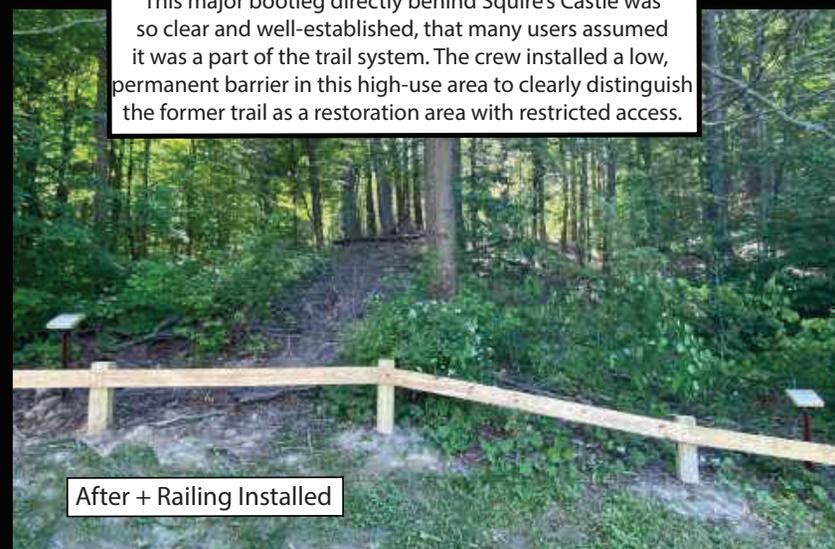
After + Railing Installed

This unsanctioned former cut-through often confused hikers around the Scenic Loop and White Pine Trailheads near the Strawberry Picnic Area. To support the new trail signs in the area, the trail crew spent an afternoon rehabilitating the site. Today, hikers happily ignore the old, confusing trail which has almost completely grown back in just one season. To support the work, Natural Resources planted saplings here and at other sites in the reservation.

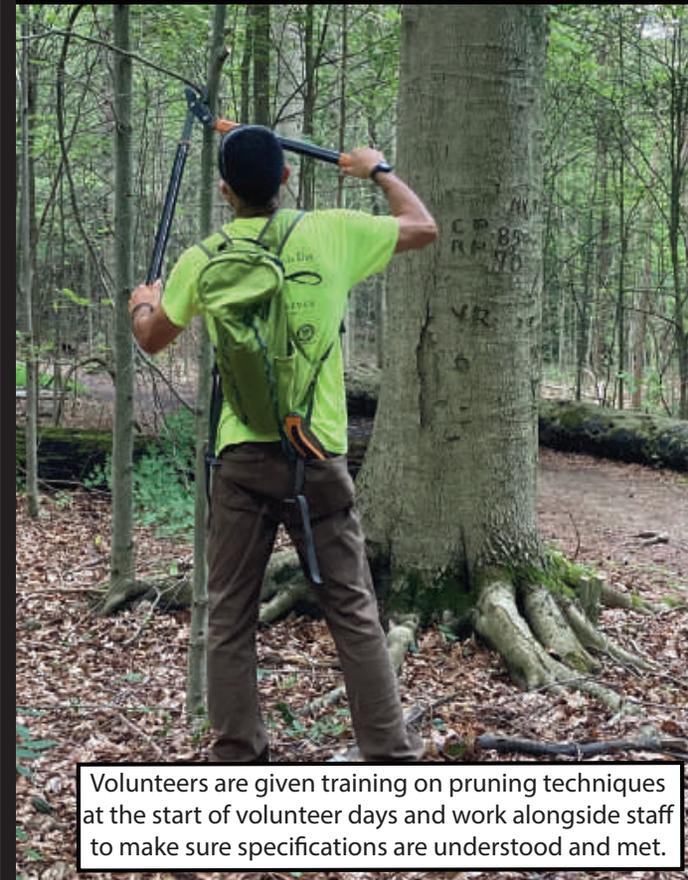
Volunteers are given training on pruning techniques at the start of volunteer days and work alongside staff to make sure specifications are understood and met.

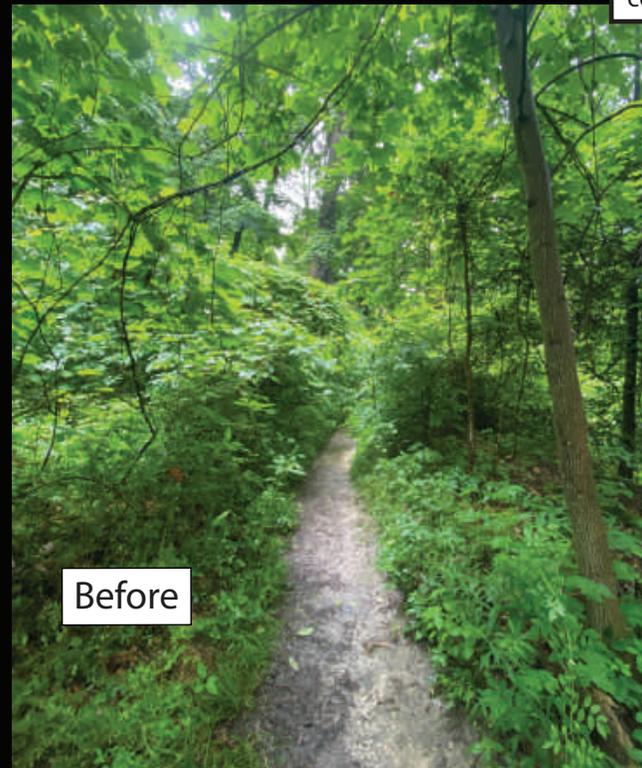
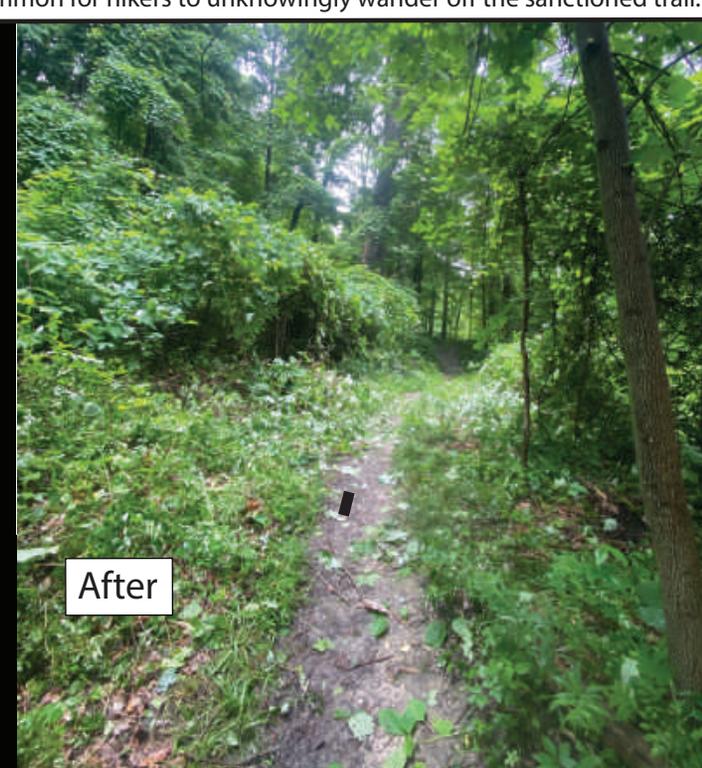
Heavy vegetation closes in much of the northern Castle Valley Trail. Before clearing, navigating the trail felt like a corn maze and it was common for hikers to unknowingly wander off the sanctioned trail.

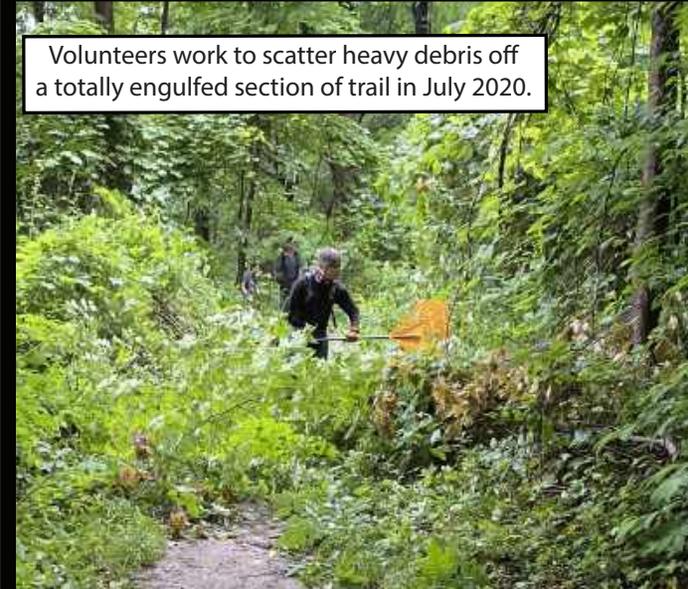
Volunteers work to scatter heavy debris off a totally engulfed section of trail in July 2020.

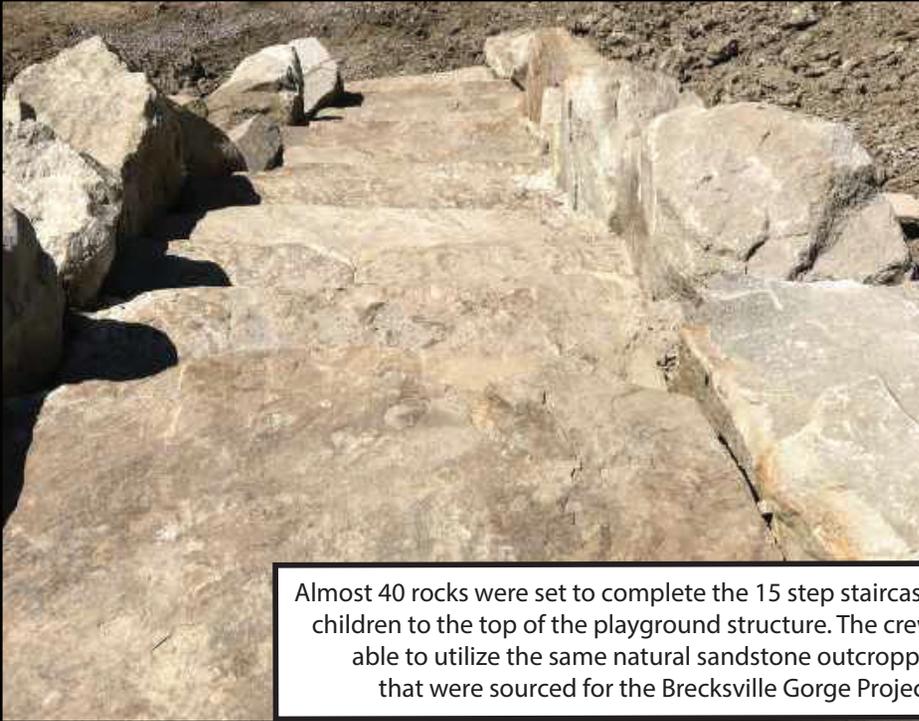
Almost 40 rocks were set to complete the 15 step staircase leading children to the top of the playground structure. The crews were able to utilize the same natural sandstone outcroppings that were sourced for the Brecksville Gorge Project.

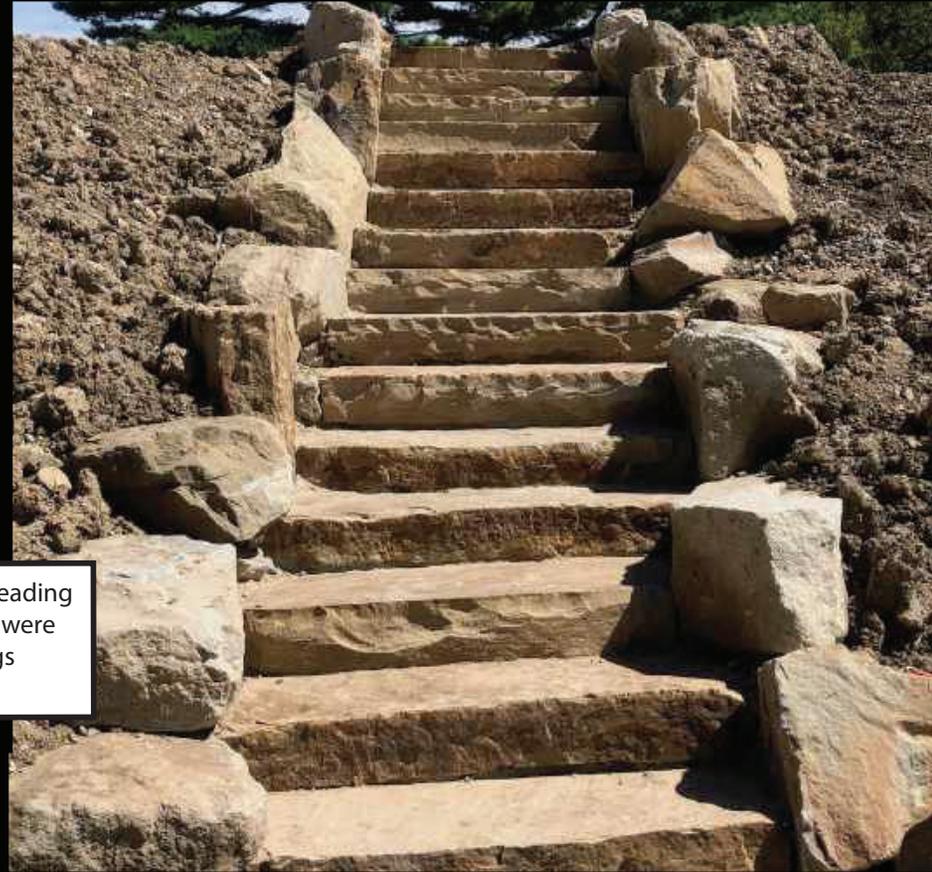
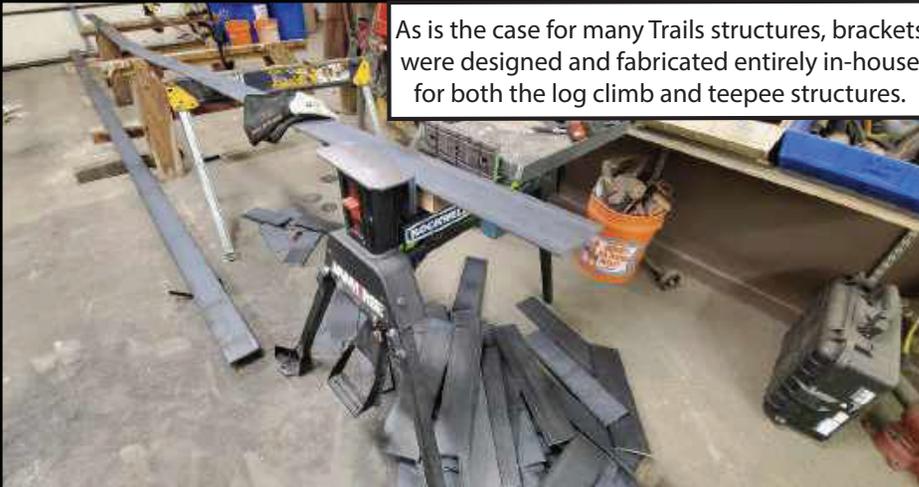
As is the case for many Trails structures, brackets were designed and fabricated entirely in-house for both the log climb and teepee structures.

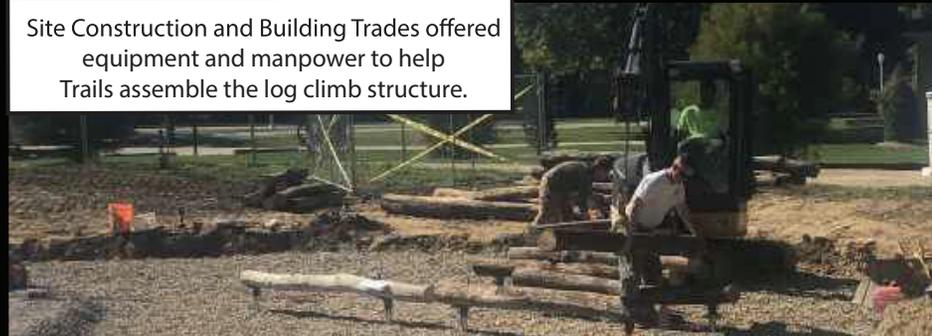
Site Construction and Building Trades offered equipment and manpower to help Trails assemble the log climb structure.

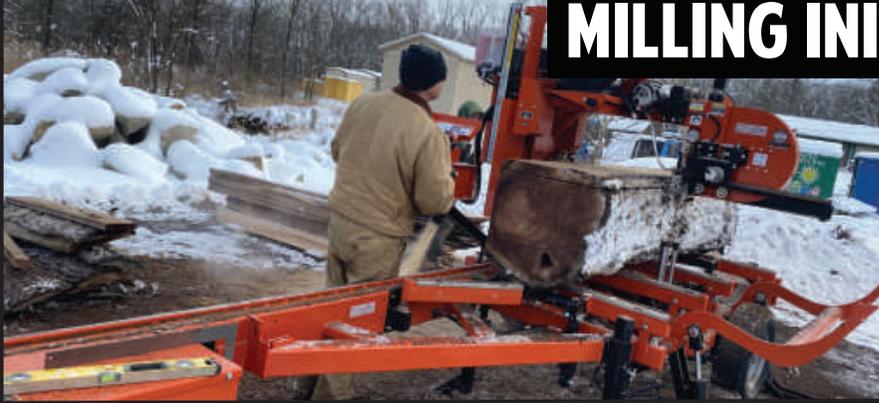
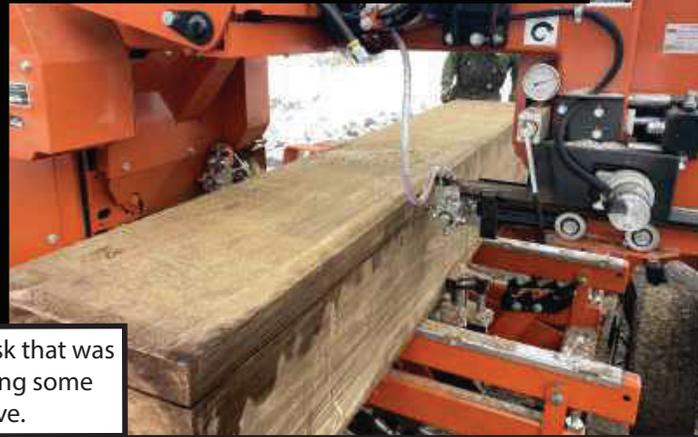
The new Woodmizer bandsaw mill is able to rotate logs through hydraulics, a task that was previously done by hand. An on-board computer sets the cutting depth creating some of the most consistent boards we have seen since we started the initiative.

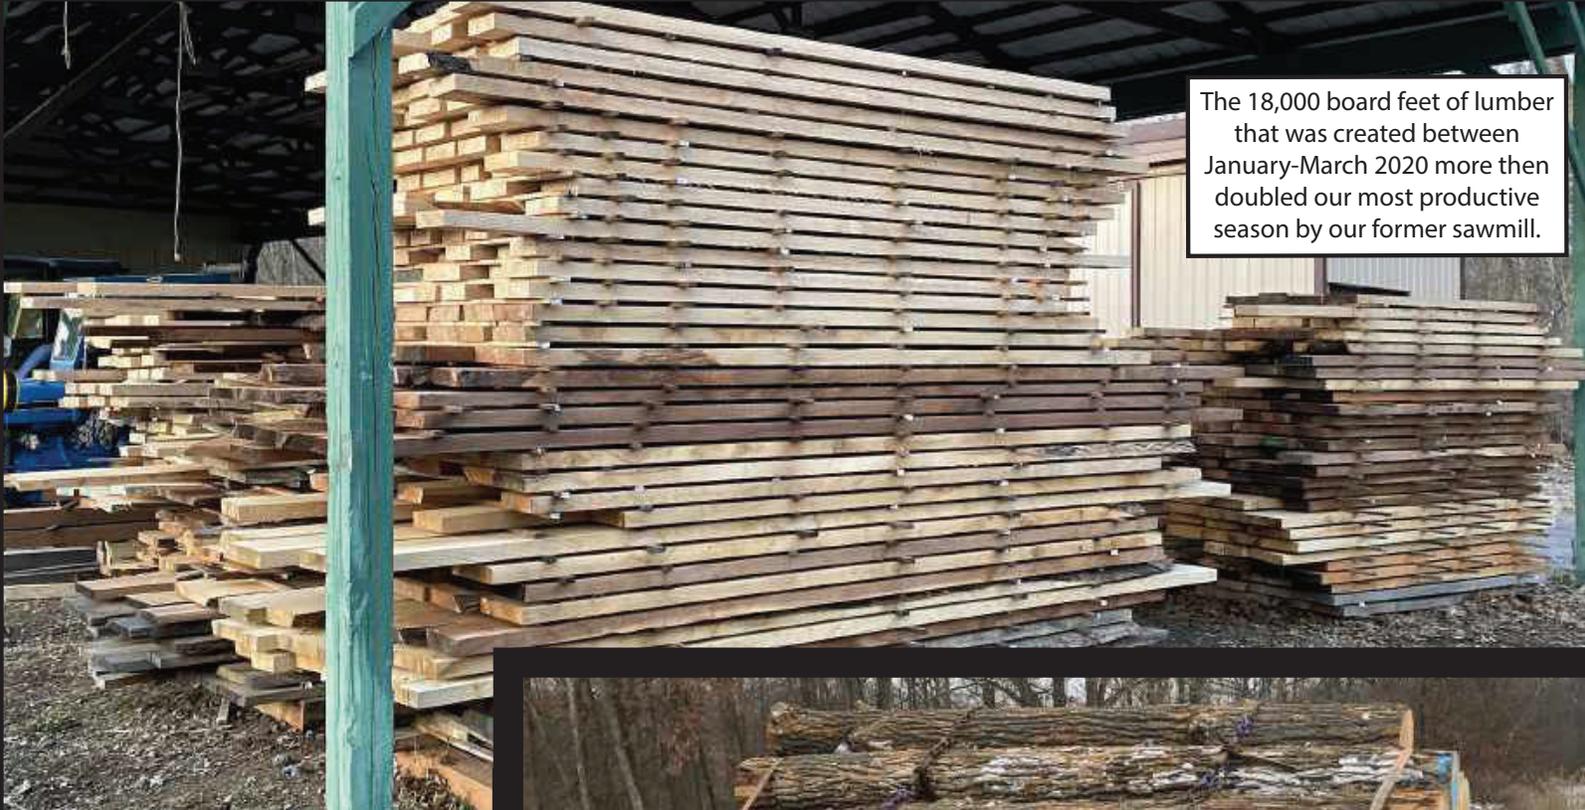
The 18,000 board feet of lumber that was created between January-March 2020 more than doubled our most productive season by our former sawmill.

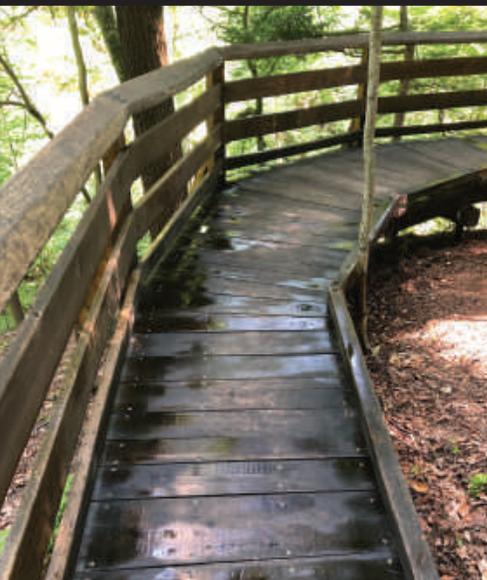
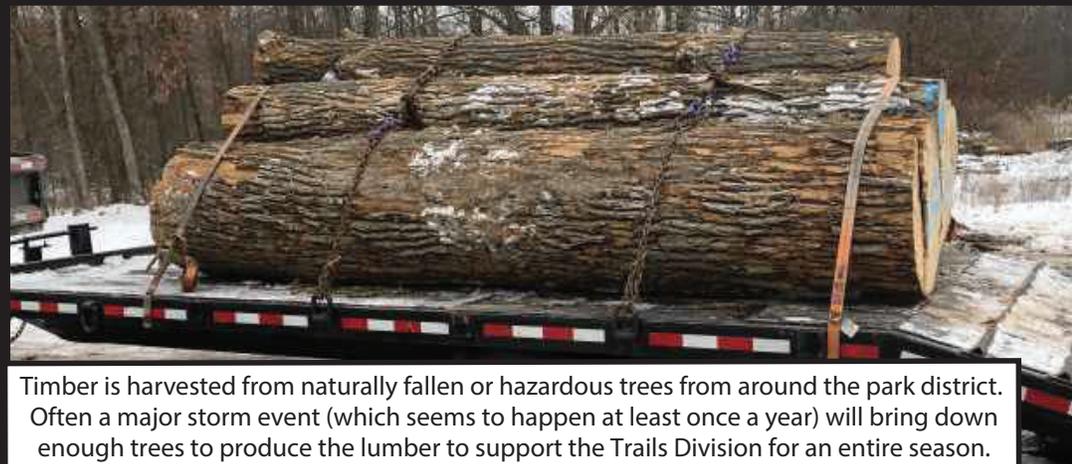
Timber is harvested from naturally fallen or hazardous trees from around the park district. Often a major storm event (which seems to happen at least once a year) will bring down enough trees to produce the lumber to support the Trails Division for an entire season.

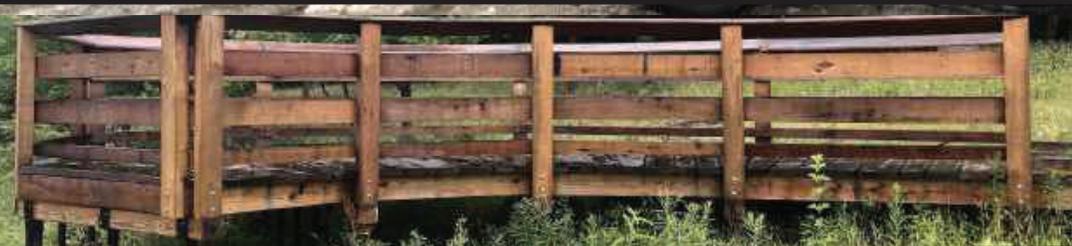
In addition to creating the new lumber, we are also invested in protecting the integrity of our existing milled structures. We have begun to use a treatment that is used on log homes which has shown to have excellent protective qualities. Beginning with some of our earliest projects, we have begun rotating through some of our milled structures, cleaning them and applying the log oil when conditions are appropriate.
