Hinckley Lake Dam

June 15, 2017

Hinckley Lake Dam – Principal Spillway Modification & Hydraulic Concept Study

Principal Spillway Modification
Hydrologic & Hydraulic Concept Study

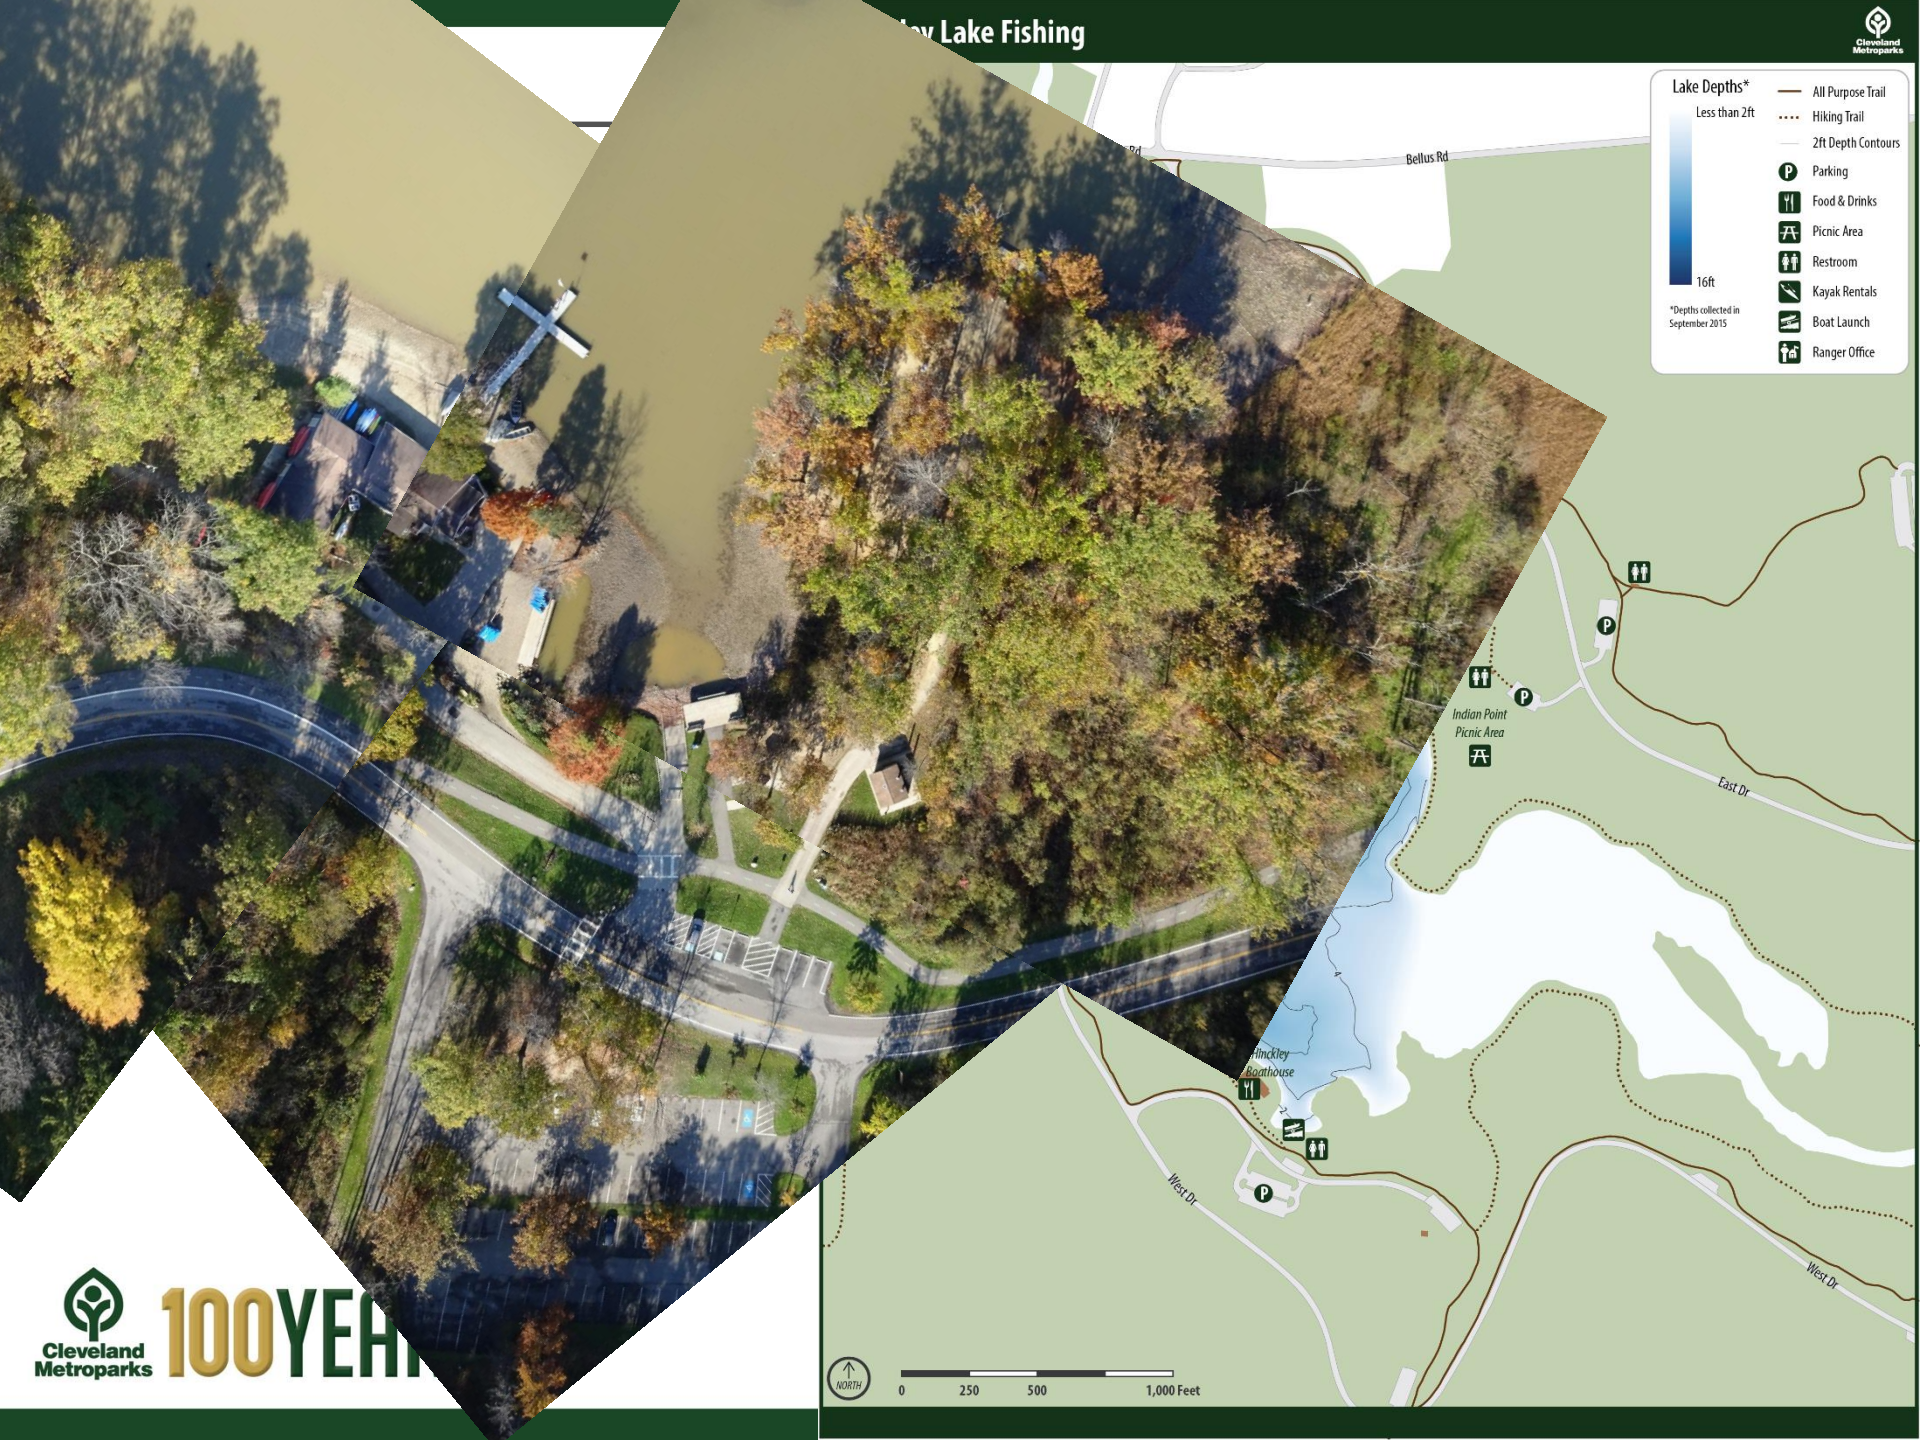
Lake Depths*

Less than 2ft

16ft

*Depths collected in September 2015

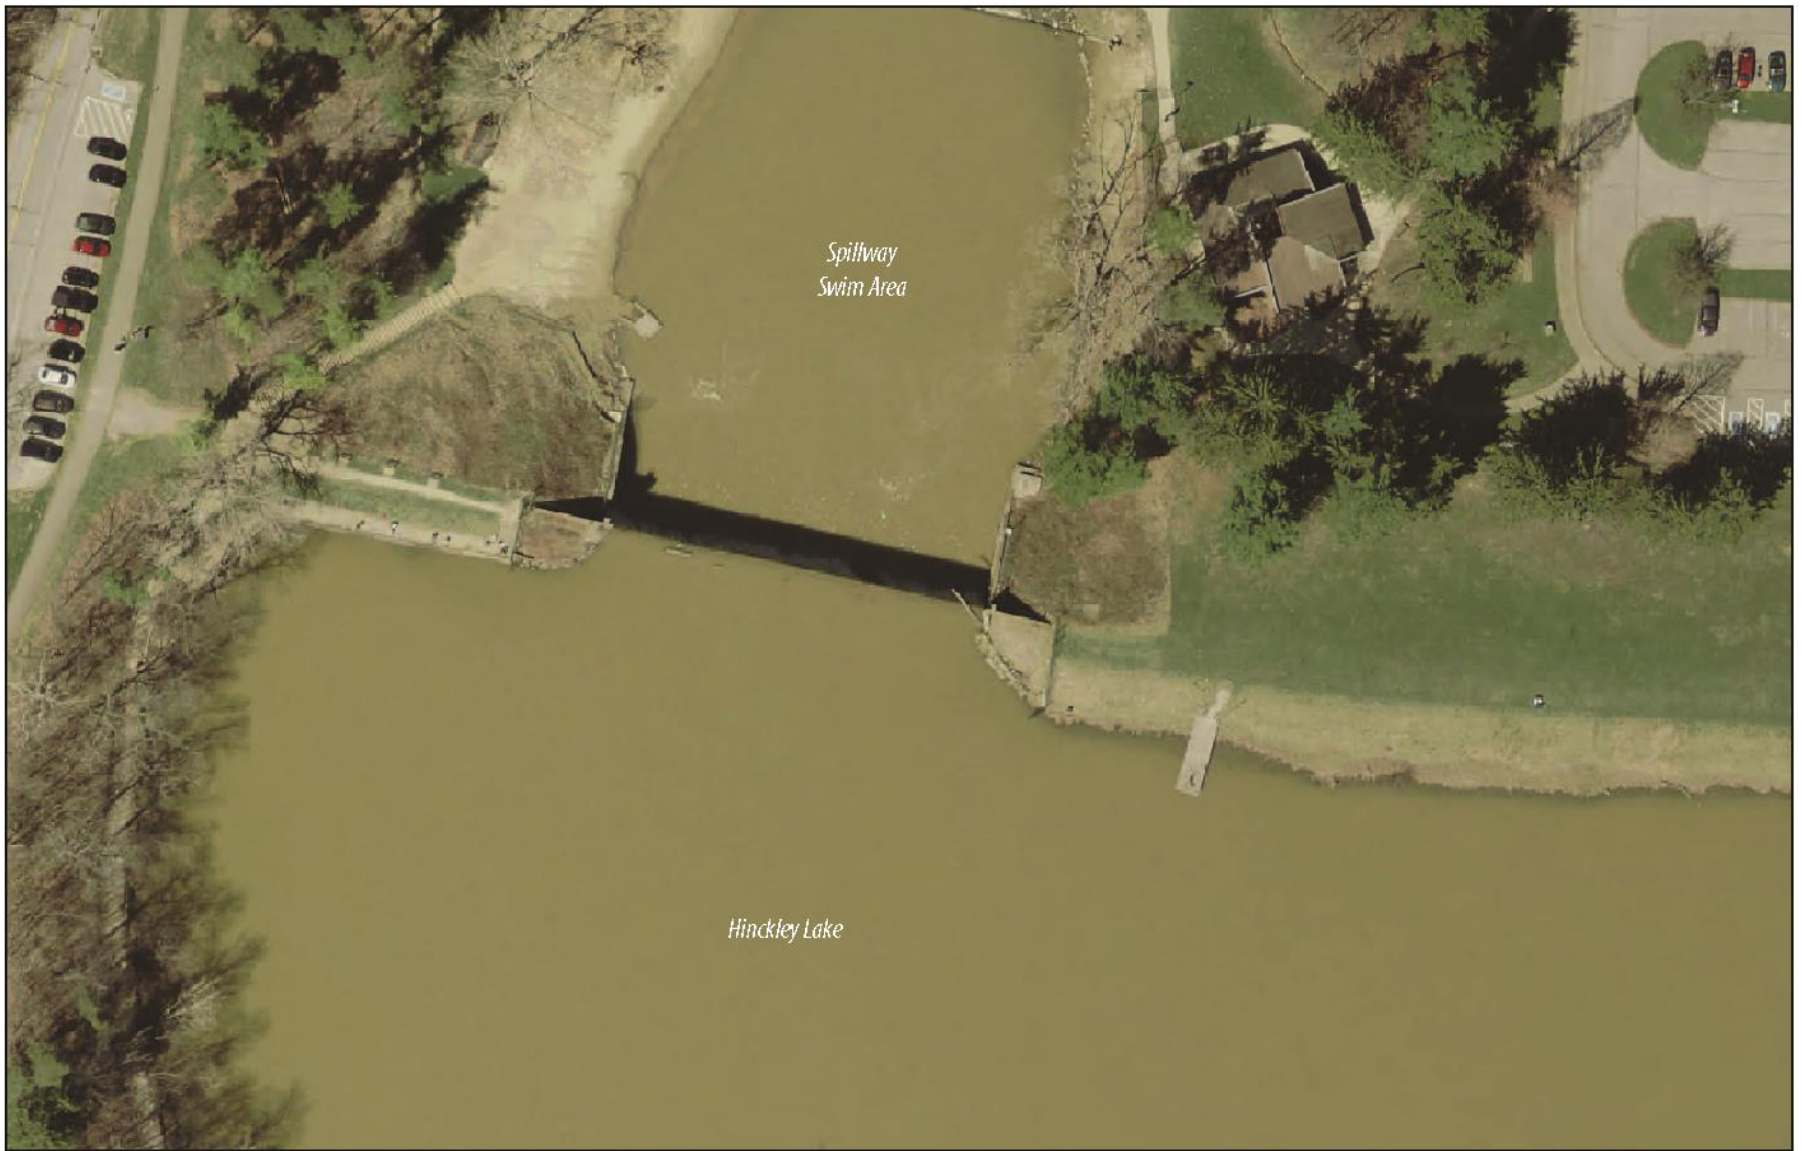
Hinckley Reservation
Existing Conditions: Dam and Spillway

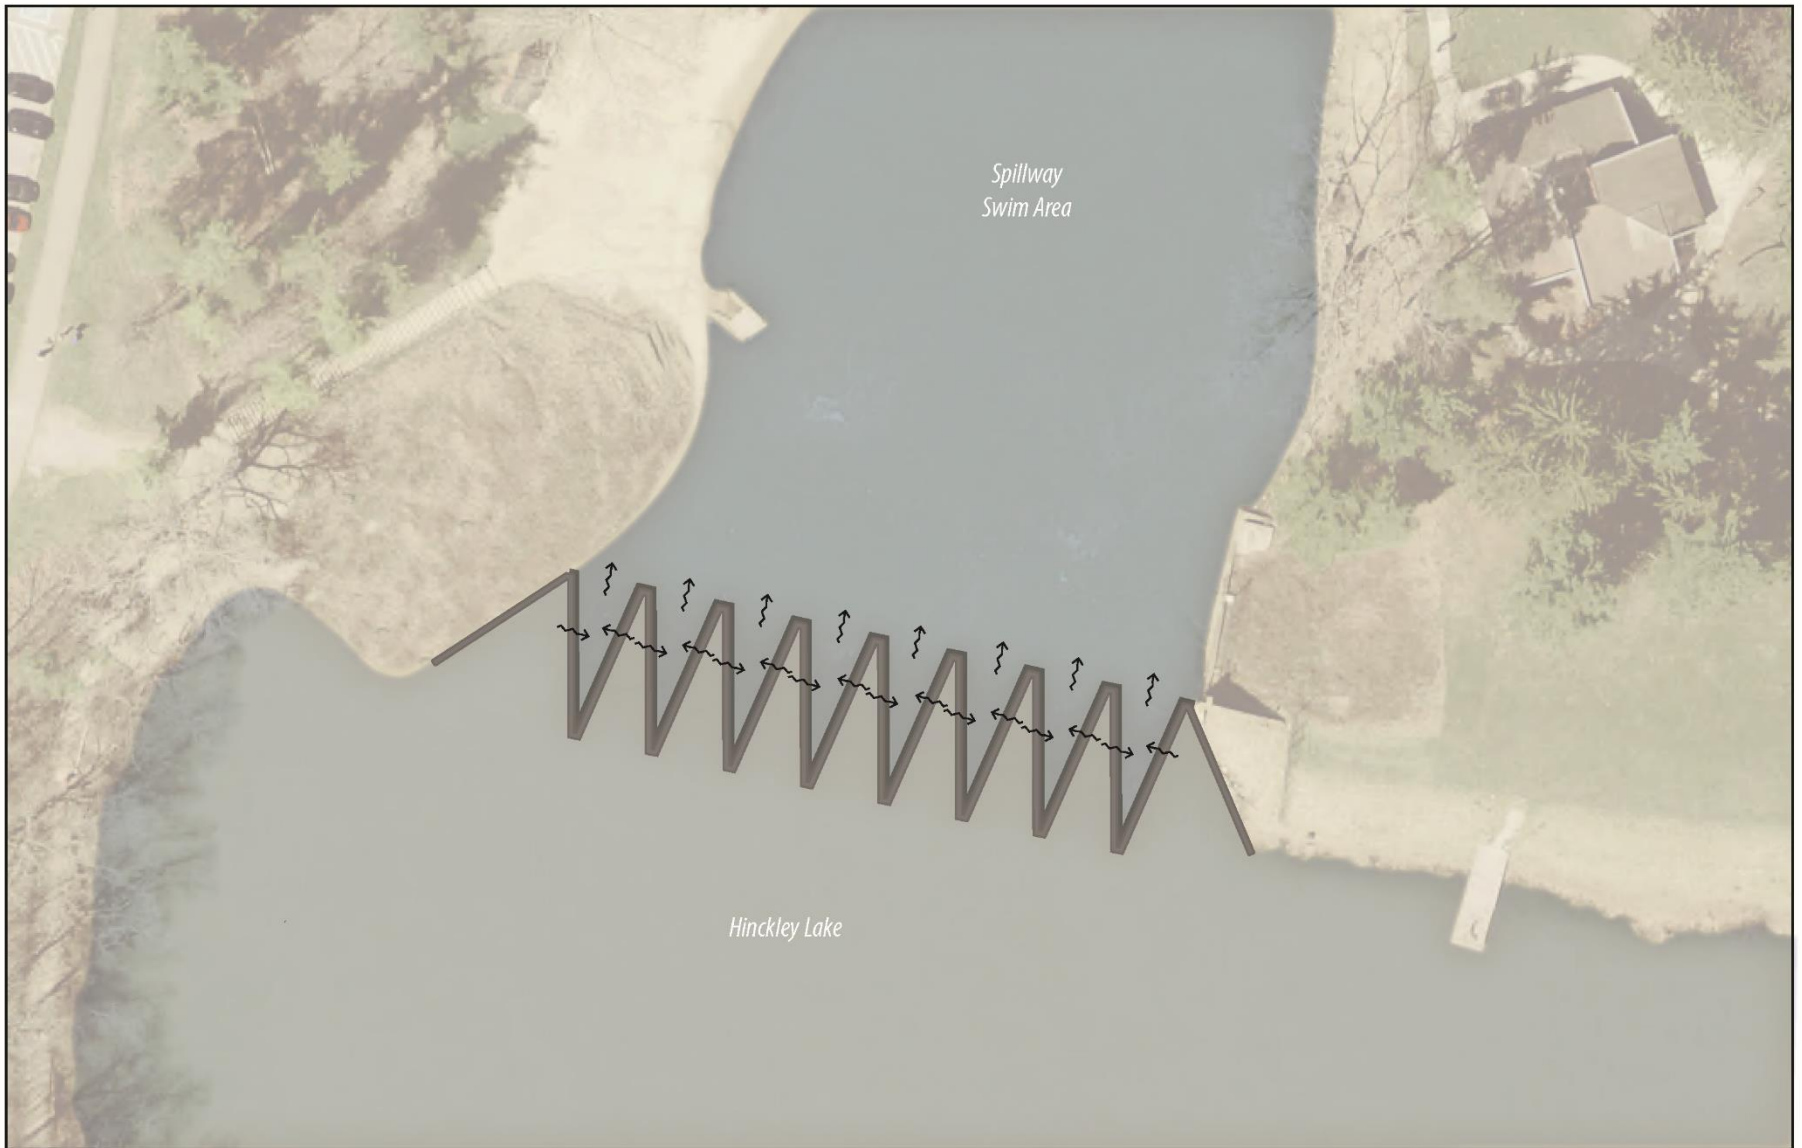
Hinckley Reservation
Labyrinth Weir Concept

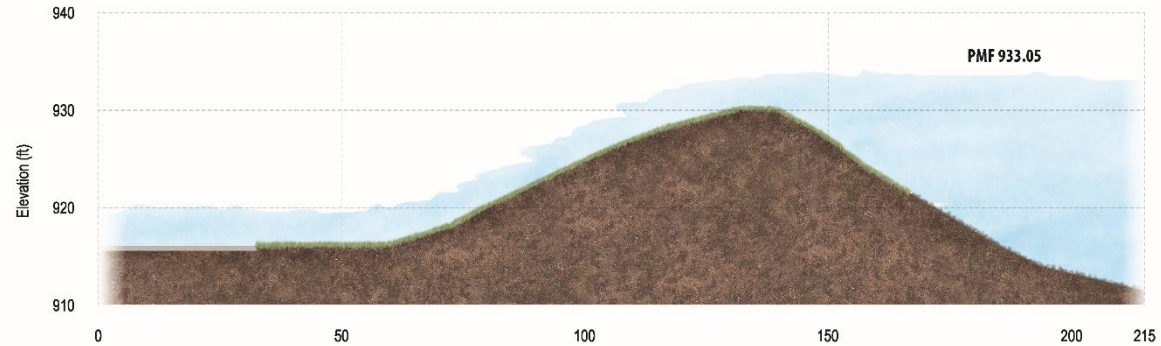
TYPICAL SECTION A - A
 HORIZONTAL SCALE: 1" = 20'
 VERTICAL SCALE: 1" = 10'

Hinckley Lake Dam – Embankment Armoring – Roller Compacted Concrete
