DOAN BROOK ESTUARY FEASIBILITY REPORT

The Doan Brook Watershed Partnership

Project No.: 11569
Date: July 8, 2019

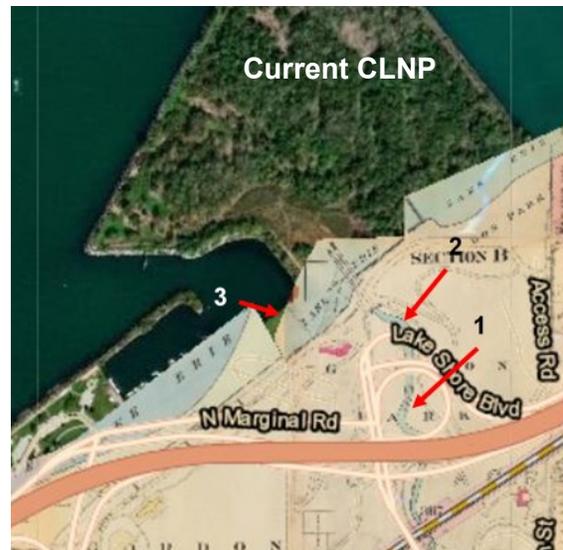
Figure 1.2 1927 Map Overlaid with Current Aerial and Roads

Examination of the 1927 aerial overlaid with modern streets provides a greater understanding of the original location and condition of the Doan Brook that have since been severely impacted. In Figure 1.2, arrow location 1 points to a historic channel alignment within the I-90 cloverleaf on-ramp. Arrow location 2 points to a meander bend in the Brook heading west towards the marina, which is very near to the original lake entry point. Arrow location 3 points to the existing greenspace in the corner of Dike 14. This area is bounded by a sheet pile wall and fill; behind this area is the natural shoreline, which provides good reasoning to remove it as part of the potential new estuary area.

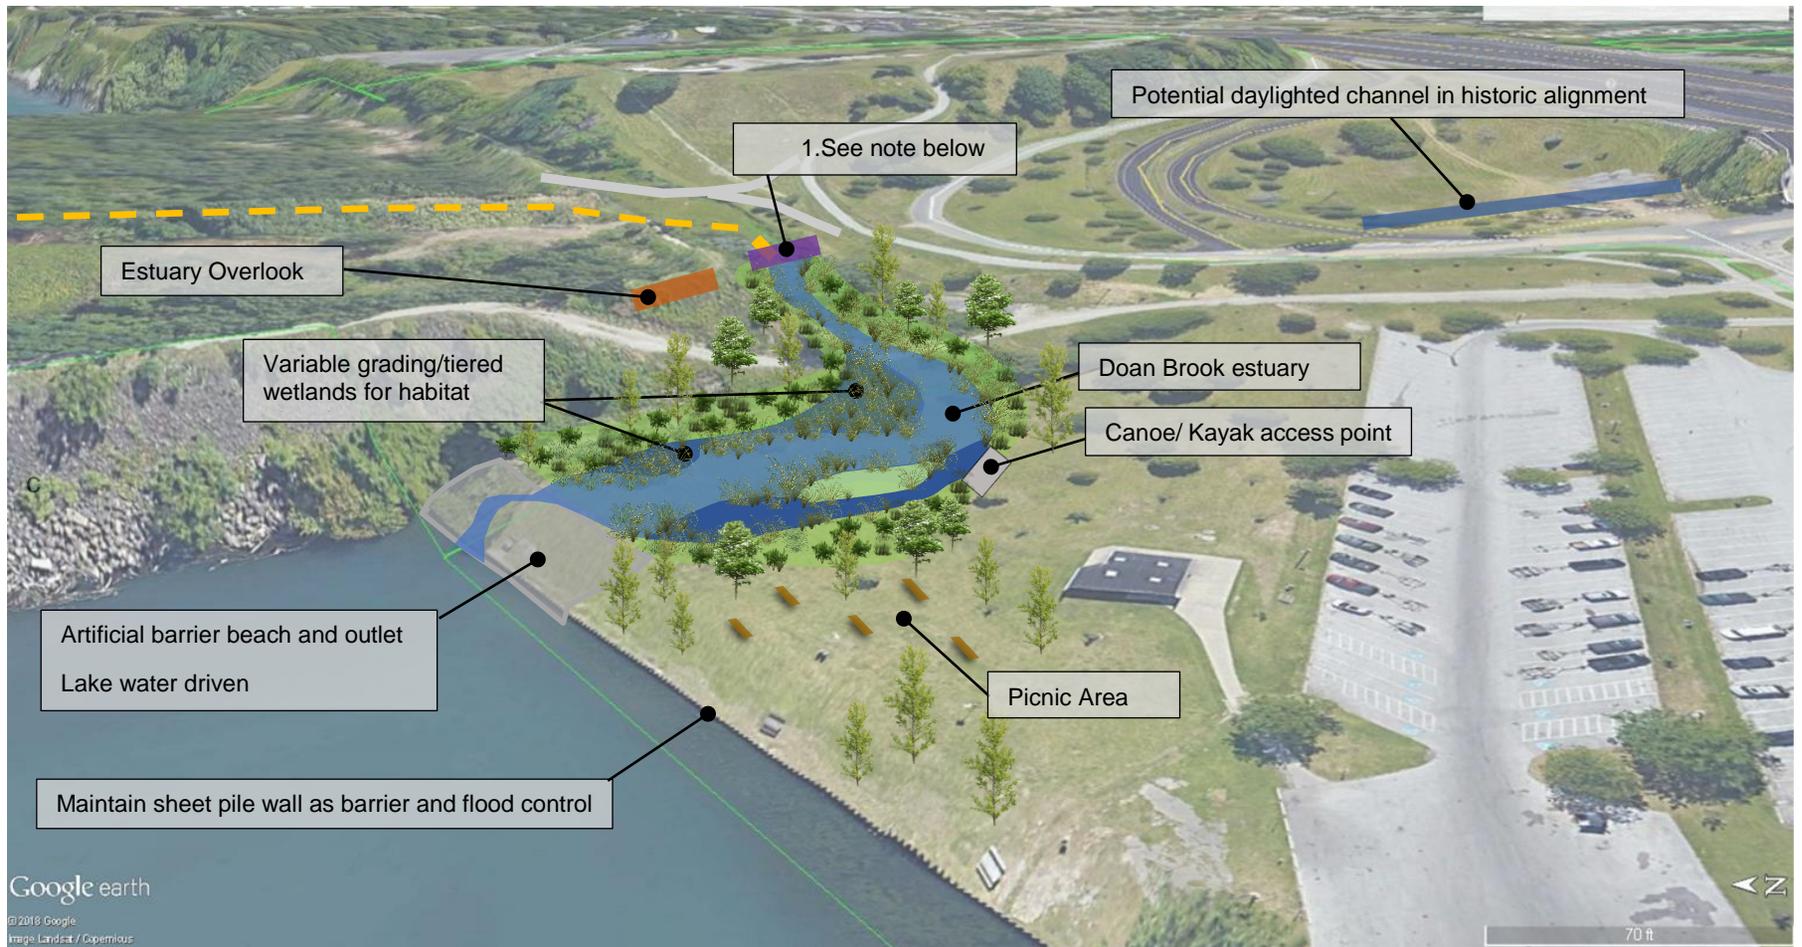
Figure 4.1 Doan Brook Estuary in Gordon Park Concept (Alternative 4)

1. Existing junction box location. See Figure 4.3.

The DBWP has proposed Alternative 4, the concept of daylighting Doan Brook within the I-90 cloverleaf (where it is currently culverted) in its historical alignment and the restoration of coastal estuary habitat in Gordon Park at the former location of the natural mouth of Doan Brook. Doan Brook, once a natural estuary with sweeping meanders, wetlands, and a barrier beach, now completely lacks access and connection to the Lake. These fundamental changes to the landscape will serve as the foundation for significant improvements in the functionality and ecology of Doan Brook. The concept also builds upon the existing habitat within the CLNP by not disturbing the integrity of the dredge spoil, thereby leveraging the positive aspects of that site and further augmenting the large lakefront preserve with an adjacent estuary connection. The concept, however, does consider the water quality concerns and existing aquatic habitat within the E. 72nd St. harbor. The goal of this concept is to achieve a more natural connection to the lake and daylight as much stream channel as possible while preserving the existing culvert infrastructure under CLNP. Preserving the existing culvert and utilizing a diversion gate structure to regulate flow from the Doan Brook allows for the creation of estuary conditions when water quality is optimal while minimizing concerns regarding impacts to water quality and fish currently using the E. 72nd Street harbor. In total, the restoration would result in over 760 linear feet of restored channel and over 1.7 acres of lacustrine wetland at the mouth of the Brook (Figure 4.1).

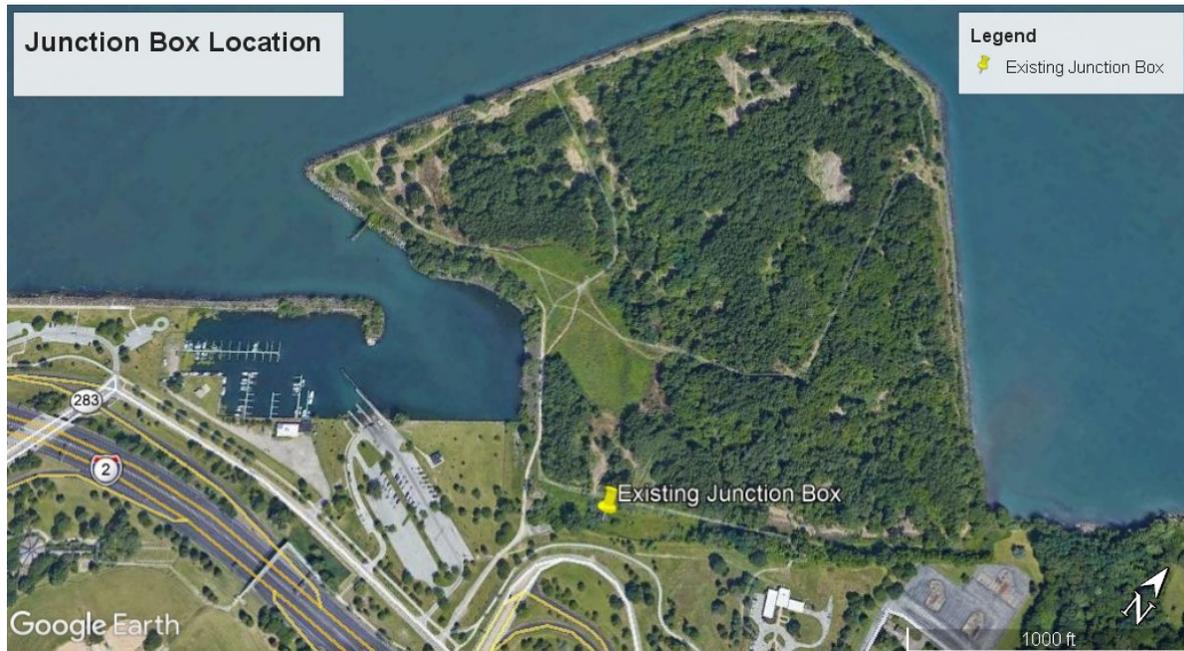
Figure 4.2 Existing Doan Brook Culvert Junction Box Location

Restoration of a coastal estuary in Gordon Park (versus CLNP) was deemed most feasible of the concepts reviewed by the TAC (Section 2.0). The nexus between Doan Brook and the estuary would be located at the junction box currently within the CLNP (Figure 4.2).

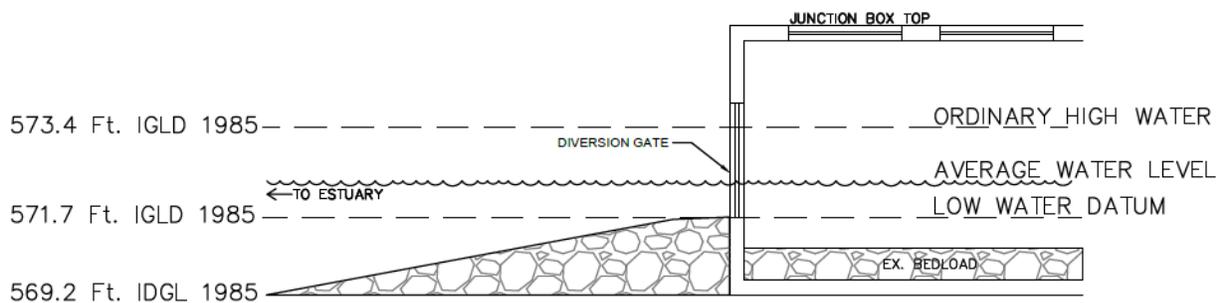
Figure 4.3 Profile View of Junction Box with Gate Control System

Due to water quality concerns potentially impacting the E. 72nd St. harbor, the existing culvert and junction box would remain in place, and a diversion gate/orifice connection would be installed in the junction box to divert flow west towards Gordon Park. The diversion gate is key to the success of the concept and to maintain a adequate water quality in the proposed estuary. The proposed gate elevation (described further in Section 9.2.5) would be set at approximately a 570 elevation. The entire MLK culvert water elevation is controlled by Lake Erie water level. Therefore, if the Lake is at a 572 elevation the water elevation in the culvert and through the new gate opening would be a 572, thereby conveying 2 feet of depth through the gate entrance. The culvert invert at the junction box location is 565 elevation thereby providing 5 feet of depth from the bottom to the proposed gate outlet. This difference in elevation eliminates any concern of heavier bedload sediments such as sand and small gravel from entering and accumulating in the new estuary. Suspended sediment or dissolved pollutants will remain the primary concern, but the gate will have the ability to seal the culvert such that flow events with water quality concerns can be separated from the estuary and continue down the existing culvert as it does currently.

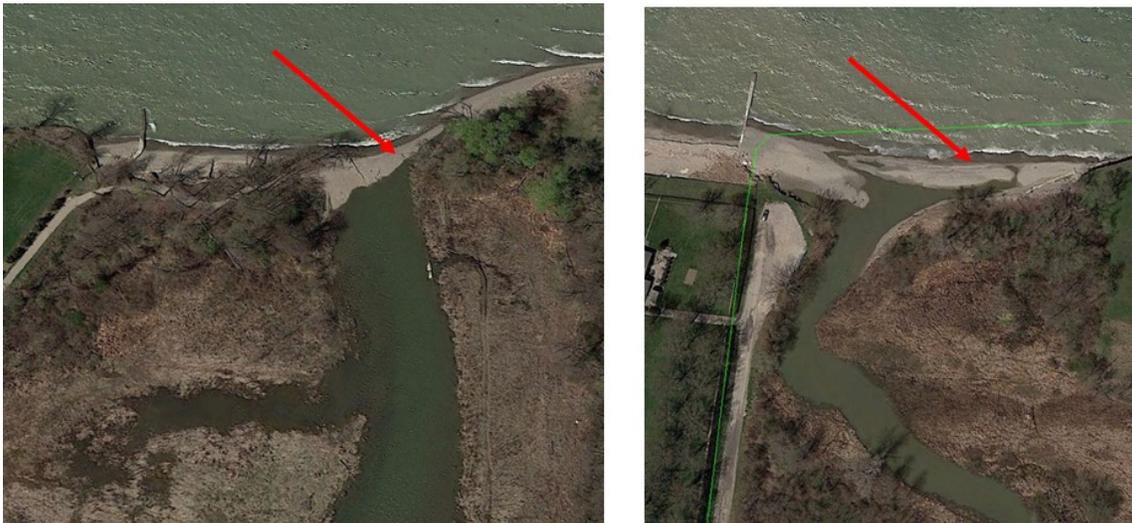
Figure 4.4 Two Examples of Natural Tributaries Confluences with Lake Erie and the Formation of a Barrier Beach

Finally, many estuary systems form a barrier beach, which is a natural phenomenon caused by the accumulation of sediment from both the tributary and lake drift (Figure 4.4). The energy differential during flood discharge into the lake causes an aggradation of material, resulting in a sediment bar or beach. This beach serves as a protection against wave action but results in a slightly higher estuary water elevation than the lake. This elevation difference causes the formation of a small riffle during baseflow, allowing concentrated flow/velocities entering the lake. These connections can be highly variable in width and dimension but are important to protect the estuary from lake waves. They serve as a more consistent low water elevation control that is important for plant development and nursery habitat for fish.

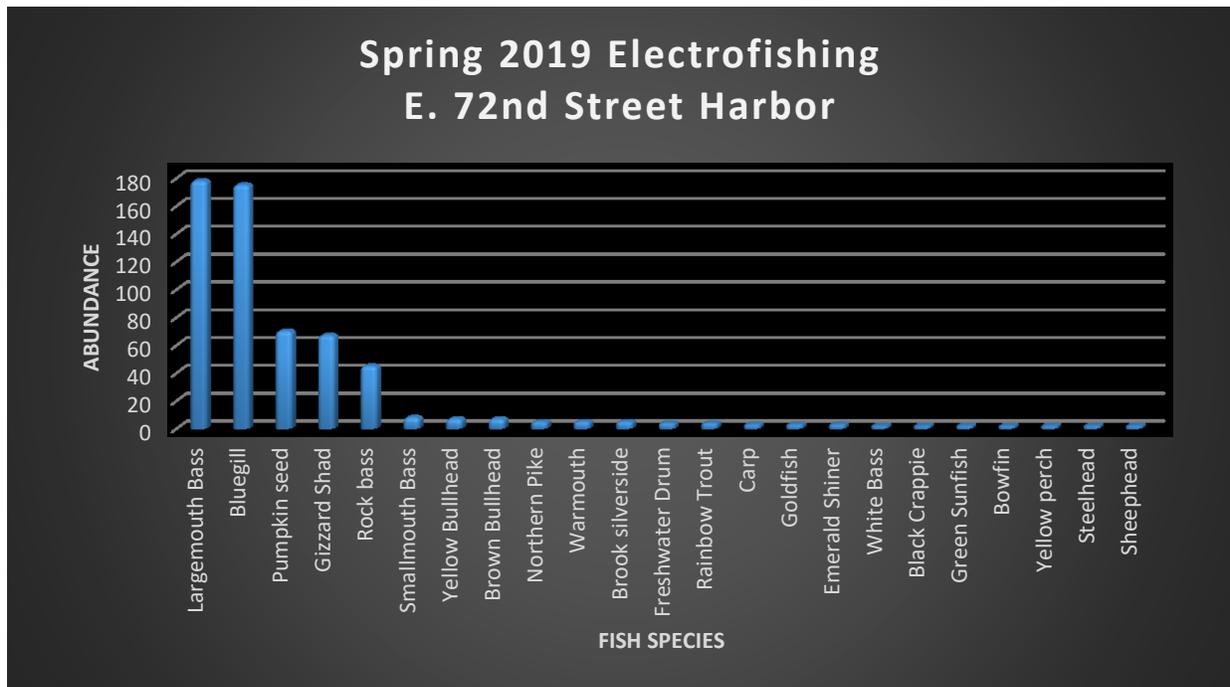
Figure 5.1 Fish Species Abundance in the E. 72nd Street Harbor in Cleveland, Ohio

As a result of these concerns, additional water quality and fish data was collected during the feasibility study by EnviroScience, NEORSD, and Cleveland Metroparks. Electrofishing was conducted in the E. 72nd St. harbor on April 2, 18, and 30, 2019. Species presence was recorded on April 18, but abundance was not. For the purposes of this analysis, we entered a value of “1” for any species that was observed on the 18th. Twenty-three species were observed across the three electrofishing efforts (Figure 5.1). Most of the species captured were moderately tolerant of

lower water quality. The most abundant species include Largemouth bass (*Micropterus salmoides*) and Bluegill sunfish (*Lepomis macrochirus*). Both species are part of the sunfish family (*Centrarchidae*), which is moderately tolerant of pollution and habitat alterations (EPA, 2008). The Largemouth Bass is reportedly more tolerant of turbidity than the other basses of the genus *Micropterus*, especially in waters where food is abundant (Etnier and Starnes, 1993; Miller, 1975). Bluegill Sunfish is among the most tolerant of North American fishes and can tolerate low dissolved oxygen levels as well as habitat disturbance (Baker, 1983; Matthews, 1987; Killgore and Hoover, 2001). The centrarchids, however, are vulnerable to the loss of adequate midwater and benthic food items (Ohio EPA, 1987). Next most abundant species, including Pumpkinseed Sunfish (*Lepomis gibbosus*) and Rock Bass (*Ambloplites rupestris*), are often associated with clearer waters with low siltation (Bouck, 1972; Robison and Buchanan, 1988; Jenkins and Burkhead, 1994). Rock bass regional and state tolerance classifications range from “intermediate” (Whittier and Hughes, 1998; Halliwell et al., 1999) to “intolerant” (Lyons, 1992), suggesting that their presence may be linked to the clearer vegetated waters of the E. 72nd Street harbor. Non-native species caught include goldfish, rainbow trout, and common carp; however, these species occur commonly in the Great Lakes and were relatively low in abundance. Overall, the results of the spring 2019 electrofishing efforts produced a species assemblage that is representative of an urban fishery. While these findings do not indicate that the water quality in the E. 72nd Street harbor is poor or that high-value sport fish do not utilize the harbor at certain times, it does indicate that the majority of individuals that typically use the harbor may be tolerant of limited changes in turbidity, temperature, and water chemistry.

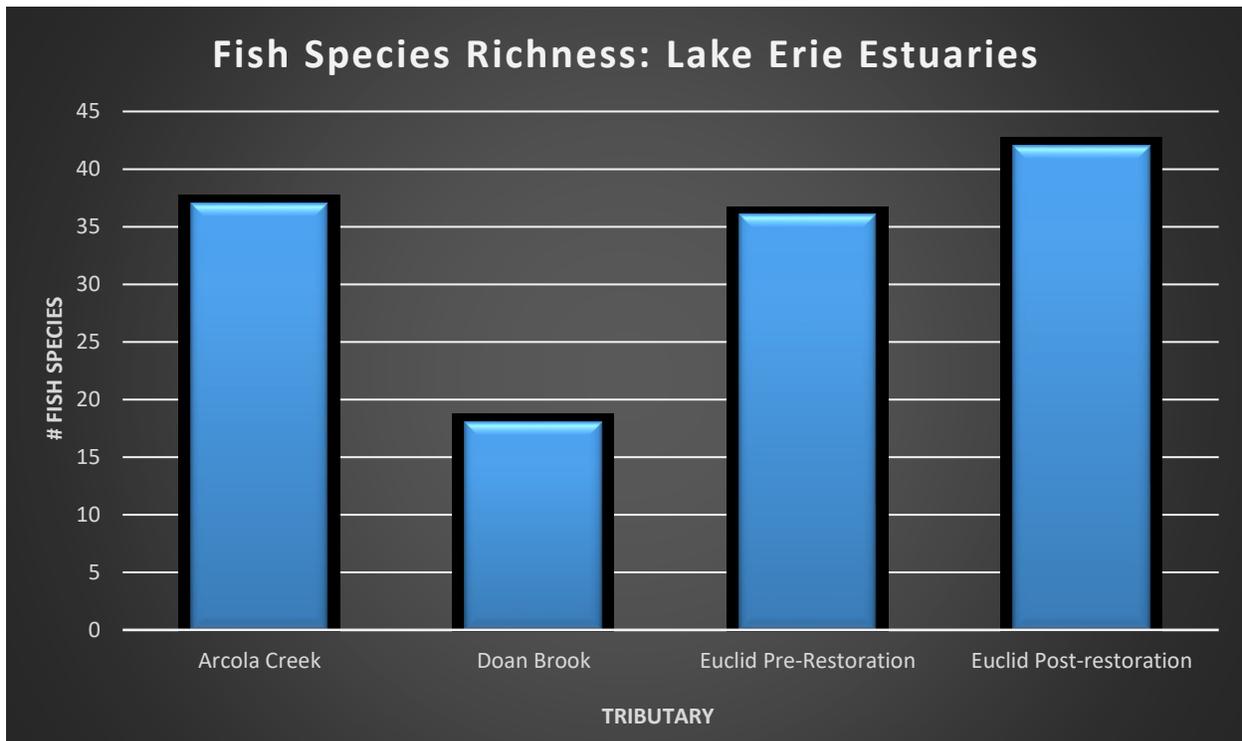
Figure 6.1 Fish Species Richness in Northeast Ohio Direct Lake Erie Tributaries

To approximate species composition in an estuary in Gordon Park, our team assessed fish species composition and richness of other direct tributaries to Lake Erie that have either a natural or restored estuary. Data collected from river miles 0-1.6 only (near mouth) were used to develop the potential fish species list to ensure that the focus was on the biological potential of the proposed estuary. Figure 6.1 illustrates the difference in species richness between current conditions in Doan Brook (near mouth) and other direct tributaries to Lake Erie with either natural or restored estuaries. Euclid Creek, in particular, is considered a useful comparison due to its similar watershed land-use/land-cover, although Euclid Creek's existing connection to Lake Erie was not altered. Arcola Creek has an intact natural estuary and natural barrier beach, which would be representative of a reference site and/ or a least-impacted condition. Figure 6.1 indicates that systems with natural connections to Lake Erie have a considerably higher species diversity than Doan Brook.

Because only a highly impacted hydrologic connection exists between Doan Brook and Lake Erie via the Doan Brook culvert at high lake levels, the fish species richness is comparatively very low. The water quality and lack of habitat in the lower Doan Brook further contribute to the lack of richness and abundance, especially in comparison to other Northeast Ohio Tributaries. In comparison with these tributaries, upon daylighting Doan Brook and restoring an estuary in Gordon Park, it does appear that significant biological uplift will be gained.

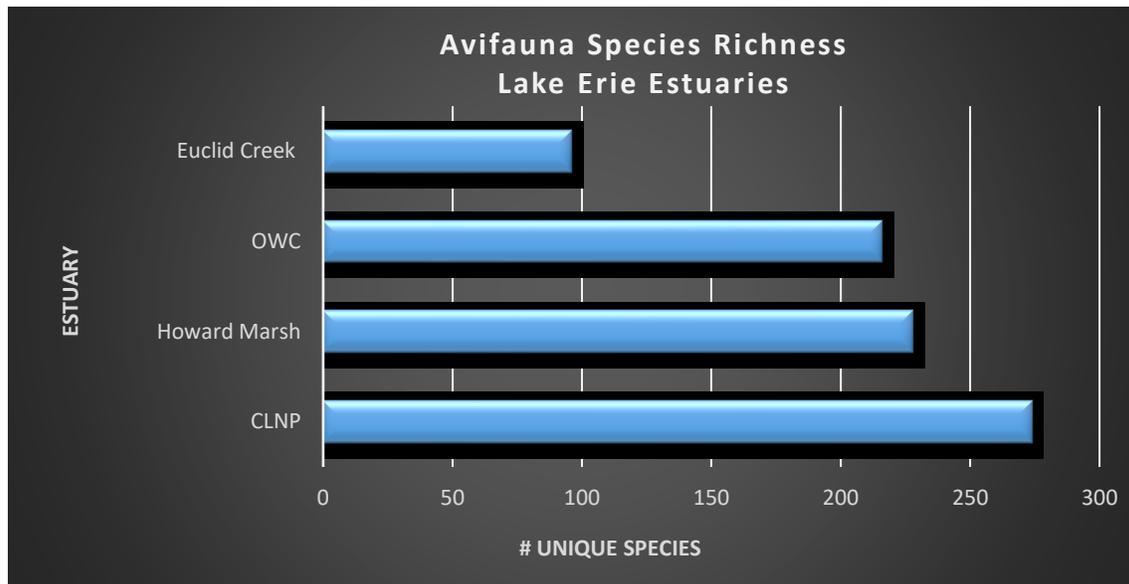
Figure 6.2 Avifauna Species Richness Across Lake Erie Estuaries

To develop the list for potential bird species to benefit from the Doan Brook Estuary, our team collected lists of current observations at nearby CLNP and combined that list with historical observations (when exposed shoreline/mudflat existed) along with data from other coastal estuaries along Lake Erie. We also compared species richness with other Lake Erie estuaries to better understand where Gordon Park and CLNP fall in terms of supporting high-quality bird habitat. To compare using consistent datasets, we graphed ebird data from Euclid Creek, Howard Marsh, Old Woman Creek, and CLNP (Figure 6.2).

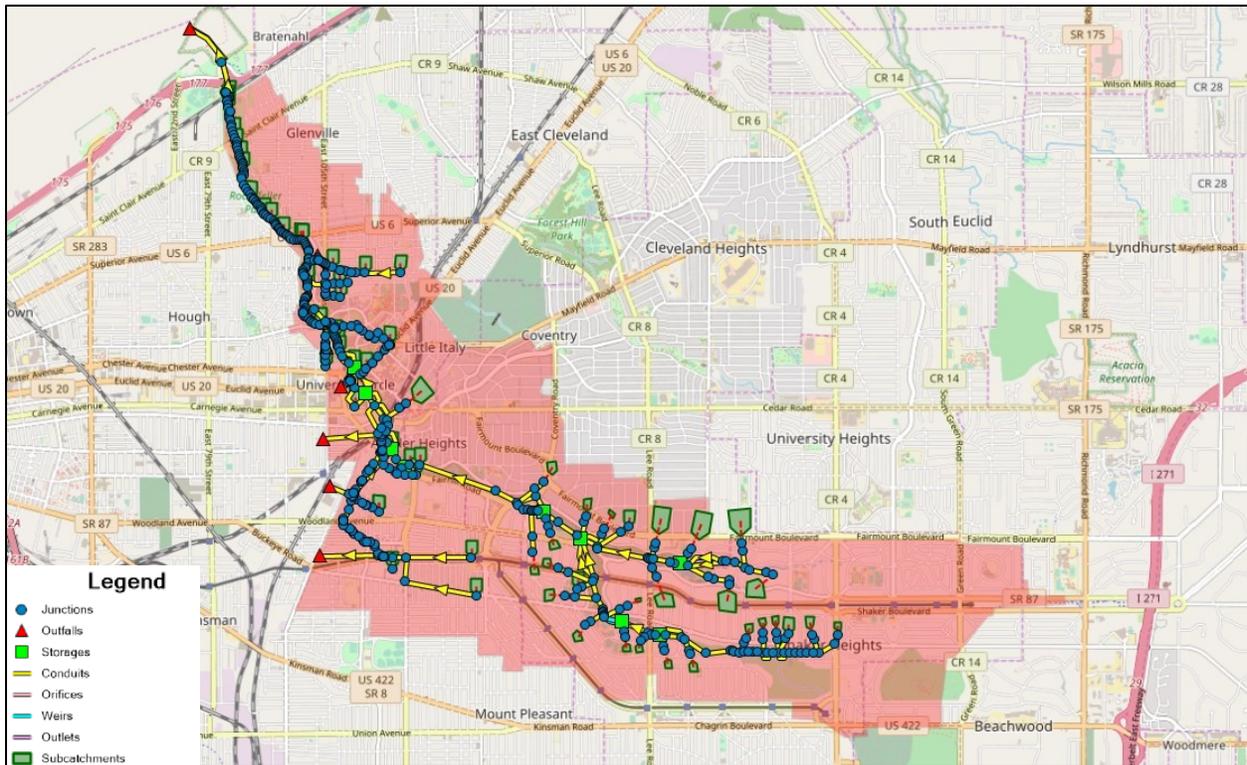
Figure 9.1 Doan Brook Model Schematic and Watershed

The Doan Brook watershed encompasses approximately 11.7 square miles within the cities of Cleveland, Cleveland Heights, and Shaker Heights and drains to Lake Erie within the CLNP. GPD Group obtained a copy of the hydrologic and hydraulic model for Doan Brook via email from NEORSD in November of 2014 for a different project in the watershed. The model was developed using the EPA Storm Water Management Model (SWMM). Based on the information contained within the model, it was imported from a previous model platform to SWMM in 2006 with updates completed in 2010. For this study, SWMM was utilized within PCSWMM software developed by Computational Hydraulics International. SWMM is the calculation engine used within PCSWMM. The vertical datum for the model is National Geodetic Vertical Datum of 1929 (NGVD 29). Included notes also indicate that the model was never fully calibrated, meaning additional work would be needed on the model for it to be usable. Figure 9.1 below shows the SWMM model schematic overlain with the overall Doan Brook watershed. Please note that while the hydraulic components of the SWMM model are generally geographically located and sized, the subwatersheds within the model were not geographically located. However, the area data for the subwatersheds does correspond to the overall watershed size of 11.7 square miles.

The existing model was reviewed to verify that none of the parameters were significantly beyond industry accepted standards. Thirteen subcatchments had storage depth parameters that were well beyond normal standards, and as no information was provided indicating why the parameters were chosen, they were revised. Additionally, the transects defining the channel and floodplain between the project area and Saint Clair Avenue were revised based on the survey provided by NEORS D stormwater master planning efforts and NEORS D LiDAR as they did not contain all the flow for large simulated events. The supplemental data was transformed from the North American Vertical Datum of 1988 (NAVD 88) to NGVD 29. Lake levels for Lake Erie were used as the boundary condition for the model and are based on the International Great Lakes Datum 1985 (IGLD 85). Lake levels were converted to NGVD 29, which is approximately 0.98 feet higher than IGLD 85 and 0.73 feet higher than NAVD 88. It should be noted that a detailed review of the model was not completed as it was outside the scope of this project.

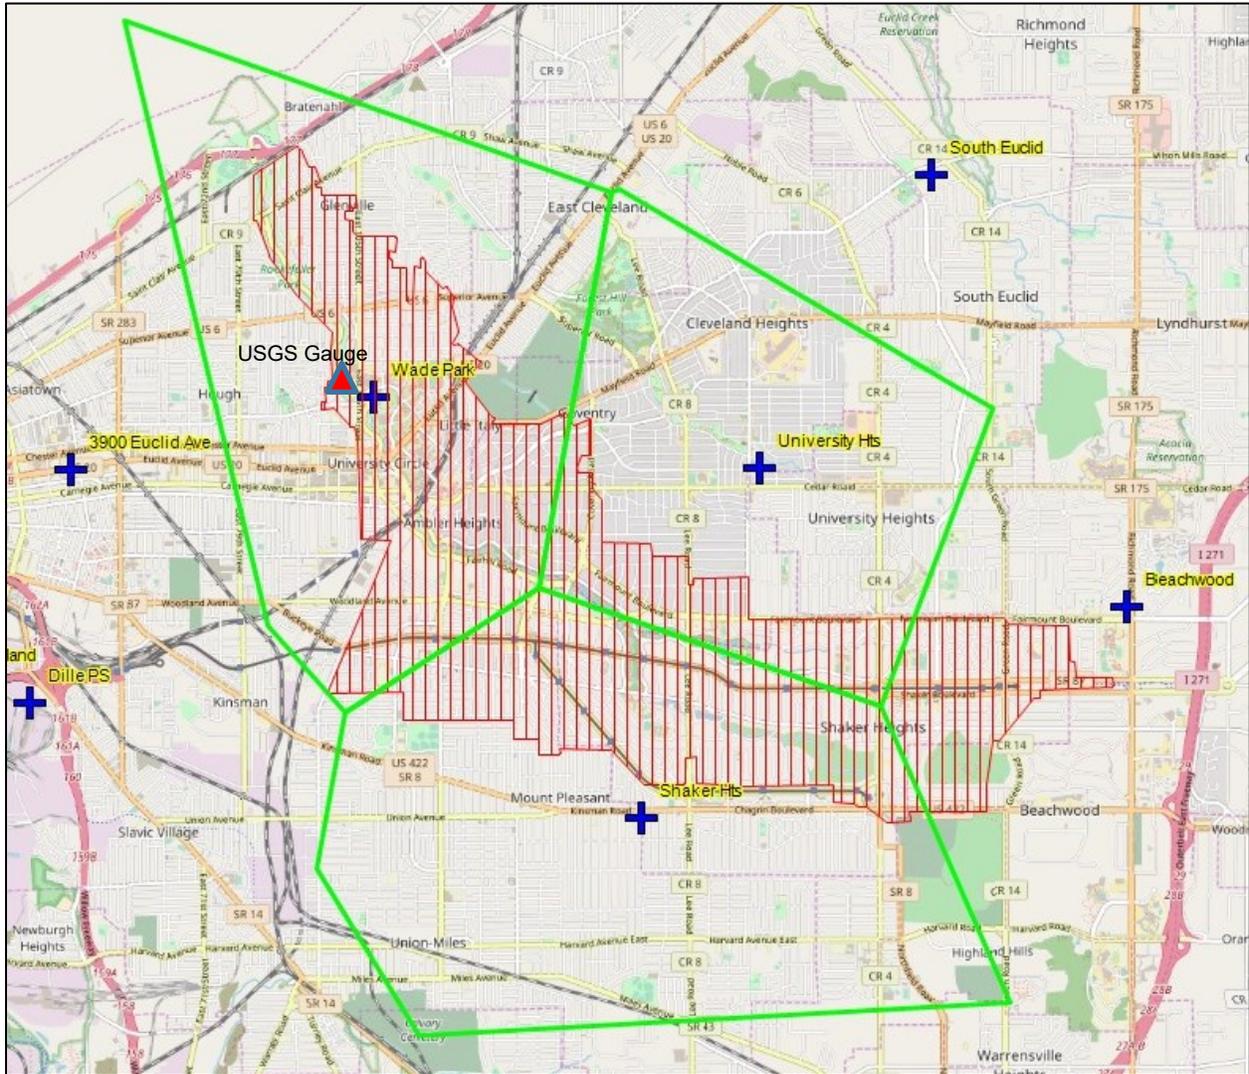
Figure 9.2 Gauge Location Map

The USGS, in partnership with NEORS D, has been maintaining a stream gauge on Doan Brook just downstream of Martin Luther King Jr. Drive and approximately 600 feet upstream of Wade Park Avenue. Discharge data is available dating back to October 2017 and gauge height data is available dating back to November 2018. The watershed area upstream of the gauge is 9.9 square miles or approximately 85% of the overall watershed. As a majority of the watershed drains to the gauge location, it was used as a calibration point for the model. NEORS D maintains rain gauges within their service area and several are within the limits of the Doan Brook watershed. Figure 9.2 shows the location of the USGS Gauge, the NEORS D rain gauges, and the Thiessen polygons used to assign the rain gauges to the proper subcatchments. As the subcatchments were not drawn to actual size, it was assumed that their location in the model was correct and as such the gauges were assigned to the subcatchments that fell within the associated

thiessen polygon. The Wade Park, University Heights, and Shaker Heights gauges were used, while the Beachwood gauge was not, as the model components didn't extend beyond the thiessen polygon for the other gauges.

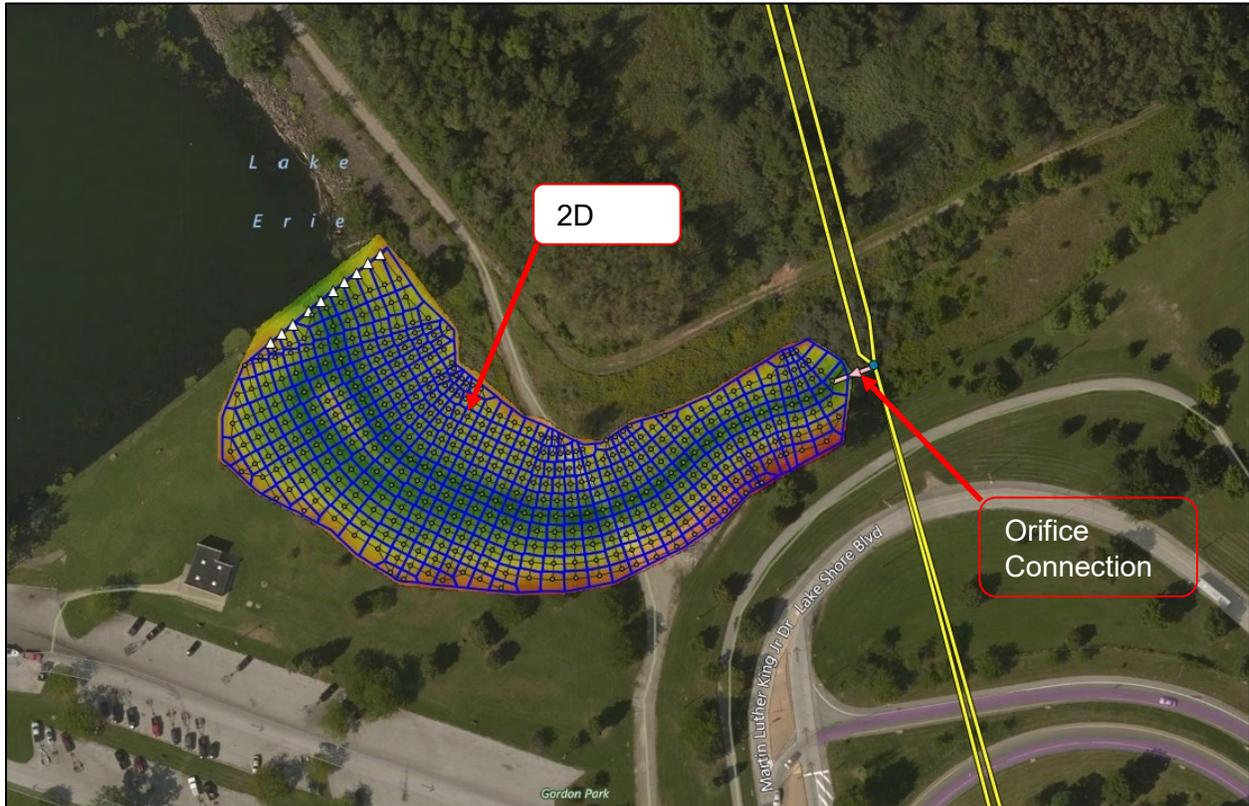
Figure 9.3 Proposed Model Schematic

features to perform a 2D analysis. A series of nodes and conduits are developed based on the proposed grading to simulate flow through the estuary. A 6-foot-wide by 3-foot-tall opening to divert flow to the estuary is proposed in the existing structure located just north of Lakeshore Blvd. within the limits of Dike 14. The opening was analyzed as an orifice within the model and assigned an orifice coefficient of 0.6. The diversion opening is proposed to be approximately 5 feet above the invert of the existing Doan Brook structure, which will place the bottom of the opening below the level of the lake. No other significant changes were made to the model versus the existing conditions model. The schematic of the model setup is shown in Figure 9.3.

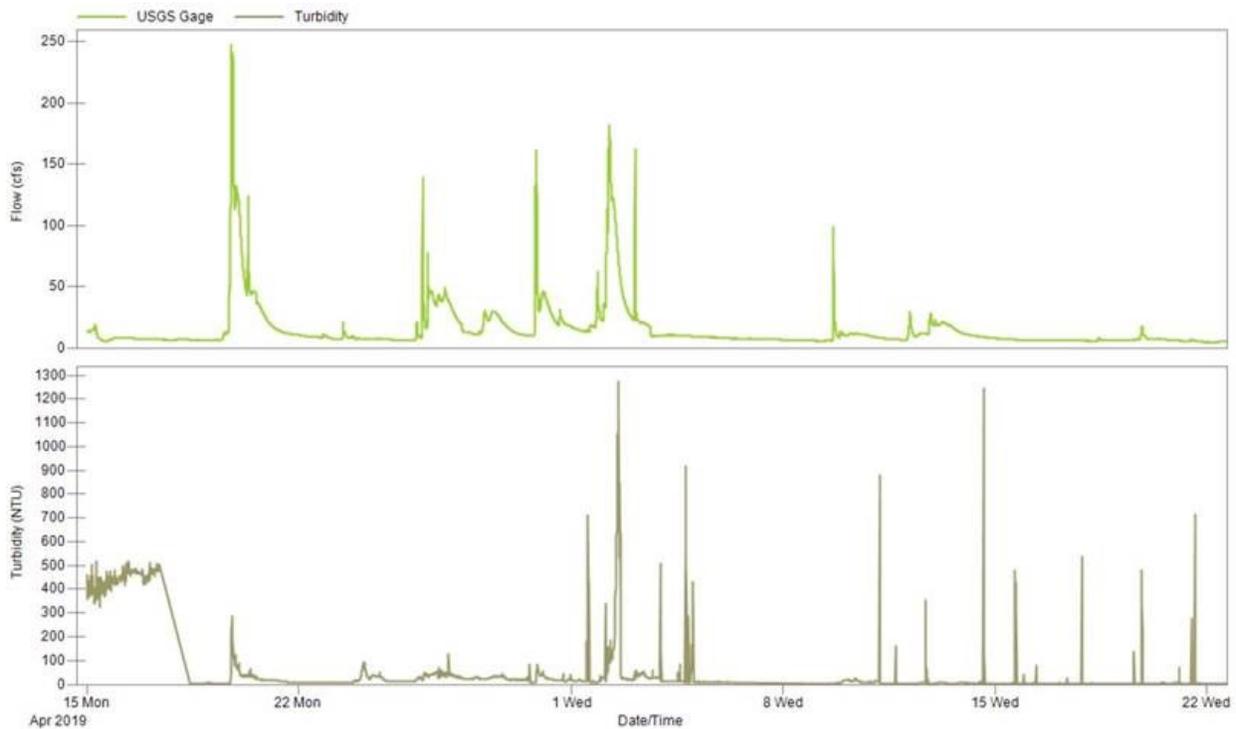
Figure 9.4 Flow and Turbidity Data for Doan Brook

Flow data for the Doan Brook was obtained from a USGS gage located approximately 3,650 feet upstream of the sonde. While the devices are not in the same location, the best available existing data was utilized for this feasibility study. Typically, flow and turbidity data are casually related; however, as you can see in Figure 9.4 below, the turbidity in Doan Brook does not always correlate strongly to discharge. In most cases however, turbidity does appear to spike following high flow events.

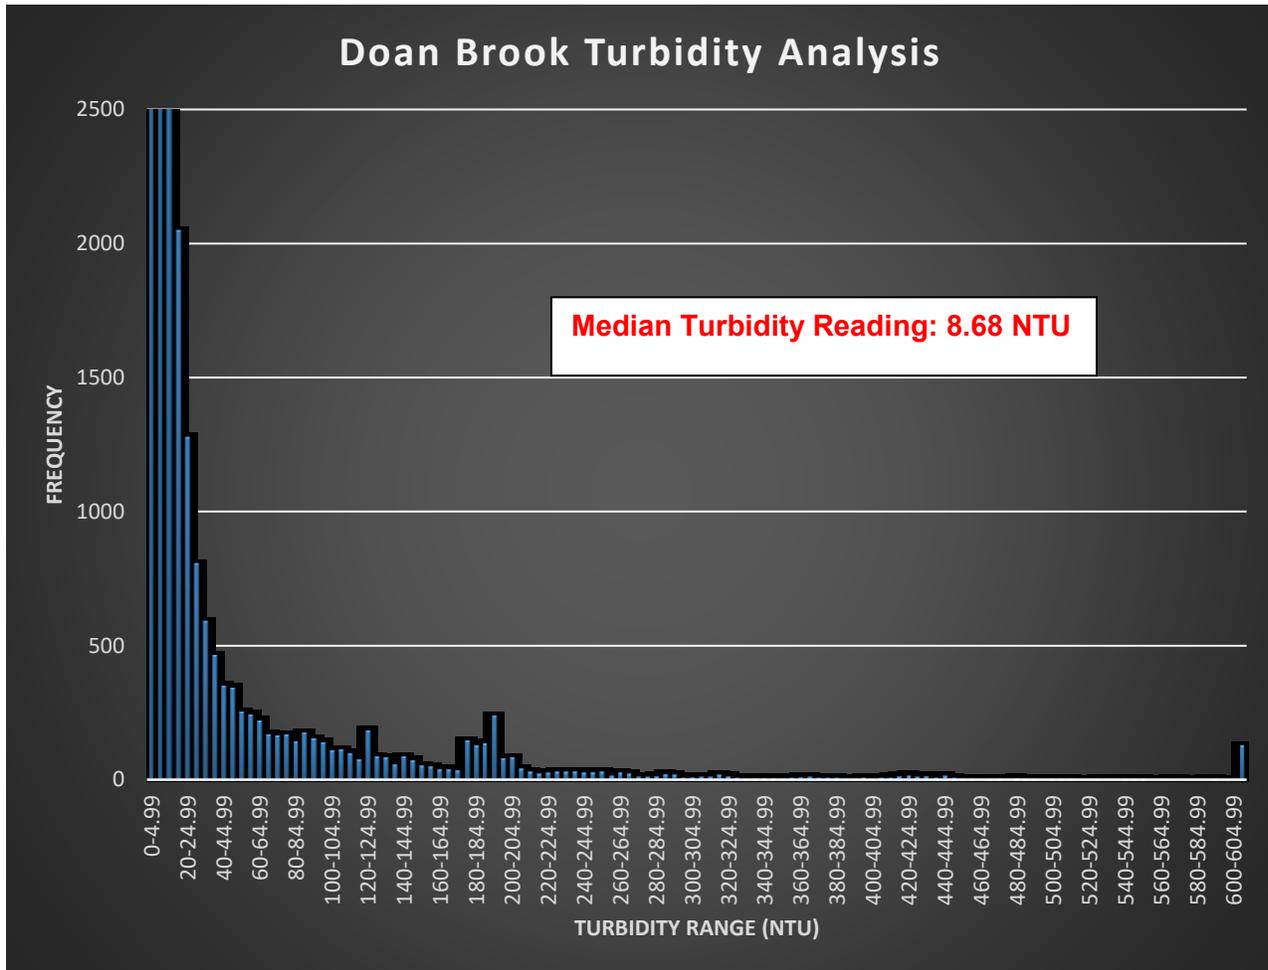
Figure 9.5 Turbidity Readings in the Lower Doan Brook from December 2017 – April 2019

Turbidity in Doan Brook falls within comparable values to turbidity readings taken from the E. 72nd Street harbor approximately 60% of the time (Figure 9.5). The average and median turbidity in the harbor was 4.1 NTU. The high was 5.3 and the low was 3.0 NTU. While this turbidity is very low, especially for open water, the turbidity of the Brook was often close in range. This finding is likely because at the time the data were collected, Lake Erie levels were nearing record highs causing a backwater condition throughout the entire culvert and the lower Doan Brook. In comparing the two water bodies, we chose to compare the median reading versus the average because there were outliers in the data from the Doan Brook sonde that did not appear to correlate with legitimate readings.

For the purposes of our analysis, we divided the Doan Brook data into turbidity ranges of 5 NTUs and plotted the frequency of occurrences within those selected ranges. Approximately 60% of the occurrences fall within 0-10 NTU. Twenty-four percent of datapoints fell between 10 and 20 NTU, at which point the frequency drops sharply. Eight percent of the data exceeded ranges of 100-104.9 NTU. This data suggests that in order to prevent a negative impact on harbor water quality, water from the Doan Brook should be reduced or cut off from the potential estuary during high-turbidity events (typically following very heavy rainfall).

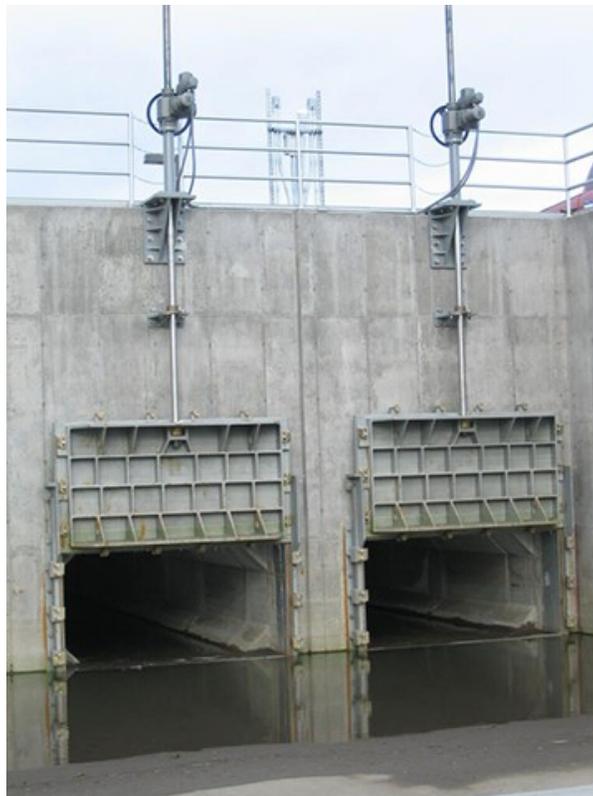
Figure 9.6 External Gate Example with Electric Motor

EnviroScience and GPD investigated mechanisms to control the flow from the Doan Brook culvert into the proposed estuary during periods of high flow at the existing junction box. Gates could be mounted either inside or on the outside of the existing junction box. After evaluating several gate and weir options, an externally mounted gate appeared to be the most effective solution to manage sediment and water quality (Figure 9.6). This gate will provide the control necessary and would be more cost-effective than a gate mounted inside the junction box. Other options for control could be backflow prevention devices; however, these only prevent flow in one direction and therefore would not be the appropriate tool for this project.

The proposed gate could be controlled manually by means of a hand crank, hand wheel, or an electric motor. The electric motor could be controlled remotely and therefore reduce the amount of manpower necessary to control the gate. The proposed gate should be constructed of 316 Stainless Steel, which has increased corrosion resistance versus 304 Stainless Steel. GPD contacted several manufacturers regarding a 6-foot-wide by 3-foot-tall stainless-steel gate (per EnviroScience's proposed concept). The manufacturers included:

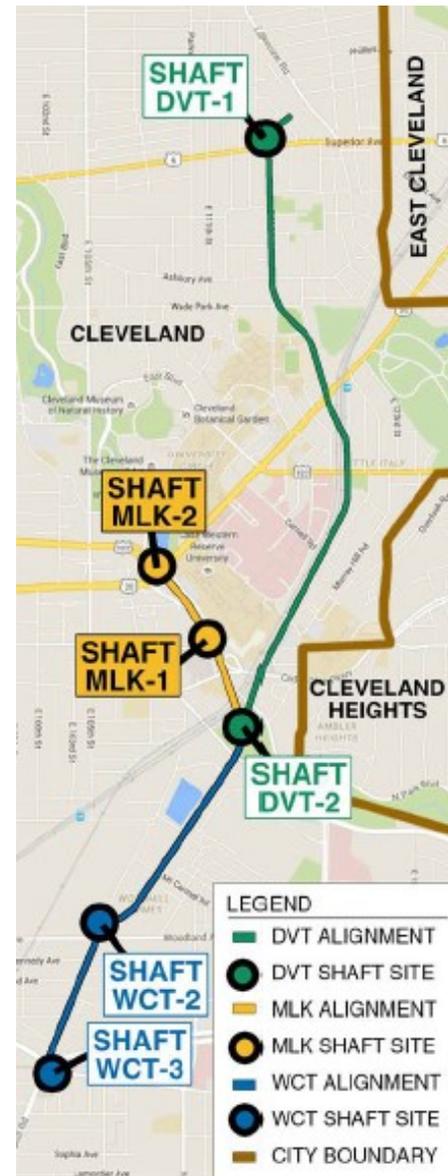
Figure 10.1 Doan Valley Interceptor Tunnel location (NEORSD, 2016)

Segment 1: DVT Segment

- Extends 10,000 feet from Ambler Park to Superior Avenue at East 115th Street.
- The 18-foot diameter tunnel is in rock at depths between 50 and 120 feet.
- Traverses three neighborhoods: Forest Hills, Glenville, and University Circle.

The Doan Valley Interceptor Tunnel is slated to drastically reduce CSO events, thereby improving the water quality of the Doan Brook significantly. The table below shows the reduction of gallons (in millions) projected for each CSO located along the DVT. These projections are based on the model calibration performed by NEORSD in November of 2018 to incorporate baseline (existing conditions modeling) to reflect a more accurate understanding of how current conditions would be affected post-DVT construction.

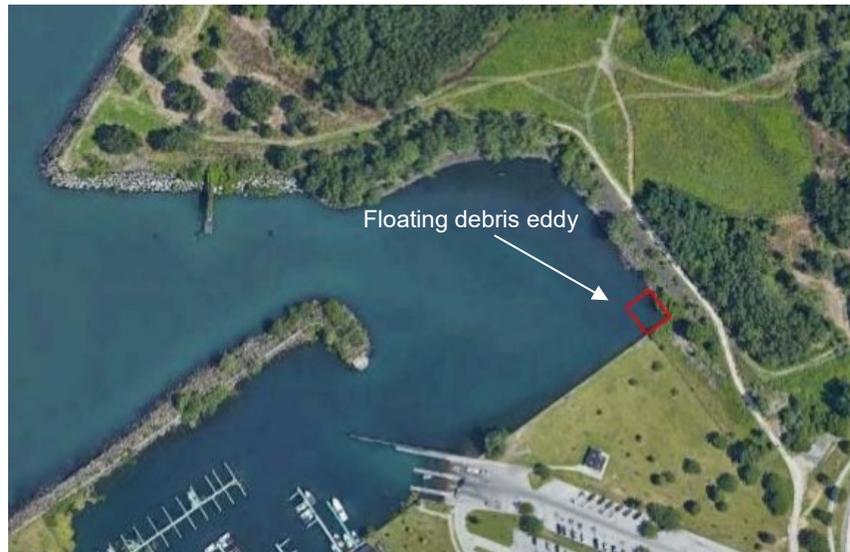
Figure 10.5 Location of Eddy Trapping Floating Debris in the E. 72nd St. Harbor

The Cleveland Metroparks, as the land manager at Gordon Park, also performs trash and debris removal near the E. 72nd Street harbor. Currently, park staff do not remove debris floating in the harbor or marina, but they do remove any debris that is washed or blown up onto the boat ramps as part of their efforts to maintain safe access to the lake (Matt Krems, Senior Park Manager, Lakefront Reservation, personal communication, May 29, 2019). After a discussion with Gordon Park staff, we learned that the floating debris mat that typically becomes temporarily trapped in an eddy in the southeast corner of the harbor (Figure 10.5) often ends up on or near the boat ramps when the winds shift. Although trash and debris does make its way into the E. 72nd Street harbor, it does not appear to affect use of the harbor or the marina.

To understand the possible impact of Doan Brook on trash flow into the potential estuary, EnviroScience used dive inspection to investigate the condition of the Doan Brook culvert between Broad Ave. and MLK Jr. Drive (entrance) and the outfall at Lake Erie. During the culvert inspection, no large debris was discovered inside of the culvert. Additionally, very little floating small debris was present, suggesting that most trash/debris is being captured upstream before Doan Brook enters its culvert. While this does not mean that debris will not be contributed from Doan Brook into the potential estuary, this investigation does provide anecdotal evidence that the debris load may not be heavy as anticipated as a result of Doan Brook's highly urbanized watershed and more complex stream channel upstream of the culvert.
