DRAFT DOAN BROOK ESTUARY FEASIBILITY REPORT

The Doan Brook Watershed Partnership

Project No.: 11569

Date: July 8, 2019

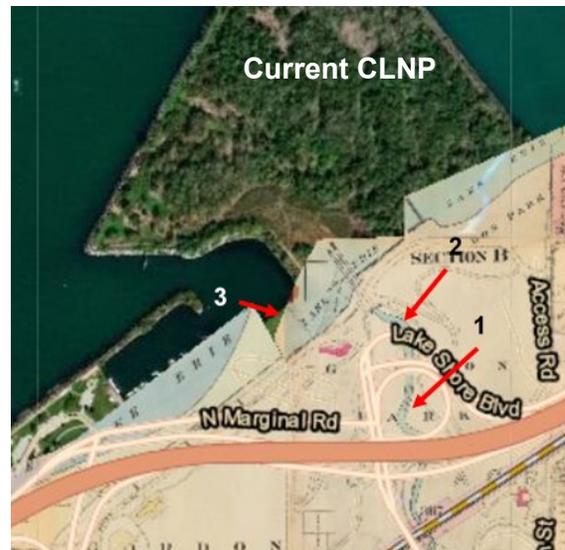
Figure 1.2 1927 Map Overlaid with Current Aerial and Roads

Examination of the 1927 aerial overlaid with modern streets provides a greater understanding of the original location and condition of the Doan Brook that have since been severely impacted. In Figure 1.2, arrow location 1 points to a historic channel alignment within the I-90 cloverleaf on-ramp. Arrow location 2 points to a meander bend in the Brook heading west towards the marina, which is very near to the original lake entry point. Arrow location 3 points to the existing greenspace in the corner of Dike 14. This area is bounded by a sheet pile wall and fill; behind this area is the natural shoreline, which provides good reasoning to remove it as part of the potential new estuary area.

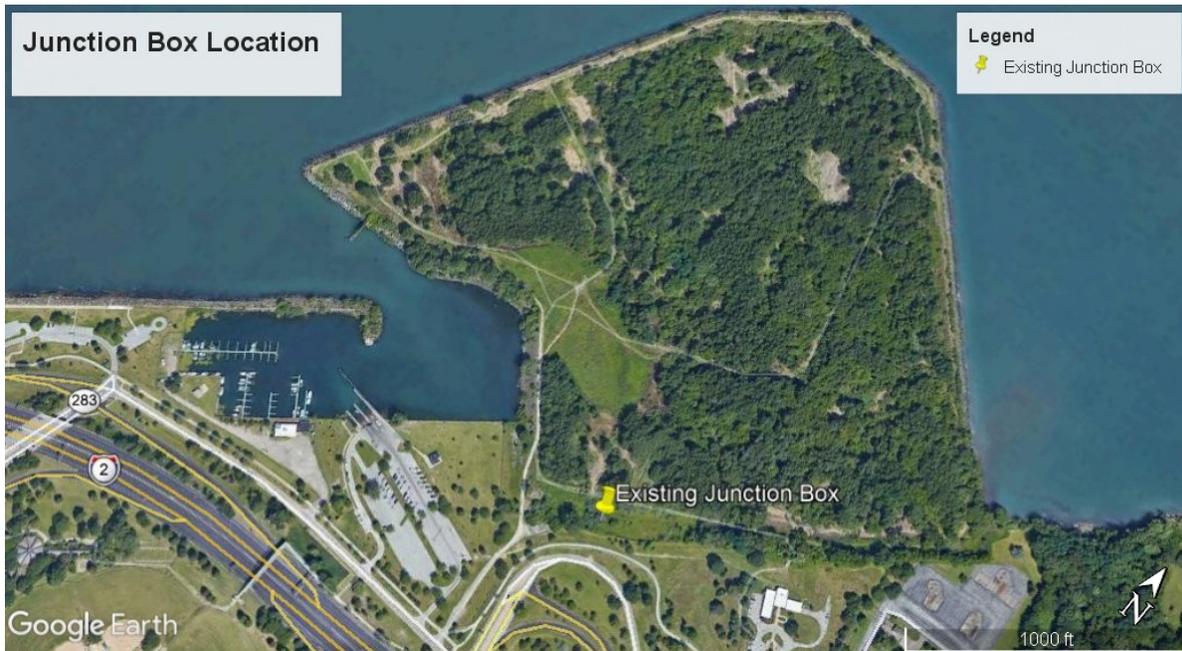
Figure 4.2 Existing Doan Brook Culvert Junction Box Location

Restoration of a coastal estuary in Gordon Park (versus CLNP) was deemed most feasible of the concepts reviewed by the TAC (Section 2.0). The nexus between Doan Brook and the estuary would be located at the junction box currently within the CLNP (Figure 4.2).

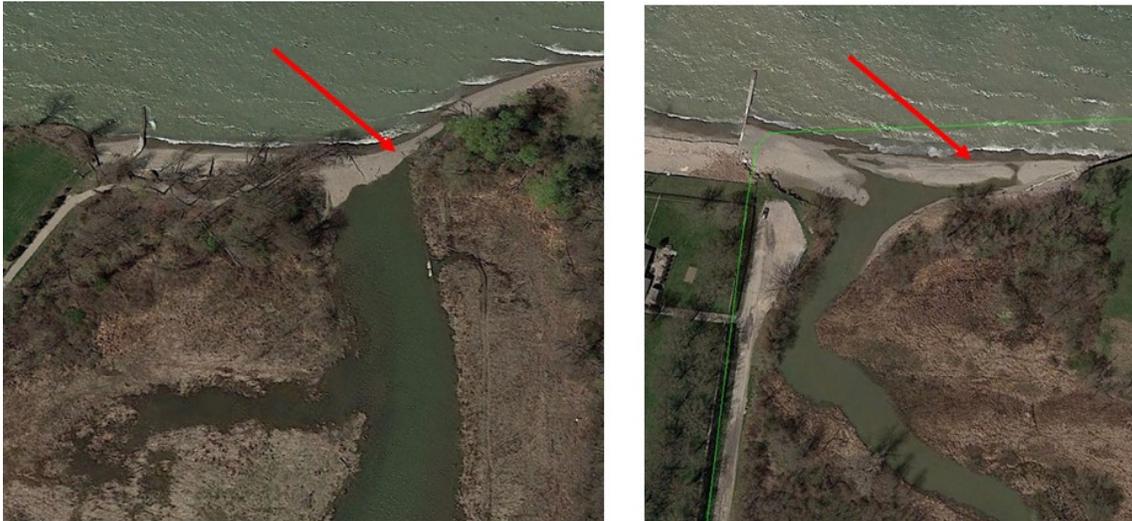
Figure 4.4 Two Examples of Natural Tributaries Confluences with Lake Erie and the Formation of a Barrier Beach

Finally, many estuary systems form a barrier beach, which is a natural phenomenon caused by the accumulation of sediment from both the tributary and lake drift (Figure 4.4). The energy differential during flood discharge into the lake causes an aggradation of material, resulting in a sediment bar or beach. This beach serves as a protection against wave action but results in a slightly higher estuary water elevation than the lake. This elevation difference causes the formation of a small riffle during baseflow, allowing concentrated flow/velocities entering the lake. These connections can be highly variable in width and dimension but are important to protect the estuary from lake waves. They serve as a more consistent low water elevation control that is important for plant development and nursery habitat for fish.

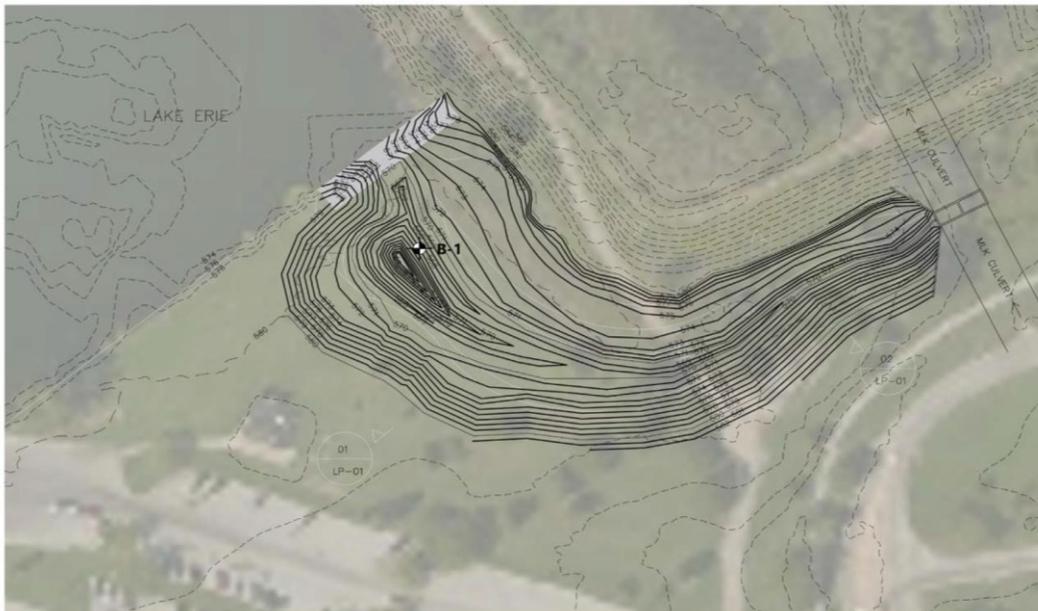
Figure 8.1 Soil Sampling (Boring) Location in Gordon Park

Wildcat and hand-augering were not productive below the grass and topsoil due to a fill soil that contained sandstone fragments. When trying to drive the Wildcat Penetrometer, GPD was met with resistance (50+ blow counts) at both test locations and could only drive it about 12 inches below the surface. To gain useful information about soils in potential excavation areas, GPD then returned to the sampling site to complete the work with a drill rig with permission of the Cleveland Metroparks. Figure 8.1 shows the location of the drill rig sampling effort, which was designed to target the area of deepest excavation according to the proposed grading plan.

Soil boring logs indicated that the soils at the sampling site are a mixture of junk fill material underlain by potentially native soils. From the ground elevation at 578 feet, the boring consisted of junk fill comprised of damp, dense, brown and black, fine to coarse sand and silt; minor gravel; and traces of brick and slag down to about 7 feet. From 7 feet below ground surface down to 12 feet, the fill was comprised of brick and slag. Beyond approximately 12 feet, the boring consisted of wet, very dense, gray and black, fine to medium sand, a possible characteristic of native glacial deposits. No petroleum was detected at the time of sampling, though soil samples have been sent for laboratory analysis.

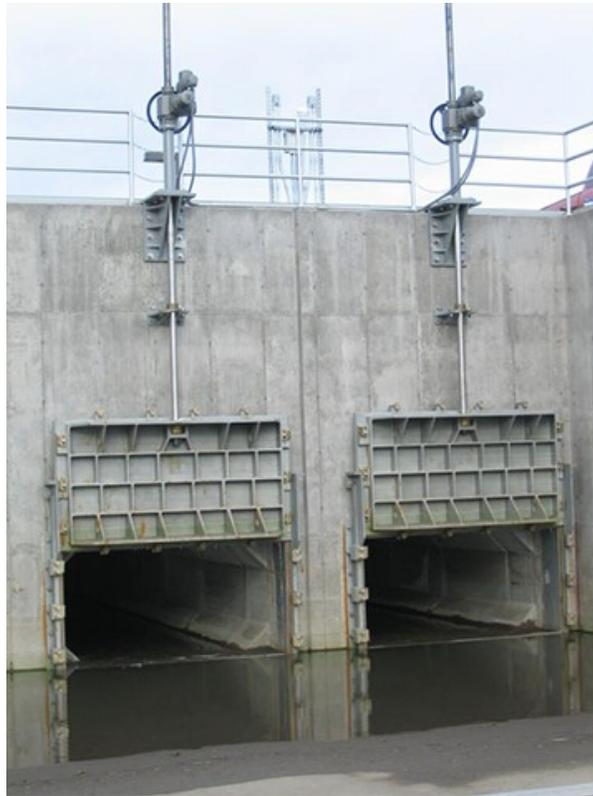
Figure 9.6 External Gate Example with Electric Motor

EnviroScience and GPD investigated mechanisms to control the flow from the Doan Brook culvert into the proposed estuary during periods of high flow at the existing junction box. Gates could be mounted either inside or on the outside of the existing junction box. After evaluating several gate and weir options, an externally mounted gate appeared to be the most effective solution to manage sediment and water quality (Figure 9.6). This gate will provide the control necessary and would be more cost-effective than a gate mounted inside the junction box. Other options for control could be backflow prevention devices; however, these only prevent flow in one direction and therefore would not be the appropriate tool for this project.

The proposed gate could be controlled manually by means of a hand crank, hand wheel, or an electric motor. The electric motor could be controlled remotely and therefore reduce the amount of manpower necessary to control the gate. The proposed gate should be constructed of 316 Stainless Steel, which has increased corrosion resistance versus 304 Stainless Steel. GPD contacted several manufacturers regarding a 6-foot-wide by 3-foot-tall stainless-steel gate (per EnviroScience's proposed concept). The manufacturers included:

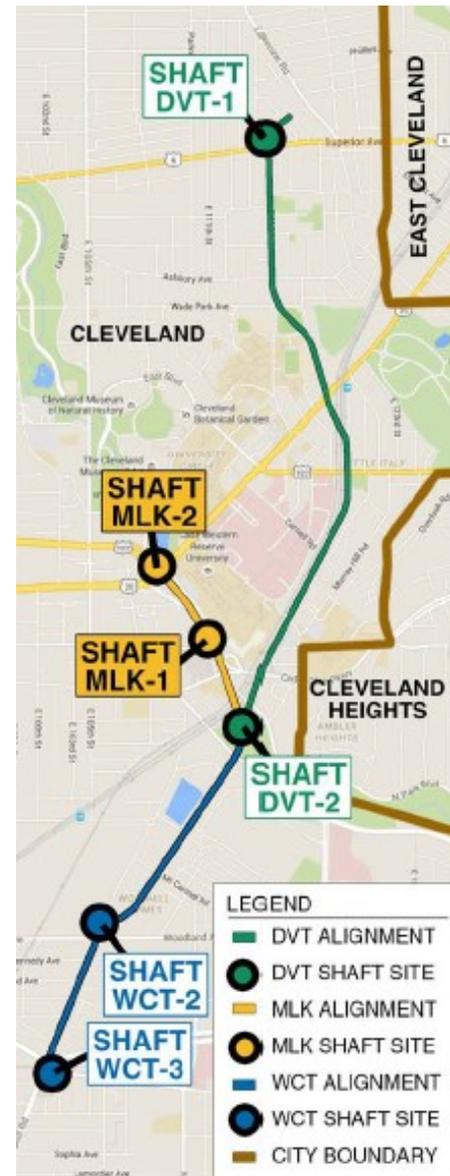
Figure 10.1 Doan Valley Interceptor Tunnel location (NEORSD, 2016)

- Extends 10,000 feet from Ambler Park to Superior Avenue at East 115th Street.
- The 18-foot diameter tunnel is in rock at depths between 50 and 120 feet.
- Traverses three neighborhoods: Forest Hills, Glenville, and University Circle.

The Doan Valley Interceptor Tunnel is slated to drastically reduce CSO events, thereby improving the water quality of the Doan Brook significantly. The table below shows the reduction of gallons (in millions) projected for each CSO located along the DVT. These projections are based on the model calibration performed by NEORSD in November of 2018 to incorporate baseline (existing conditions modeling) to reflect a more accurate understanding of how current conditions would be affected post-DVT construction.

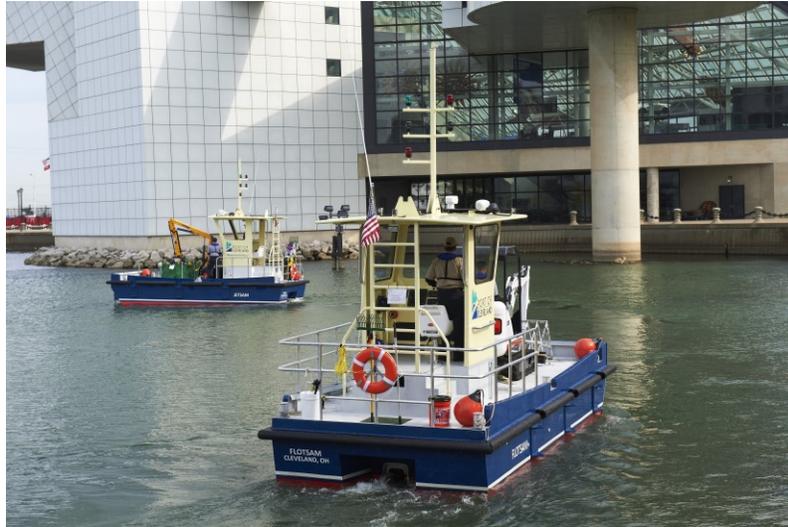
Figure 10.4 Boats Flotsam and Jetsam Removing Debris in the Cleveland Harbor

efforts to remove debris from Cleveland's waters are a partnership between the Port, the Downtown Alliance, and the Cleveland Metroparks.

While the debris removal efforts of the Port do not currently include the E. 72nd Street harbor, their efforts to remove floating debris may help to minimize floating debris pushed into the E. 72nd Street harbor by wind and wave currents.

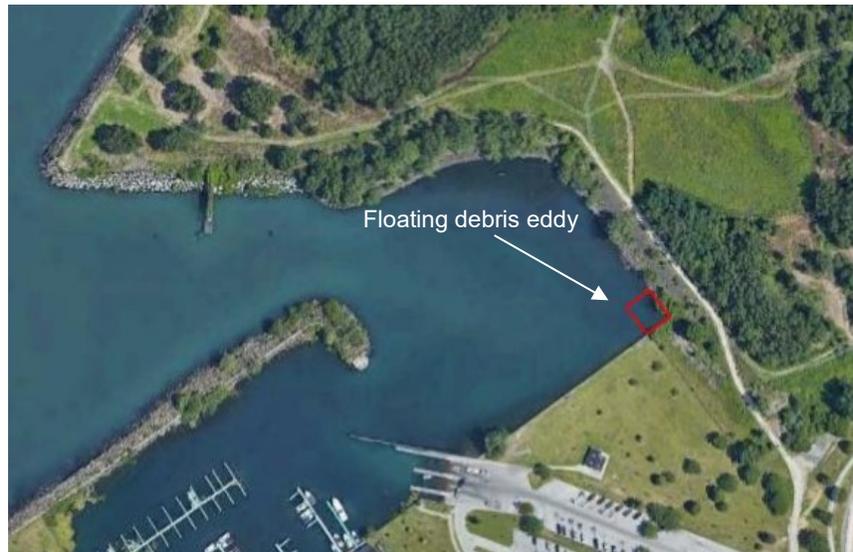
Figure 10.5 Location of Eddy Trapping Floating Debris in the E. 72nd St. Harbor

The Cleveland Metroparks, as the land manager at Gordon Park, also performs trash and debris removal near the E. 72nd Street harbor. Currently, park staff do not remove debris floating in the harbor or marina, but they do remove any debris that is washed or blown up onto the boat ramps as part of their efforts to maintain safe access to the lake (Matt Krems, Senior Park Manager, Lakefront Reservation, personal communication, May 29, 2019). After a discussion with Gordon Park staff, we learned that the floating debris mat that typically becomes temporarily trapped in an eddy in the southeast corner of the harbor (Figure 10.5) often ends up on or near the boat ramps when the winds shift. Although trash and debris does make its way into the E. 72nd Street harbor, it does not appear to affect use of the harbor or the marina.

To understand the possible impact of Doan Brook on trash flow into the potential estuary, EnviroScience used dive inspection to investigate the condition of the Doan Brook culvert between Broad Ave. and MLK Jr. Drive (entrance) and the outfall at Lake Erie. During the culvert inspection, no large debris was discovered inside of the culvert. Additionally, very little floating small debris was present, suggesting that most trash/debris is being captured upstream before Doan Brook enters its culvert. While this does not mean that debris will not be contributed from Doan Brook into the potential estuary, this investigation does provide anecdotal evidence that the debris load may not be heavy as anticipated as a result of Doan Brook's highly urbanized watershed and more complex stream channel upstream of the culvert.
